## Cultural Heritage and Science

# Architectural Inventory and Building Condition Assessment Research on Masonry Structures of Kanlıdivane Archaeological Site, Mersin

(Research Article)

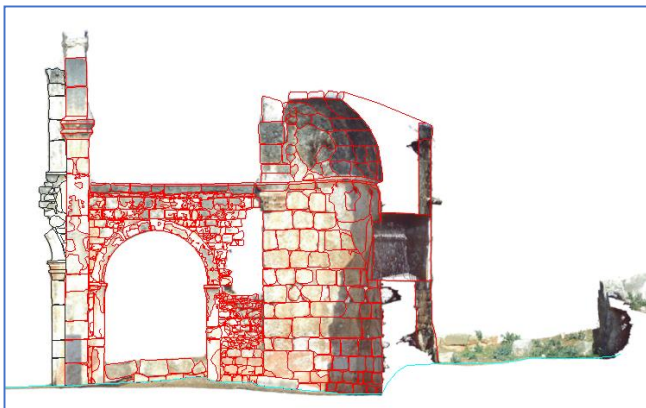
Figure 4. Architectural Survey on selected buildings

Research of building scale condition assessment has encompassed studies related to architectural survey (Figure 4) by using optical measurements techniques<sup>3</sup>, visual documentation, and detailed mapping of material deteriorations and structural deformations onto building survey drawings. Building scale studies have been conducted on the selected examples according to evaluation of site level inventory studies: The Hellenistic Tower, Tomb No 1, Tomb No 2 and Church no 4. These monuments represent characteristics of different masonry techniques applied during different historical periods (Hellenistic, Roman and Byzantine).
