# The 30 October 2020, $M_w$ 6.6 Sisam (Samos) Earthquake: Interpretation of Strong Ground Motions and Post-Earthquake Condition of Nearby Structures

**Abstract:** A major magnitude  $M_w$  6.6 earthquake struck offshore of the city of İzmir, Turkey and the city of Neon Karlovasion, Greece which has the epicenter located at north of Sisam/ Samos Island in the eastern Aegean Sea on October 30th, 2020. The moment magnitude of the earthquake has been reported variously, such as 6.6, 6.9 and 7.0 by different agencies. Seismic instruments indicate the earthquake originated at a depth of 17.2 and 21 kilometers according to the Disaster and Emergency Management Presidency (AFAD) of Turkey and USGS. Doğanbey Payamlı, Ürkmez, Gümüldür, Kavakdere are the closest coastal villages of İzmir to the epicenter. The earthquake affected the mid-rise buildings located on the soft soil and then, tsunami stroked the coastal villages of İzmir. In this study, the strong ground motion records in a distance range from epicenter to 150 km are analyzed to investigate the characteristic of the ground motions. The post-earthquake field observations mainly for the mid-rise reinforced concrete structures are re

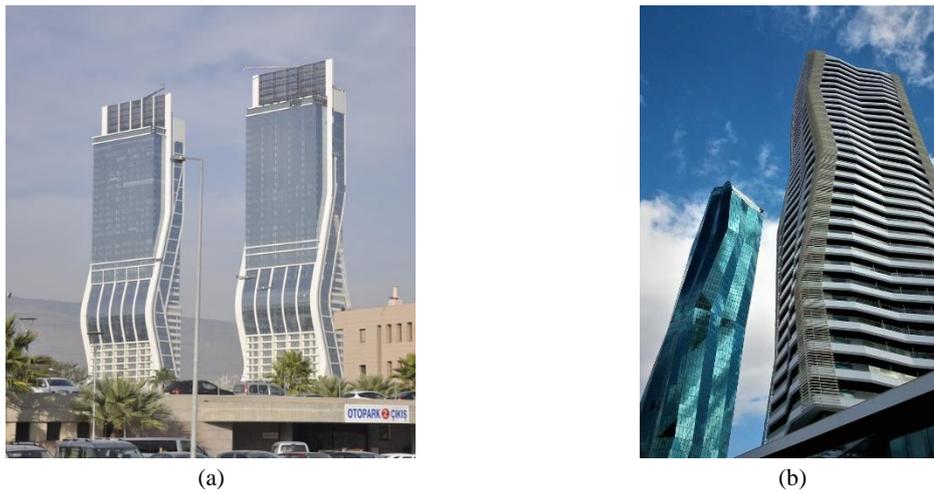
**Figure 31.** a) Folkart Towers b) Mistral Tower

Tall buildings located in Bayraklı district showed good performance except few of them which have excessive non-structural damages. The main reason of having less damage in tall buildings is considered as strong foundations with ground improvement with piles. In **Figure 31**, two remarkable tall buildings, which are Folkart Towers and Mistral located in Bayraklı are given. These two towers showed good performance at main shock and have no significant structural damage. In **Figure 32**, the only damage occurred in bridges/viaducts has been showed. The viaduct is an unfinished construction more than 10 years and the fall of the girder was the result of no lateral support connection detailing.
