The Investigation of Municipal Buildings' Environments with regard to Turkish Standards: Mersin Province Sample

Arzu BİTİGEN SAYLAM^{1,*}, Can GÜNGÖR²

¹*Gazi University Graduate School of Natural and Applied Sciences, Program of Architecture, Ankara, Turkey*

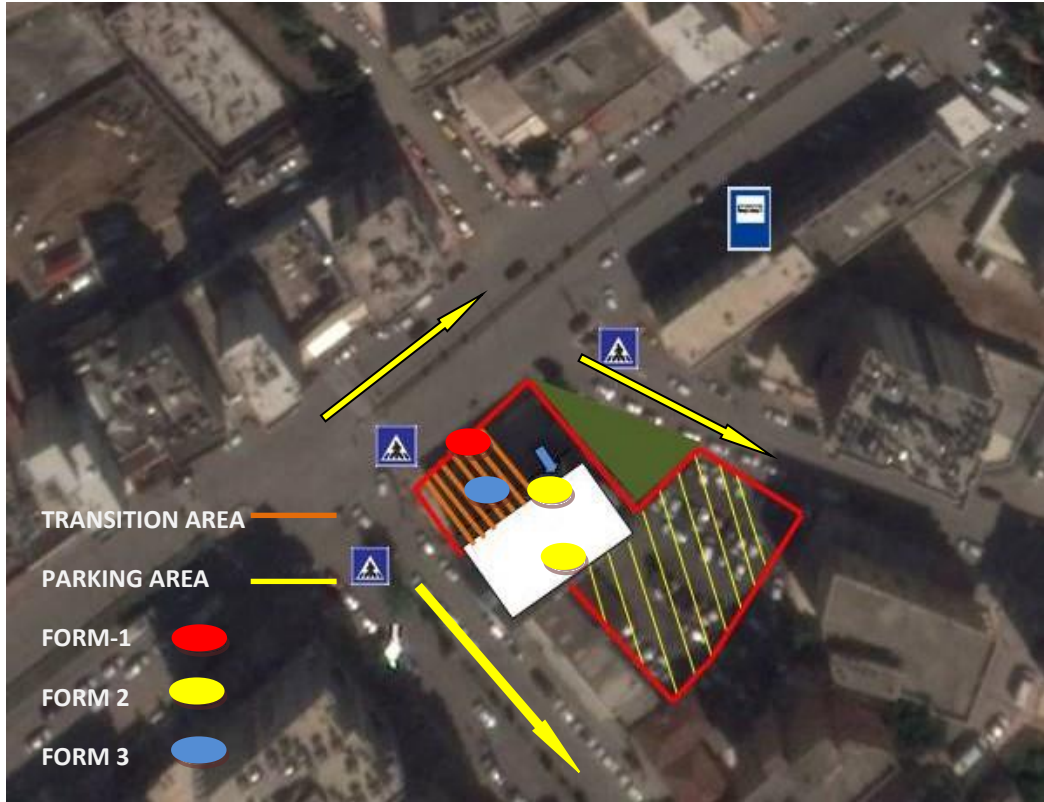
Photo 1. Mezitli Municipality Location

On three sides of the main building,roadways are located. Since it is located on the main street,it is gotten accessed from the bus stop. The implementation of

accessible route cannot be integrated with the bus stop. At the present time,the route to the bus stop is closed by some objects.

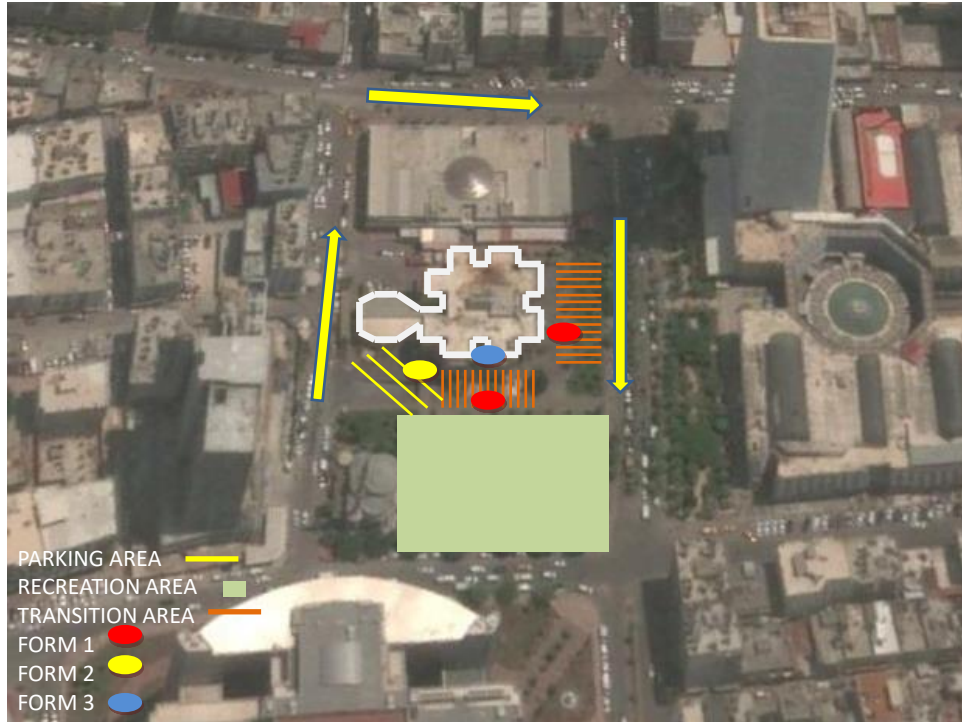
Photo 6. Akdeniz Municipality location (Photo: Arzu BİTİGEN SAYLAM, February 2016)

It is located in the city center. That a 52-storeyed high building, a courthouse and a mosque take place in the vicinity of it, has increased the density of the area. Since there is a shortage of parking in the area, users actively

use the mass transportation alternatives. The town hall with a large square, doesn't include arrangements for disabled, however, after the study, there is a layout that let the implementations to be made the easy way.
