The Restoration Proposal for Göksel Bey Dwelling in Catalca, Istanbul

Ercan Aksoy¹

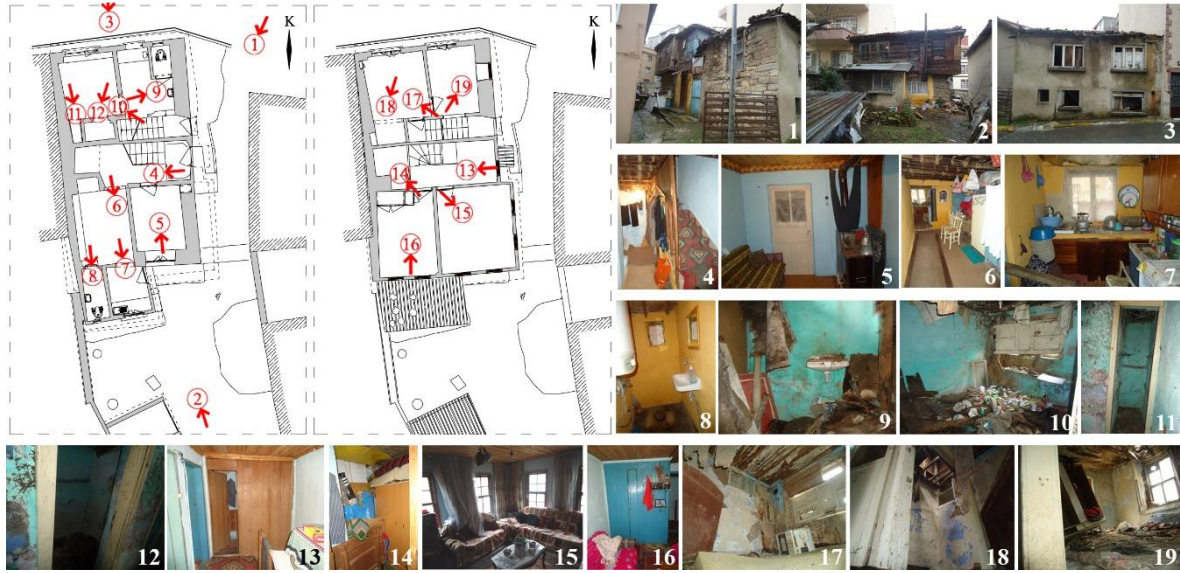
Figure 2. Photographs of Göksel Bey dwelling

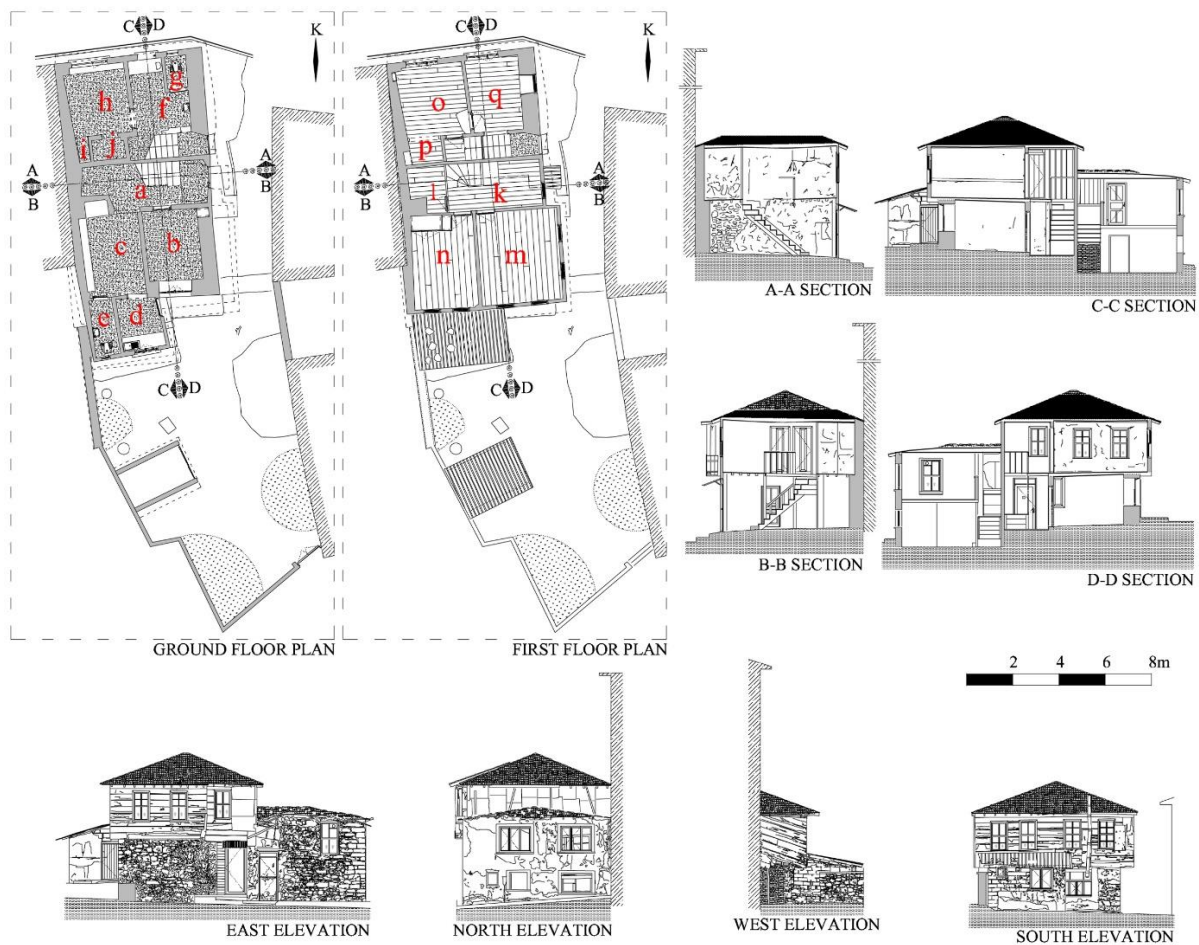
The entrance section of the southern block is 5,45x1,90 meters in size, and the staircase leading to the upper floor is located in this part (Figure 3a). The staircase made of wooden material has 12 risers, and the width of the steps is 25 cm, the average riser height is 21 cm, and the length of the steps is 1,00 meters. The west of the doors located on the southern facade of the space opens to the Hall (Figure 3c), whereas the eastern part opens to the Room (Figure 3b). The Room is 3,05 x 2,35 meters in size and is located in the southeast corner of the structure. A window is visible on the south wall, and a wooden built-in closet is visible in the north corner of the east wall (Figure 3b). The Hall area is about 3,60 x 2,50 meters. There is a niche of 1,00 x 0,70 m in size at the western corner of the northern wall of the place, in such a way that it indents the entrance section. There are no windows in the Hall, and there are two doors on the south wall (Figure 3c). The door on the east opens to the kitchen (Figure 3d), and the door on the west opens to the Restroom-Bathroom (Figure 3e). The kitchen measures 2,20 x 1,90 meters and the Restroom-Bathroom measures 2,40 x 1,05 meters. These two spaces were created by adding them to the original building mass later. There are windows on the southern facades of both the Kitchen and the Bathroom. There is an exit to the garden with a door located to the north of the eastern wall of the kitchen. The wall materials throughout the floor are stone and there is plaster and lime whitewashing application on them. The floor coverings were damaged by making a concrete screed in all places. Ceiling coverings are wooden beaming in other rooms outside the Room. The beams are located in the north-south direction of the Entrance and Bathroom, and in the east-west direction in the Hall and Kitchen. On the ceiling of the Room, a plastic application is observed on the wooden coating.

The entrance of the northern block directly accesses the Hall (Figure 3f). Since there is a difference in elevation between the stairway in front of the entrance and the decking of the space, the space is accessed by two-riser stairs. The staircase leading to the upper floor is also located directly opposite the entrance door, but it has 9 risers, the width of the steps is 25 cm, the riser height is 21 cm, and the length of the steps is 1,00 m. The Hall is 3.30x2.45 m. in size and has been downsized due to a recent addition of a Restroom in the northeast corner. The Restroom section is 1,40 x 0,90 m in size (Figure 3g). There is a window opening without joinery on the north facade of both the Hall and the Restroom. The door opening on the west wall of the Hall allows access to the Room section (Figure 3h). The space is approximately 2,85 x 2,60 m in size. The Bathroom (Figure 3j) is located on the south wall of the section with a large window on the north facade, and there is a narrow Closet (Figure 3i). The Bathroom is 1,40 x 0,90 m in size, while the Closet measures 1,00 x 0,50 meters. As in the southern section, the walls of all the rooms are stone, but there is plaster and paint on them. The

Figure 3. Measured drawing of Göksel Bey dwelling

A wooden staircase leading to the 1st floor of the southern block is bounded by a balustrade and provides access to the Hall area (Figure 3k). Although the Hall section extending in the east-west direction was originally arranged as 5,75 x 2,05 meters, it was downsized to 4,00 x 2,05 meters by creating a Closet area of 2,00 x 1,60 meters to the west (Figure 3l). There are two rooms to the south of the Hall, and it protruded from the south facade and the east facade. The room located in the southeastern part (Figure 3m) is 4,00 x 3,50 m in size and there are two windows on the south and east facades. The Room in the southwestern part (Figure 3n) has a size of 4,00 x 2,75 meters. Although there is no opening due to the fact that it is adjacent to the western part, there are two window formations on the southern facade. The formation of a wooden Closet structure is also visible in the western part of the northern wall of the Room. The wall materials of the floor are brick and plastered and painted. In addition, all floor and ceiling coverings are made of wood material.

Access to the 1st floor of the northern block is provided by a door to the north of the landing of the staircase directly to the Room space (Figure 3o). The room has a size of 3,10 x 2,75 meters and has a window on the north facade and a Closet area (Figure 3p) in the southwest corner. In addition, there is a small Built-in closet in the northwest corner. With the door located to the east of the space, a passage is provided to the other Room (Figure 3q). This room measures 3,20 x 2,20 meters and has windows on the north and east facades. On the southern facade of the space, there is a window opening that shows the staircase. Brick material was used on the walls of the floor, with plaster and paint on them, and wooden cladding was made on the floors and ceilings.

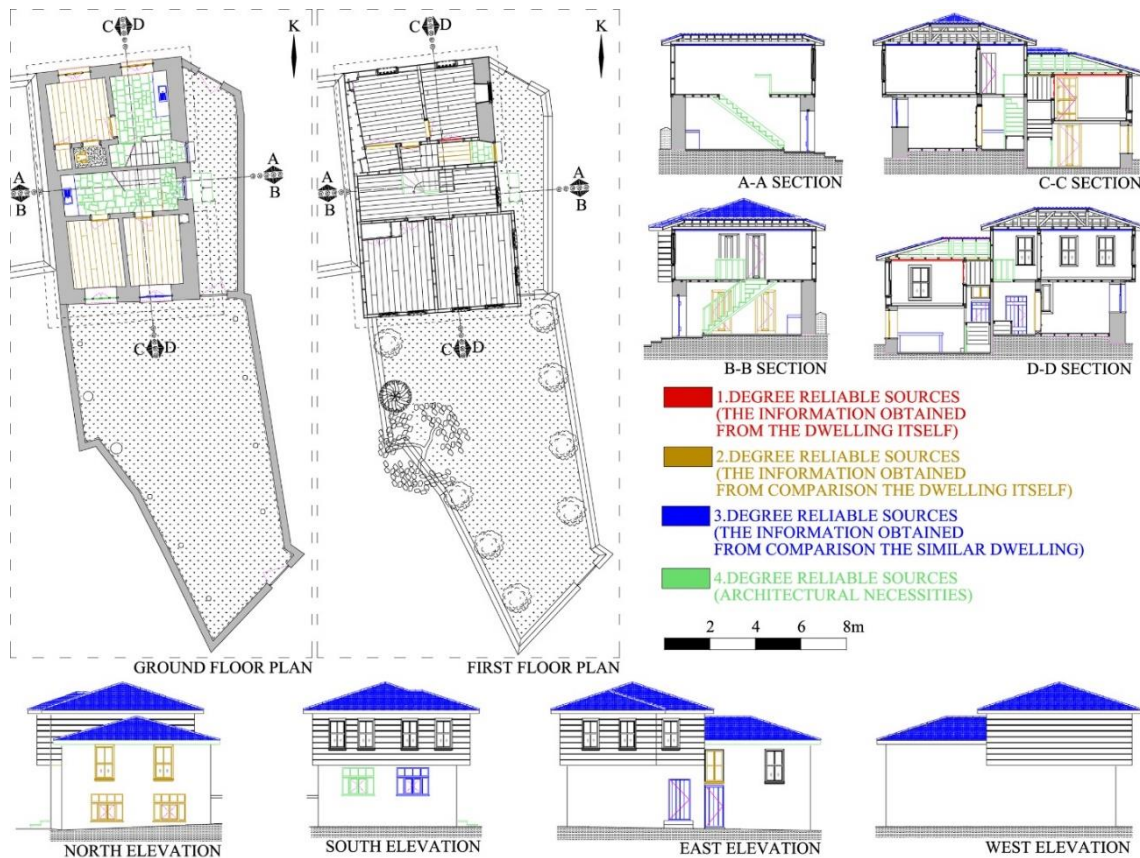
As a result of on-site examinations and resource research, 4 different reliability ratings were determined in the restitution proposal to be made as a result (Şenocak & Sağıroğlu, 2016). 1st-degree sources are data from the structure itself, detected in the building survey, with available traces (ceiling coverings, stairs-top cabinets). 2nd-degree sources include comparative data obtained from comparative examinations of the structure itself (floor coverings on the ground floor, doors on the ground and 1st floors, windows on the northern facade). 3rd-degree sources are data obtained from comparative studies with similar structures that have or do not have traces in the structure (roof coverings, entrance doors, south facade window). 4th-degree sources are the data that should exist due to architectural necessity, despite the lack of traces in the structure (ground floor coverings, stairs, north block roof construction, and eaves plate) (Figure 6). Written source was not used due to the absence of any printed or electronic source related to the structure, and verbal source was not used due to the absence of a person who knew the structure.

Figure 6. Using sources in restitution

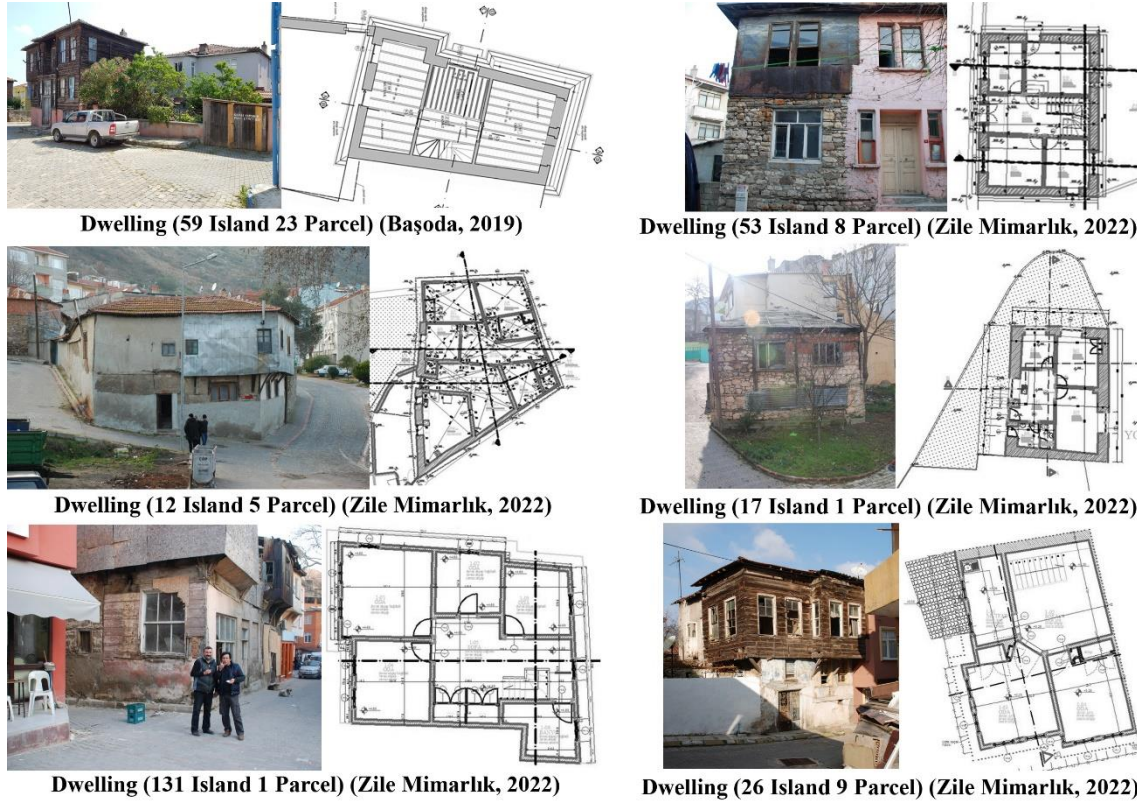
It is important to conduct a comparative study in order to obtain resources in the restitution study (Karakurt & Sağıroğlu, 2016). Therefore, comparative studies were carried out with the houses located in Çatalca, and comments were made accordingly (Figure 8). In addition, although there are excessive interventions in the structure, it is possible to detect them with traces from the structure. Kitchen and Toilet spaces were made with briquette material on the west wing of the southern facade of the ground floor (Figure 7a). This also caused the deterioration of the Room wall of the structure, which should be composed of two rooms, and the filling of the windows, which were probably the same as the ones in other rooms (Figure 7b). In addition, the niche part, which was made in the northwestern corner of the same room, formed an anomaly (Figure 7d), and since the Room's door was removed, the space has become a corridor (Figure 7c). Compared to the buildings in the same region, it is understood that the floor coverings should have stonework in the living space and wood in the rooms. However, the floors were changed with concrete (Figure 7e). On the

Figure 8. Comparative study chart (Çatalca traditional dwellings)
