The Effect of Periodic Inspection and Safety Criteria on the Service Life of Steel Construction Conveyors

Ersin Asım GÜVEN^{1*}

In this study, collapse of a coal conveyor has been investigated. The steel components, welded zones and bolt joints have been studied in terms of corrosion, strength, hardness, and microstructural analysis. Location and time information is hidden due to personal data protection law.

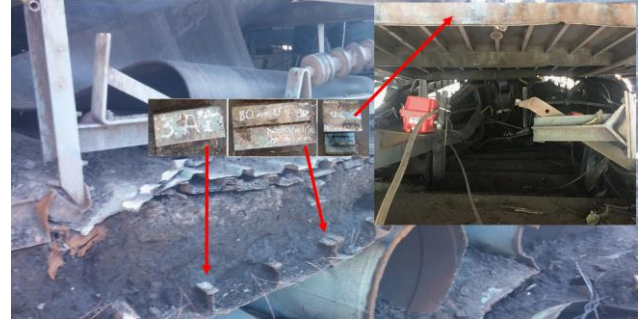
To determine the corrosion and fatigue evidence of steel, the structural steel samples were taken from unstrained part of the wreckage. The samples were taken from the "U" and "I" type

profiles, which are the carriers of the gallery. These profiles were chosen from the lower segment and the side wall, representing the entire gallery (Figure 1). Profile samples taken from the lower segment were selected from the region with both coal accumulation (Sample type A) and non-accumulation (Sample type TB), and it was tried to determine whether the coal affected the mechanical properties. In addition, one sample (Sample type U) was taken in the ceiling profile.

Figure 1. Structural steel samples.

It was understood that coal dust accumulated in the lower segment had no effect on the steel, since no strength reduction was observed in the samples coded A1-A2 and A3 taken from the lower segment.

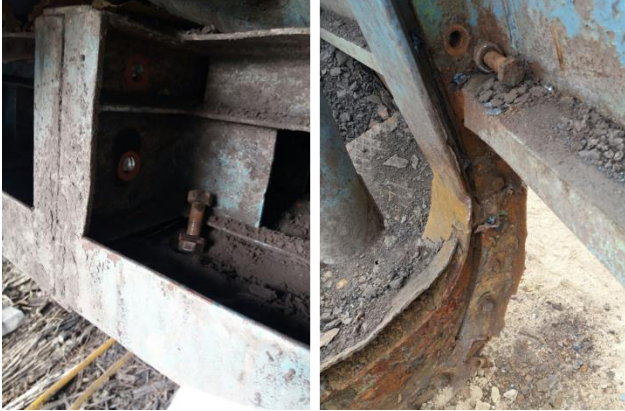
Bolt and nut samples were also chosen in a variety to represent the whole gallery and larger numbers of samples were selected from the lower segment, where the coal dust accumulation located (Figure 2).

Figure 2. Bolt and nut samples.
