Investigating the Material Deteriorations on the Facades of Stone Structures by Terrestrial Laser Scanning Method: Case Study of Mardin Mansion

Taş yapıların cephelerindeki malzeme bozulmalarının yersel lazer tarama yöntemiyle araştırılması: Mardin Konağı Örneği

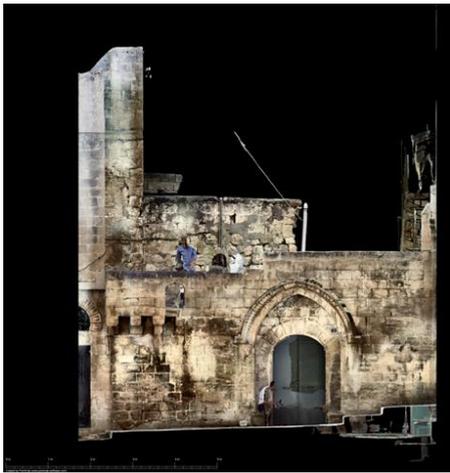
(a)

Figure 12. Orthophotographs obtained regarding the frontages a) Orthophotograph of east frontage b) Orthophotograph of south frontage c) Orthophotograph of north frontage
