Determination of Ground-Based Structural Problems in the Historical Four-Legged Minaret with Ground Penetration Radar

Süleyman İPEK^{1*}, Nursen IŞIK², Fatma Meral HALİFEOĞLU³

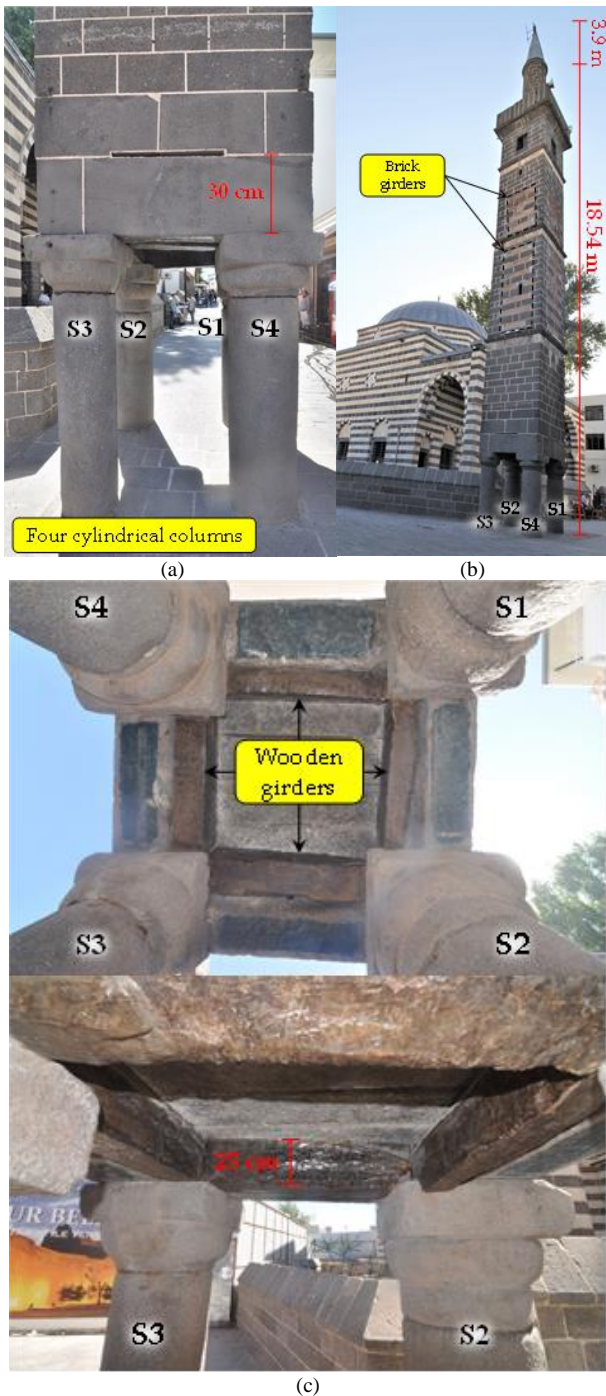
Figure 3. Photographic view of: (a) four cylindrical columns (west view), (b) brick girders (west and north views), and (c) wooden girders (bottom view)

The Four-Legged Minaret is one of these historical buildings and it is located to the northeast of the Sheikh Mutahhar Mosque. The minaret has been repaired and restored many times from the time it was built to the present day in order to eliminate the existing problems in the minaret. However, nowadays, the minaret remained outside the borders of the mosque due to the widening of the street and the introduction of a wall boundary for the mosque, and hence, the minaret remained as an independent minaret in Yenikapı Street (known also as Four-Legged Minaret Street). The square-formed minaret is carried by four cylindrical columns as can be seen in Figure 3a. The minaret, which was built with the masonry technique, has a height of 18.54 m up to the spire and 22.44 m up to the top including the finial as marked in Figure 3b. The main building material used in the minaret is basalt; however, at certain intervals, brick was also used as a girder as indicated in Figure 3b. Besides, there are four wooden girders above the cylindrical columns and under the square minaret base as shown in Figure 3c.

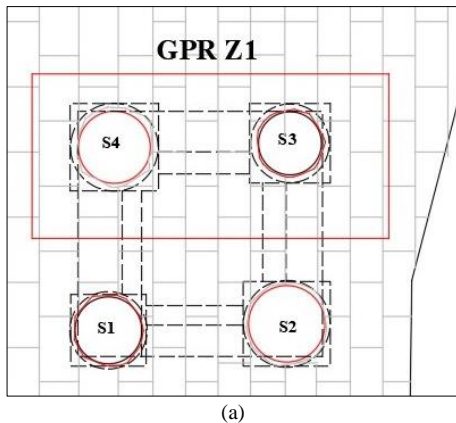
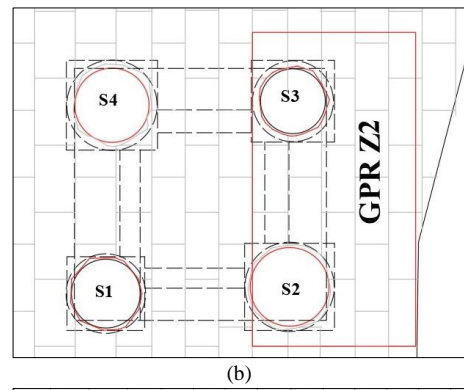
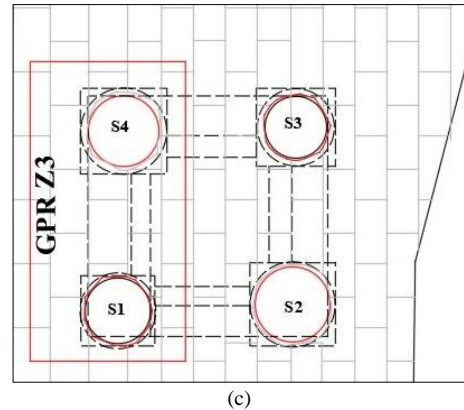
Figure 13. The locations and borders of the GPR scanning zones on the ground (each zone is shown by the box in red color)

GPR scanings on the ground of the Four-Legged Minaret were carried out by dividing the area into zones. Figure 13 indicates the location and border of each zone in which the GPR scanings were carried out. The GPR Z1 labeled zone had a profile length of 80.0 m while the GPR Z2 and GPR Z3 labeled zones had profile lengths of 50.0 m and 74.0 m, respectively. In all zones, the penetration depth was designated as 20.0 m.

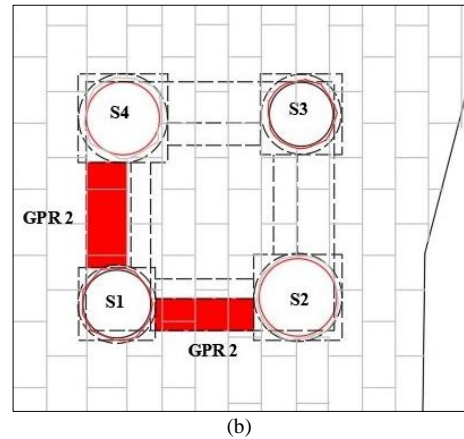
Figure 15. The indication of the GPR scanning regions on the lintels (each region is shown by the red color)

In addition to the GRP scanings on the ground, the lintels on the columns of the Four-Legged Minaret were also scanned by dividing the area into two regions named GPR 1 and GPR 2. Figure 15 indicates the border of each region in which the GPR scanings of lintels were carried out. In the scanning of the region named GPR 1, the profile length was designed as 10.0 m while in the GPR 2 labeled region, it was chosen as 15.0 m. In both regions, the 4.00-m penetration depth was designated. Region 1 involves the lintels on the S2-S3 columns and S3-S4 columns while region 2 includes the lintels on the S1-S2 columns and S1-S4 columns.

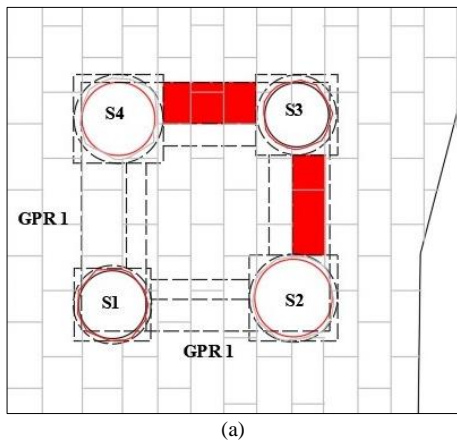
In regard to the radargram section obtained from region 1 (see Figure 16a), it can be stated that it has been observed that the cracks and fractures in the lintels are at a level that will affect the load-bearing system of the minarets. It is considered that cracks and fractures, the smallest 12.00 cm and the largest 20.00 cm, have been detected on the lintels in this area. On the other hand, broken V-type crack systems are at the maximum level in the lintels of region 2, as pointed out in Figure 16b. It is thought that the detected damages on the lintels may adversely influence the load-bearing system of the minaret.

To repair the existing damages on the Four-Legged Minaret, comprehensive survey and restoration projects should be prepared under the leadership of the relevant experts, and reinforcement applications should be carried out immediately. In addition to the determination of the damages on the minaret with non-destructive methods, observation pits should be opened in the regions determined by the experts and the physical condition of the ground should be determined. Soil improvements should be carried out around the building, and also columns and walls having axis slippages should be suspended, and reinforcement work should be
