Failure of Gedikbulak K-12 School Building on October 23, 2011, in Van, Türkiye Earthquake

Halit Cenan MERTOL

Atılım University, Engineering Faculty, Civil Engineering Department, 06830, Ankara, Türkiye
Halit Cenan MERTOL, [ORCID No: 0000-0001-8058-5798](https://orcid.org/0000-0001-8058-5798)
Corresponding author e-mail: cenan.mertol@atilim.edu.tr

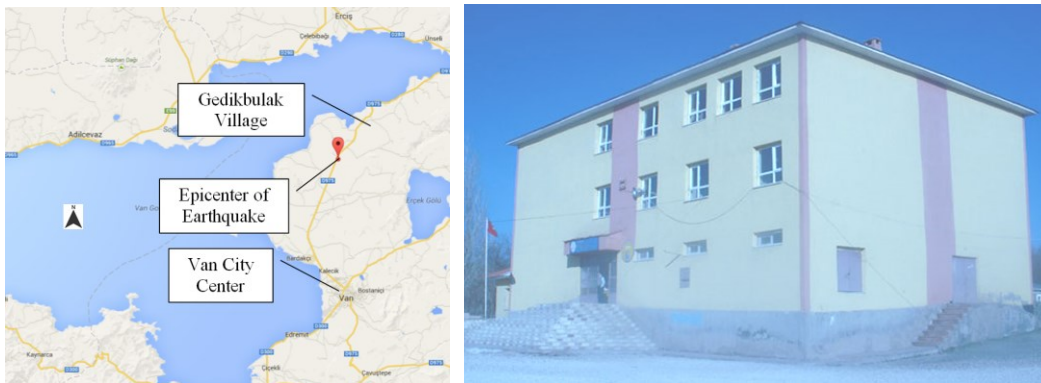
Figure 1. Location of the earthquake and photograph of school building before the earthquake.

Gedikbulak Village is located 47 km north of Van city center (between Van and Ercis) and 16 km northeast of the epicenter of the earthquake as shown in Figure 1. There were approximately 200 single or two story adobe masonry houses in the village. The only building made of reinforced concrete was the Gedikbulak K-12 School Building in the village. This school building was a typical project (No: 10370) prepared by the Ministry of Education of Türkiye and this typical project was widely being used for the construction of school buildings in various locations throughout Türkiye. Approximately 785 students were being educated in this building on a morning and afternoon session basis. The earthquake happened on a Sunday which prevented any life loss. However, there was a parents-teachers meeting on that day in the school which was luckily concluded one hour before the earthquake.

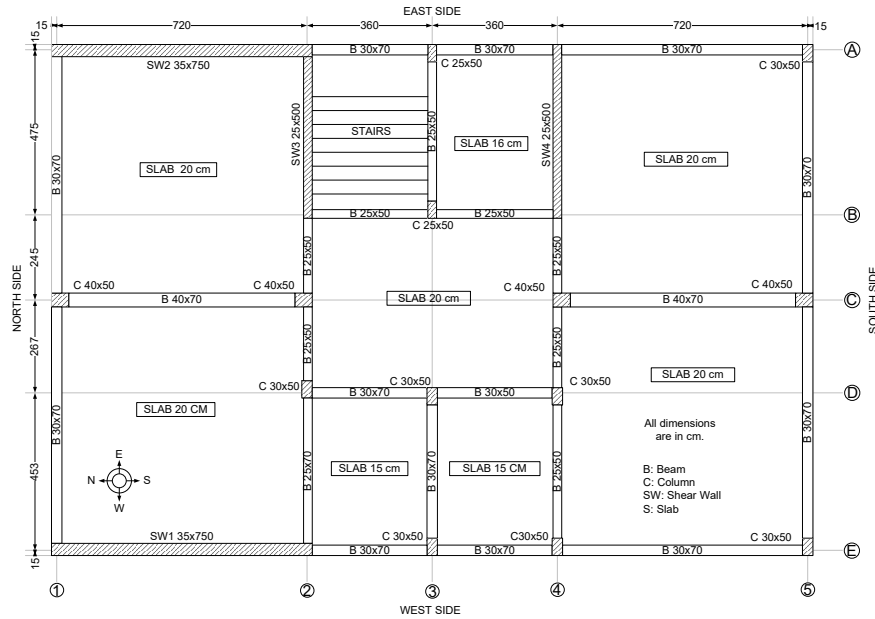
Figure 2. Typical plan view of the building.
