# Conservation Initiatives/Assessments in Rock-Carved Churches Specific to the Göreme Saklı Church

Keywords: Cappadocia, Göreme, Saklı Church, conservation.

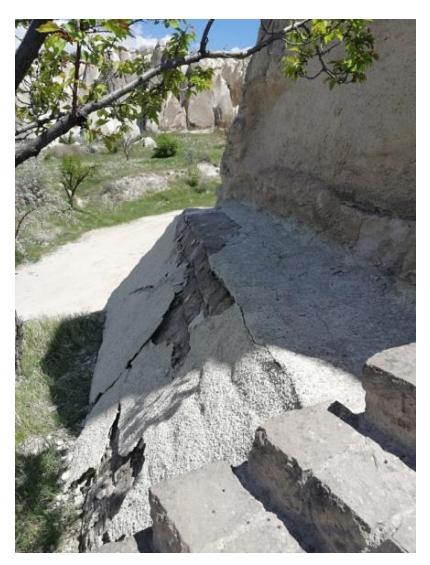
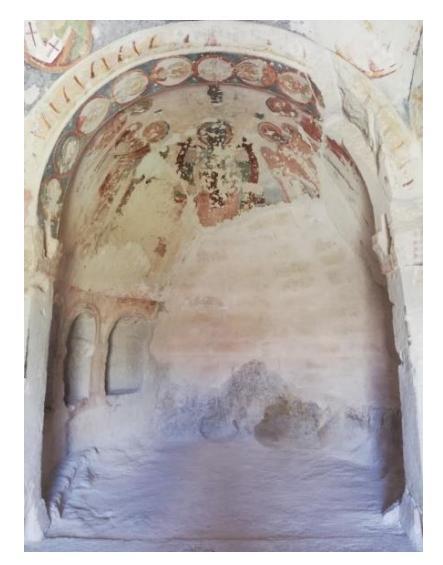
Figure 18. El Nazar Church entrance (Ertürk, 2019, Figure 19. El Nazar Church abscess (Ertürk, 2020, p.170) p.170)

In the churches in the Göreme Valley, processes were carried out to cover the primary material in the conservation interventions. The worn parts were coated and, in the repair, and application projects of El Nazar Church and St. Barbara Church, and imitation plaster was applied to the coating (Figure 18, 19). However, it was determined that the plaster was poured on all surfaces, with gaps under it. The cut stones on which the imitation plaster was poured due to frost during winter revealed an image incompatible with the rock texture. (Figure 20, 21). Cracks and crevices formed in the plaster on the

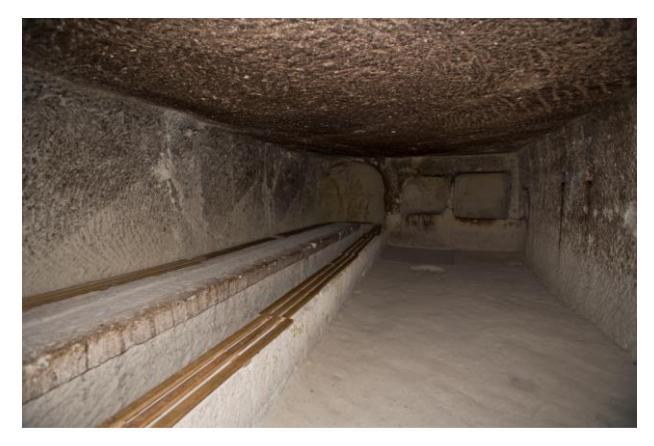
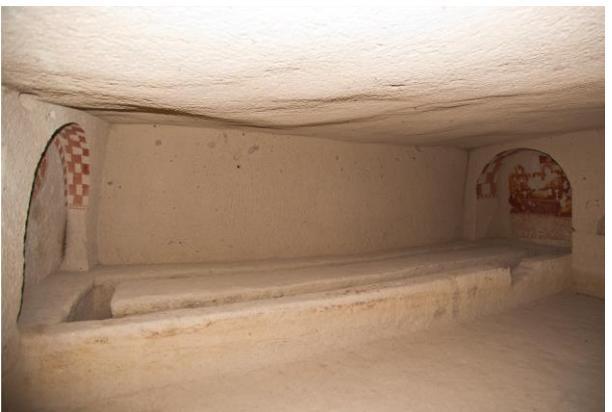
Figure 26. Karanlık Church refectory (Ertürk, 2020, Figure 27. Karanlık Church refectory (Ertürk, 2019, p.171)

In the Göreme Open Air Museum, visitors are provided with security-controlled entrances to churches and other monasteries, and visits are made under surveillance by cameras and staff. Wooden walking platforms have been placed in the spaces to prevent floor abrasions and to prevent visitors from touching the rock surfaces (Figure 26, 27, 28, and 29). Conservation projects were carried out to stop and repair the damage to the church wall paintings.

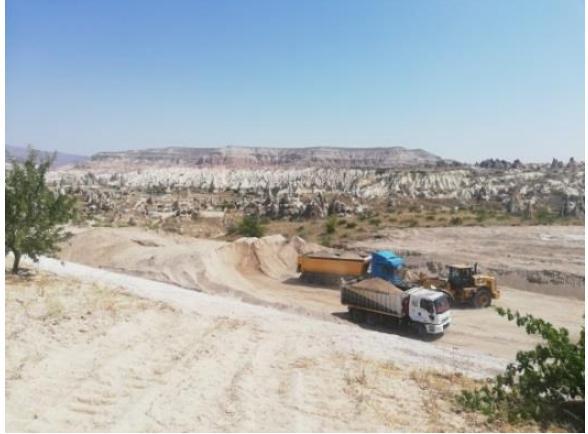
Figure 30. The Saklı Church dirt road (Ertürk, 2022)

Landscaping Projects and transportation planning studies have started in the lower valley of the Sakli Church (Figure 30, 31). The existing 2,8 km road between Göreme and Ortahisar passes in front of the registered cultural assets and churches in the Göreme Open Air Museum. The road in question damages Tokalı Church, Kızlar Monastery, Elmalı Church, Yılanlı Church, and Dark Church due to vibration and atmospheric gases. It is seen that the road, which has heavy vehicle traffic during the tourism seasons, is not sustainable and negatively affects natural and cultural assets. Route and archaeological georadar studies were carried out to create an alternative route, and the slope of the mountain where the Saklı Church is located was selected. It is on a cadastral road line with a length of 2,2 km and a width of 5 to 7 meters (Figure 32).
