Damage Assessment of Masonry Structures in Adıyaman Province After Kahramanmaraş Earthquakes (February 6, 2023)

Ertuğrul ÇAMBAY^{1*}

doi: 10.5505/fujece.2023.47955
Research Article

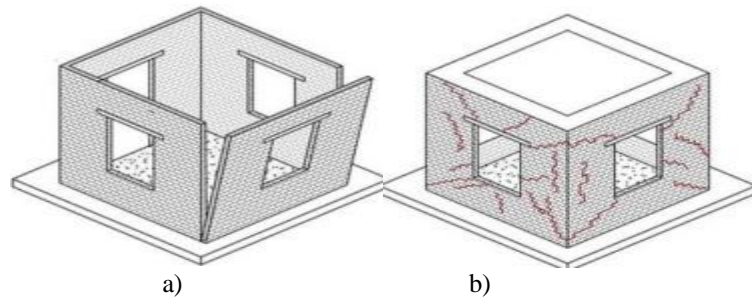
It was determined that the most damage in masonry structures in the earthquake zone occurs out of the plane, or in other words, as a result of the first damage mode (Fig 2). It was also observed that beam connection elements are missing in the majority of damaged structures. Şenol [6] damage assessment studies were carried out in Antakya and İskenderun districts of Hatay province between 20-23 February 2023, and the structures in the region; It was examined on-site in terms of structural irregularities, materials used and the effect of earthquake forces. Tomazevic [7] pointed out that as a result of the out-of-plane behavior of masonry walls, cracks may occur in the regions where stress concentrations are most intense and, as a result, collapses in the direction perpendicular to the direction of seismic movement. Subsequently, Ayala and Speranza [8] concluded that the out-of-plane behavior of walls and the collapses that occur as a result of this behavior are directly proportional to the quality and strength of the connections and wall elements.

Figure 2. a) Out-of-plane behavior b) In-plane behavior [9]

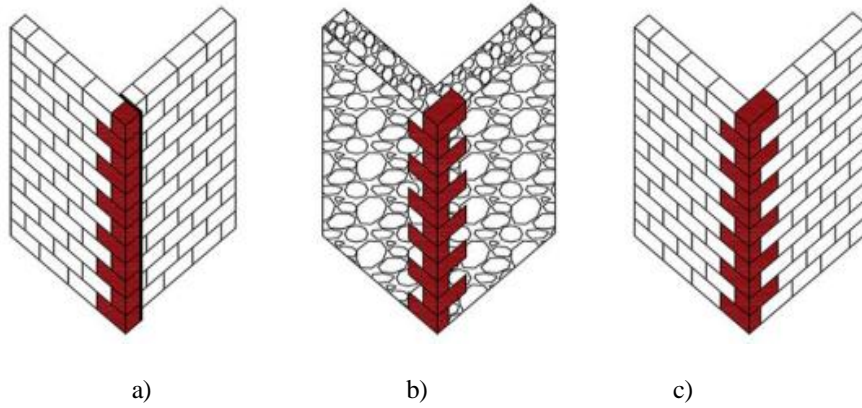
Figure 3. Corner details: (a) Lack of keystone, (b) Insufficient support c) a sufficient combination. [9]

Corner joint damages were frequently encountered in studies carried out in the earthquake zone. Proper wall-to-wall and wall-to-floor connections in this construction increase the strength of the corners under the influence of earthquakes (Fig 3).
