Finite Element Analysis of a Historic Masonry Building with Unique Architectural Features: A Case of KLP Building at İÜC Cerrahpaşa Campus

Keywords: Masonry buildings, Seismic performance analysis, Structural safety

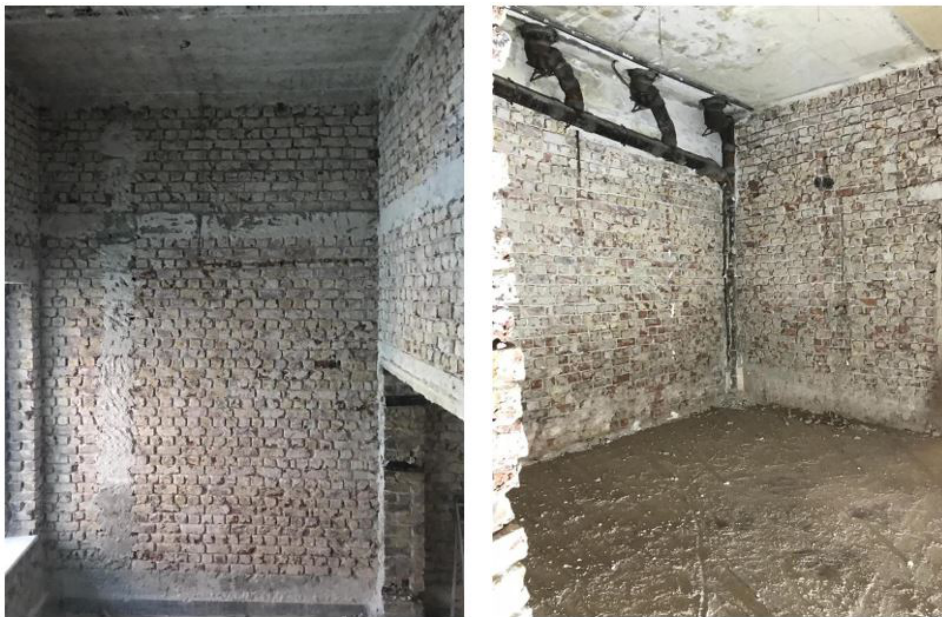
Figure 8. Connection details between the structural elements

During the restoration process, the wall plasters were removed to partially uncover the connections between the structural elements, revealing the presence of horizontal and vertical RC peripheral ties in some of the walls. It should be noted that not all walls had horizontal and vertical RC peripheral ties. As shown in Figure 8, in some sections wall-slab joints were through horizontal RC peripheral ties, while in other sections, RC slabs were directly connected to the masonry walls.

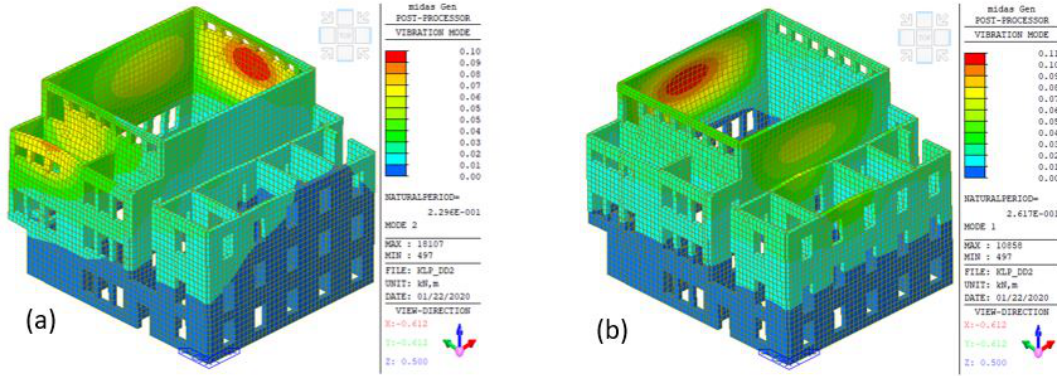
Figure 16.(a) Mode 1, T = 0.26 s, movement in the y direction, (b) Mode 2, T = 0.23 s, movement in the x direction

Modal analysis of the building under earthquake effects was performed. The number of vibrational modes required for the modal analysis was determined based on the criterion that the sum of total effective masses for each mode in the x and y directions should account for at least 95% of the building’s total mass. Accordingly, the criterion was met for the first 35 modes in both x and y directions. The first dominant mode of the building was the 1st mode and the mass participation ratio and the period for lateral movement in the y direction were found to be 50.52% and 0.26 s, respectively. The second dominant mode of the building was the 2nd mode and the mass participation ratio and the period for lateral movement in the x direction were found to be 35.4% and 0.23 s, respectively.

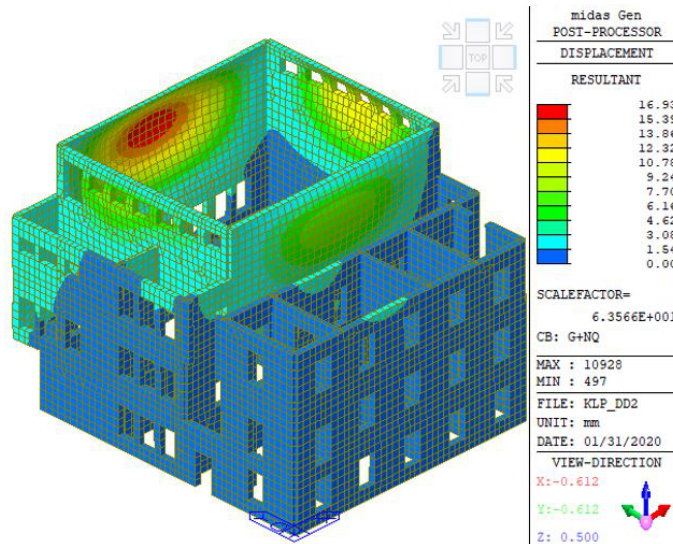
Figure 17.Displacements observed under dead and live loads (G+nQ) (G:Dead load, Q: Live load, n: Live load reduction factor)

The maximum displacement of the building was found to be 16.9 mm under vertical loads. Displacements observed under fixed and reduced live loads are shown in Figure 17. The walls of the amphitheater and the north façade walls exhibited the highest displacement values.

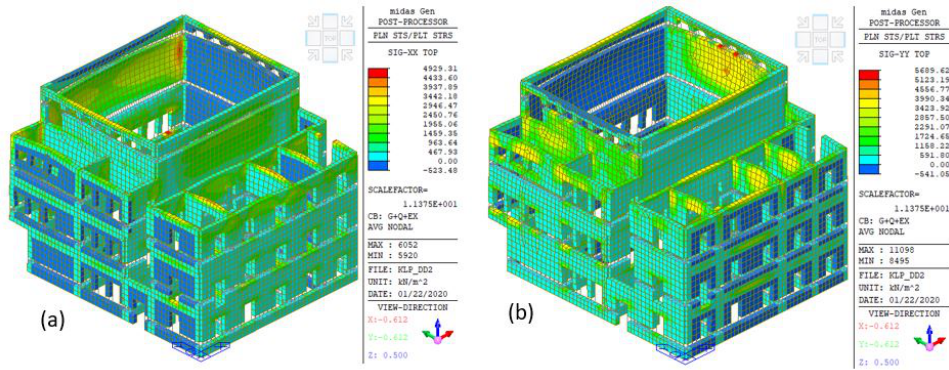
Figure 20. Stresses occurred under G+Q+Exp loading

Figure 20a displays the stresses induced by the earthquake combined load effects in the positive x direction. These stresses represent axial stresses acting in the x direction, which is perpendicular to the y-z plane. An examination of the observed stresses showed that the maximum axial stress of 4929 kN/m² was observed on the exterior wall-wall connections of the north façade. Compression effects on the west and east façade walls resulted in tensile stresses, mostly observed on the north and south façade walls. The stresses observed under earthquake combined load effects in the positive y direction are shown in Figure 20b, representing axial stresses in the y direction perpendicular to the x-z plan. An examination of the observed stresses revealed that the east façade walls, around the window openings of the amphitheater, exhibited the maximum stress of 5690 kN/m². The compressive effects on the north and south façade walls resulted in tensile stresses mainly on the west and east façade walls.

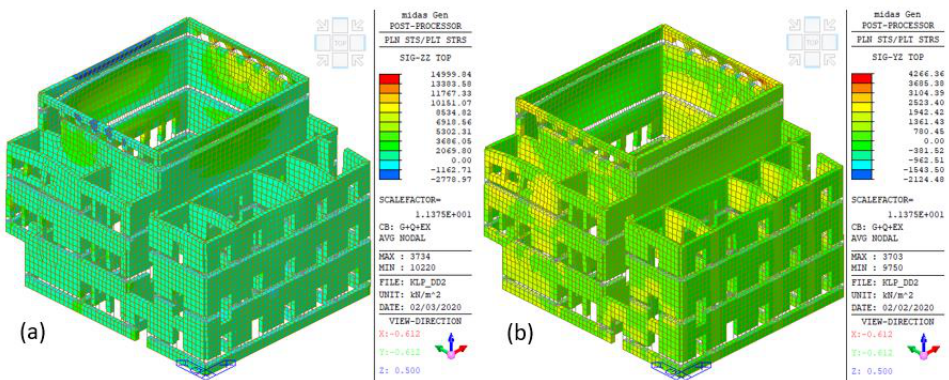
Figure 21. Stresses occurred under (a) G+Q+Exp loading, (b) G+Q+Exp loading

Figure 21a shows the axial stresses perpendicular to the x-y plane observed under earthquake combined load effects. The highest compressive and tensile stresses were observed along this axis. An examination of the observed stresses showed that the walls of the amphitheater had the highest stresses, with a maximum stress of 15000 kN/m² observed on the west façade walls between the upper window openings. Furthermore, tensile stresses observed under earthquake combined load effects in the positive x direction are shown in Figure 21b. These stresses represent tensile stresses on the y-z plane. An examination of the stresses showed that a maximum stress of 4266 kN/m² was observed on the east façade, on the upper window lintels of the amphitheater. These tensile stresses, perpendicular to the earthquake axis were relatively high.
