## COLLAPSE OF BASE SOIL AND ITS CONSEQUENCES DURING A CEMENT PLANT CONSTRUCTION

**ABSTRACT:** Collapsible soils are subjected to rapid changes in their volume when inundated with water. Collapse of such a soil deposit during construction of a cement plant in north Azerbaijan resulted in significant settlement and tilting of structures causing a 2 years delay in the construction. The investor had to bear the huge costs of delay and remediation works. The collapse susceptibility of the soil could not be identified during initial site investigations. After first indications of the collapse problem (tilting, cracking of structures) the settlements were measured at different locations for a long time and a new site investigation was executed. The results of these studies were utilized to determine the collapse potential of the soil. Interestingly, some of the indirect methods were not capable of determining the collapse potential. It was seen that, indirect methods may mislead the engineers in such soils and it is more reliable to perform direct tests to determine collapse potential in similar soil deposits. In this study, it is aimed to discuss the experience gained in this project a

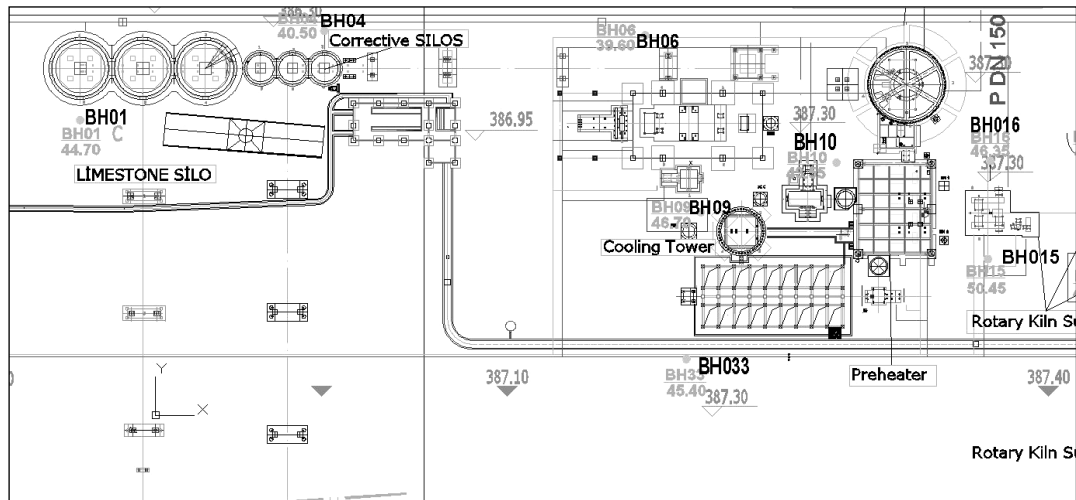
(a) Borehole locations on the west side of the construction area

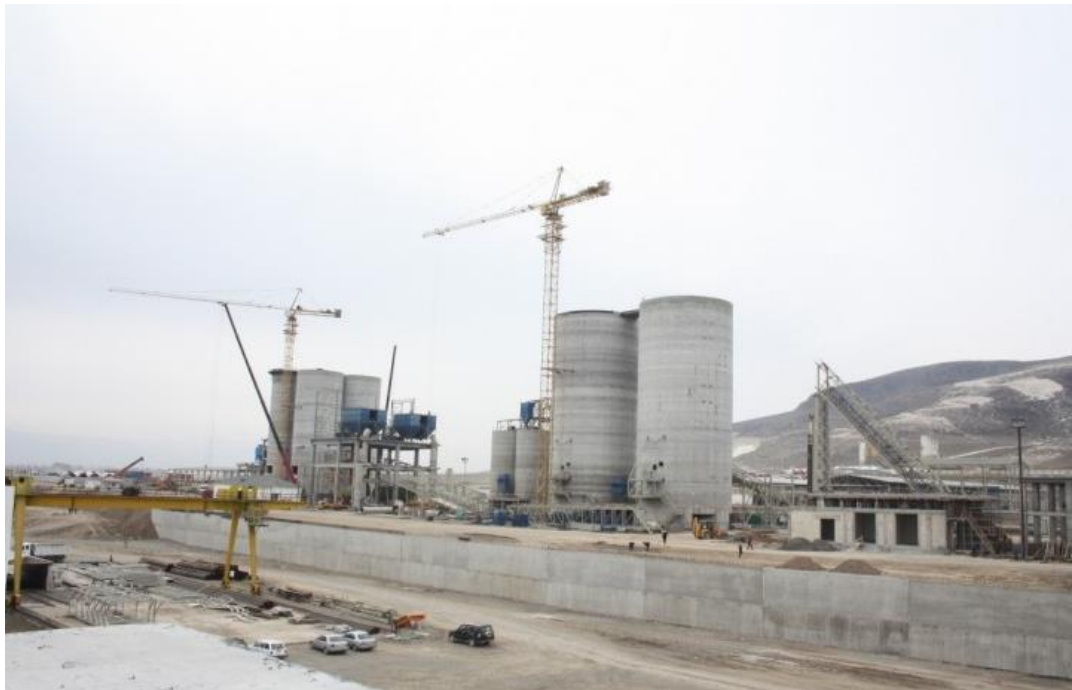
(b) A view during construction from west side of the plant  
**Figure 2.** West side of the construction area ( $\approx 850\text{m} \times 900\text{m}$ )

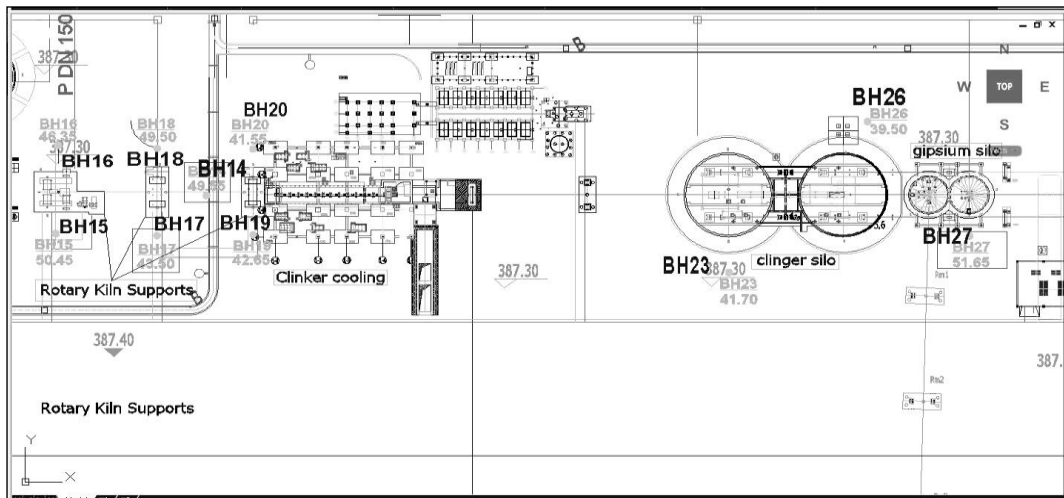
(a) Borehole locations on the east side of the construction area

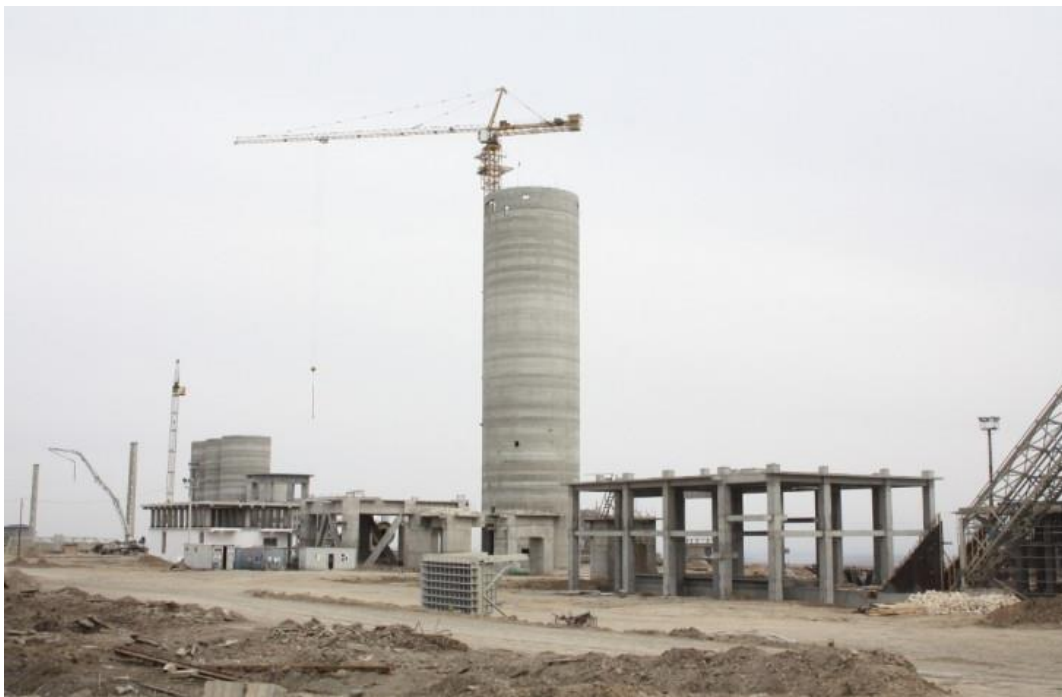
**Figure 3.** East side of the construction area (≈850mx550m)

b) A view during construction from east side of the plant
