Geotechnical Investigation for A Damaged Light Building Erected on A Fill Material-Rich in Expansive Soil

Adil Ozdemir^{1*}, Ekrem Kalkan^{1,2,3}, Duygu Turhan¹

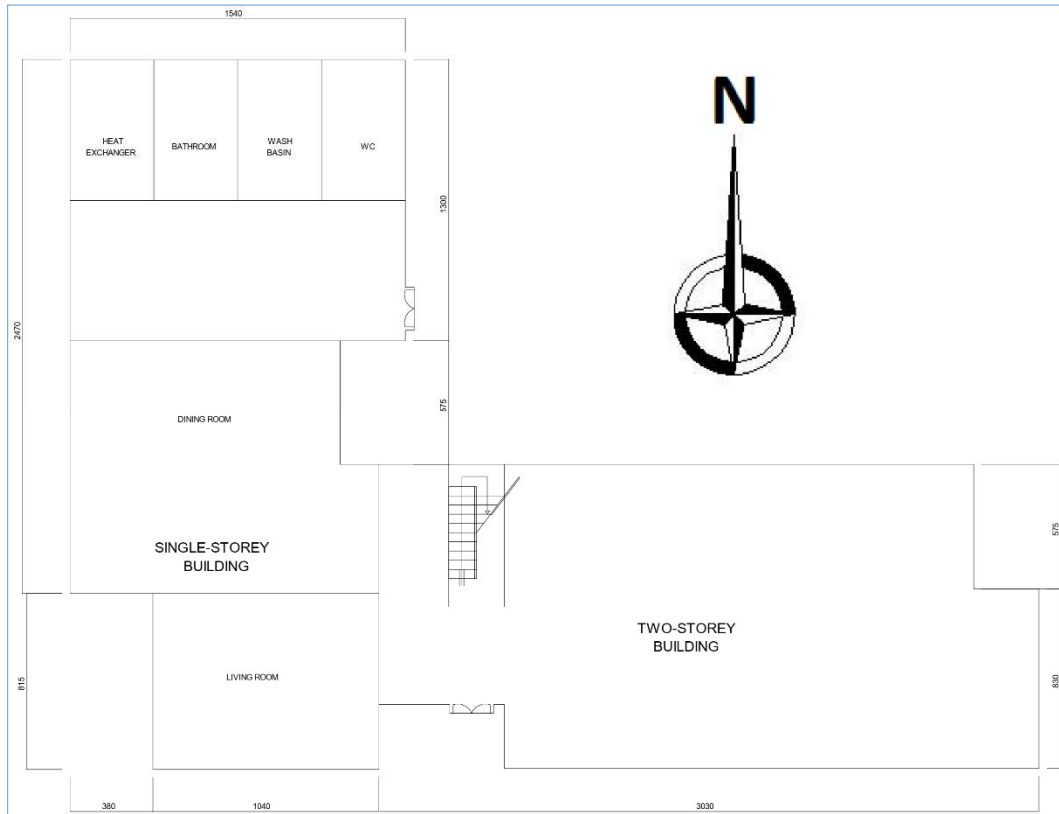
Fig. 2. Simplified plan of the building

The light building is a 2-storey reinforced concrete building constructed about 30 years ago. In the following years, a single-storey building was added adjacent to this building to provide services such as recreation and cafeteria. A simplified plan of the current state of these buildings is given in Fig. 2.

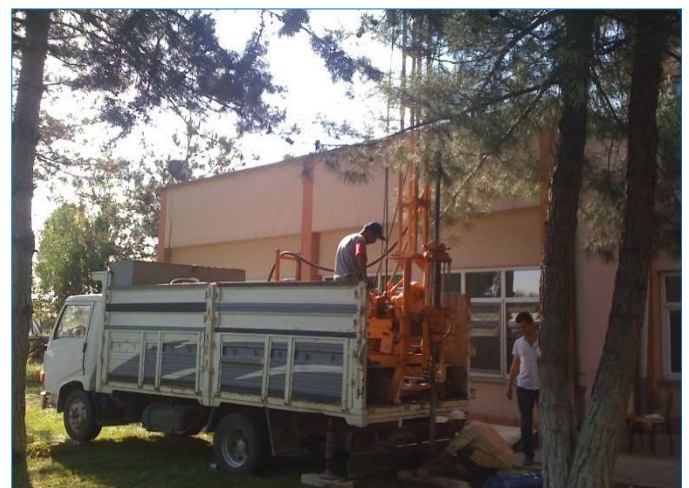
The geotechnical boreholes in the study area were carried out to determine the lithological properties of the soils, their changes in the vertical direction, groundwater status and engineering parameters. In order to determine the geological and geotechnical properties of the foundation soil in the study areas, 6 geotechnical boreholes, each with a depth of 10 m, were carried out (Fig. 9).

Fig. 9. A view of the drilling operation

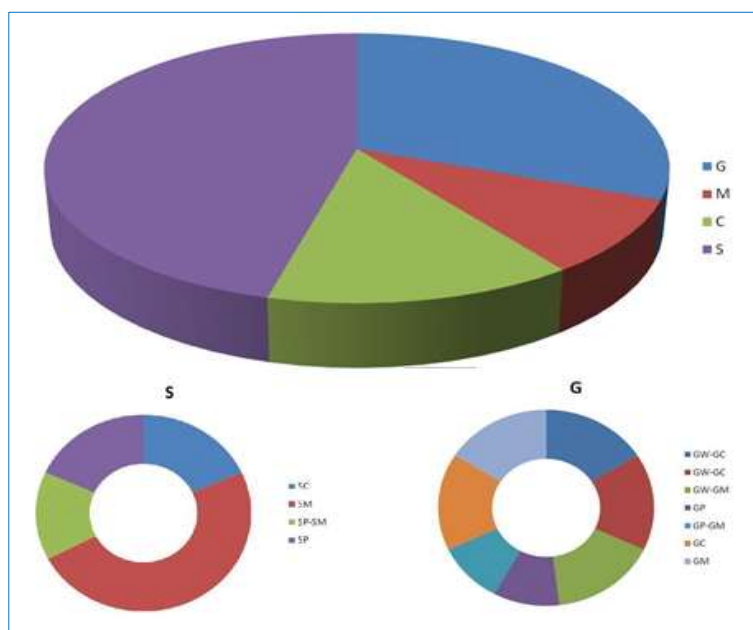
study area to determine the engineering properties of the soils, and soil classes were determined according to the Unified Soil Classification System (USCS) using these data (Table 1 and Fig. 14).

Fig. 14. Soil class distribution according to the results of the tests (USCS) performed on the samples taken from the boreholes

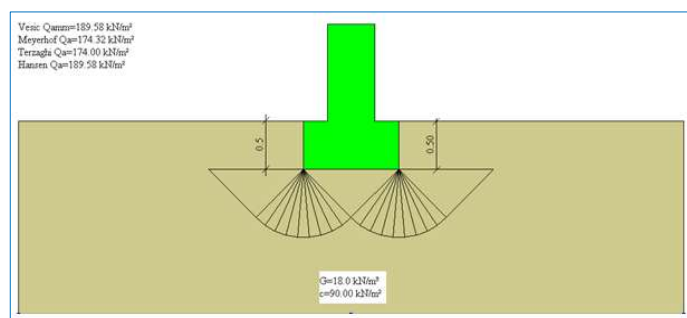
The bearing capacity was calculated separately by each of the methods of Terzaghi (1943), Meyerhof (1951), Hansen (1970) and Vesic (1975) (Table 6). In the calculations, the angle of internal friction was taken as zero ($\phi = 0$) and the factor of safety (FoS) was taken as 3. The undrained shear strength was taken as 90 kPa (Fig. 15).

kPa. As mentioned before, the buildings have 1 and 2 storeys. In residential buildings, a stress of 1.5 tons/m² per story can be obtained. Therefore, the average stress transmitted to the ground from the foundations will be 3 tons/m², i.e. 30 kPa for a 2-storey building. This value is considerably lower than the calculated allowable bearing capacity. Therefore, no failure of bearing capacity is expected for these structures.

Fig. 15. Bearing capacity analysis, failure mechanism

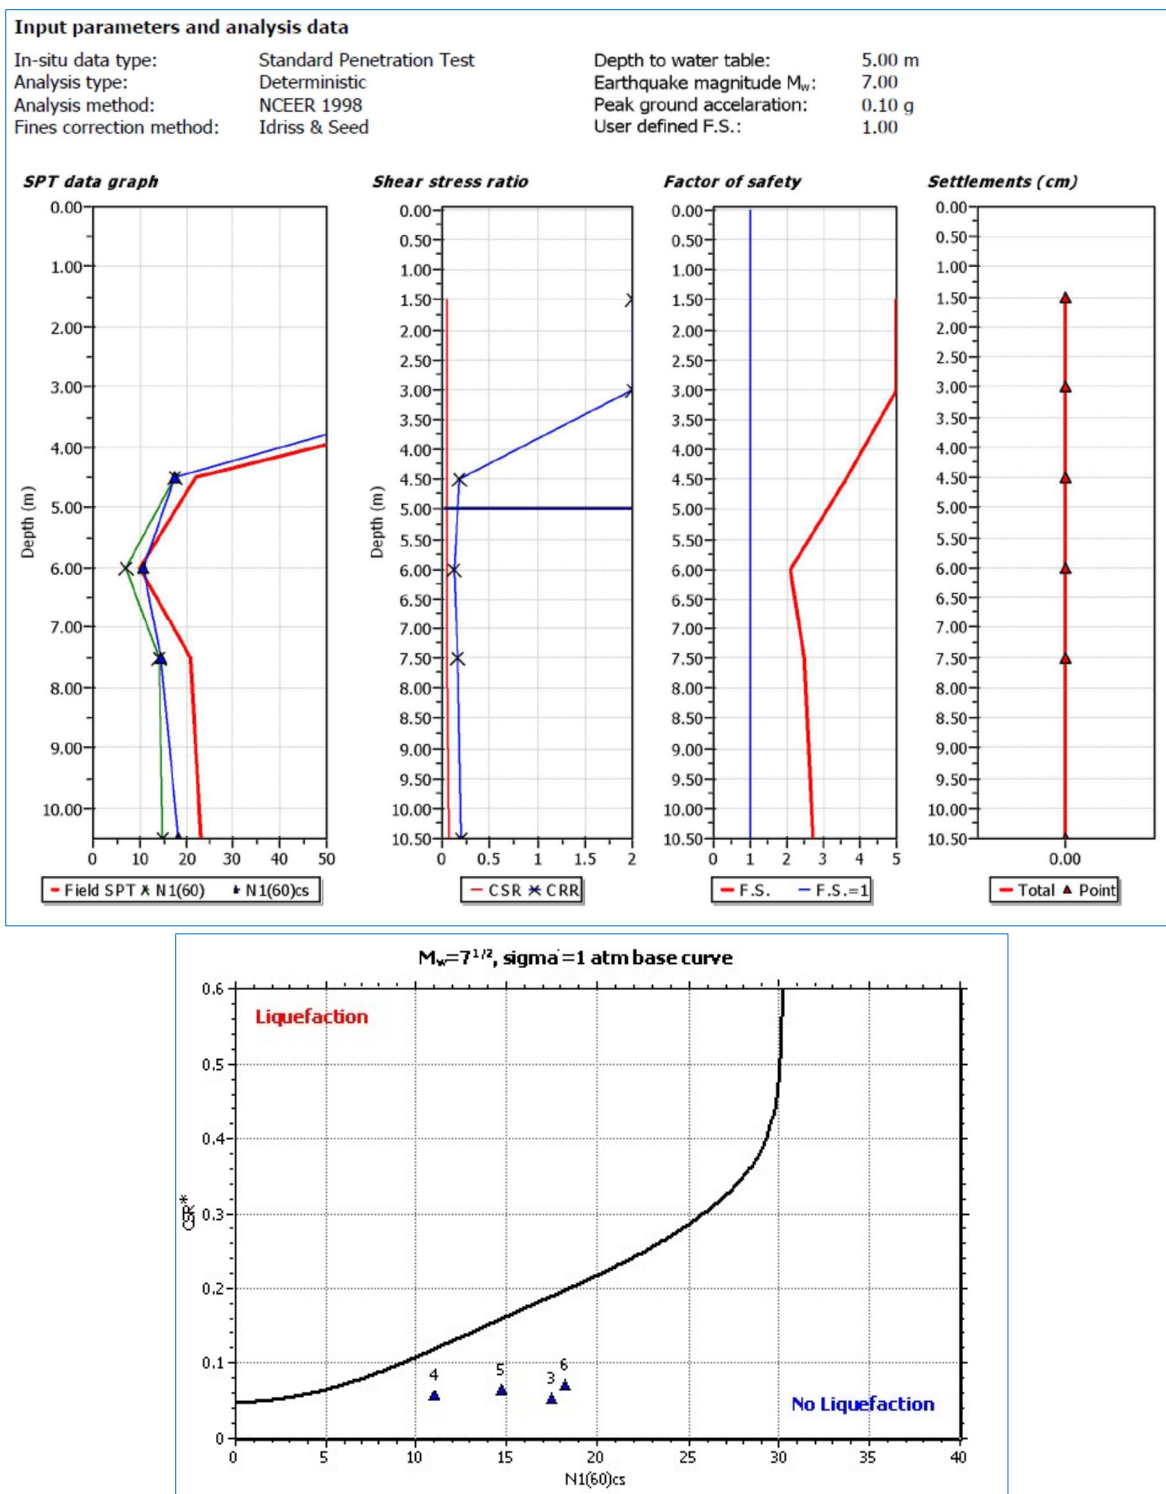
Fig. 16. Liquefaction analysis graphs

Among the boreholes, SK 5 is the borehole with the highest groundwater level and the lowest SPT values in sand - gravel levels. For this reason, the riskiest borehole SK-5 was selected for liquefaction analysis. Since the study area is a 4th degree earthquake zone, 0.1g horizontal ground acceleration was used in the liquefaction analysis and the method recommended by NCEER (1997) was used in the calculations. When Fig. 16 is examined, it is seen that there is no liquefaction in the sand and gravel levels in borehole SK-5, which is considered the most-risky in terms of liquefaction. Therefore, there is no liquefaction risk in the study area.
