Damage Assessment of Rock-Cut Ortahisar Castle in Cappadocia Region

Şerife ÖZATA^{1,*}, Emine Görün ARUN²

Abstract

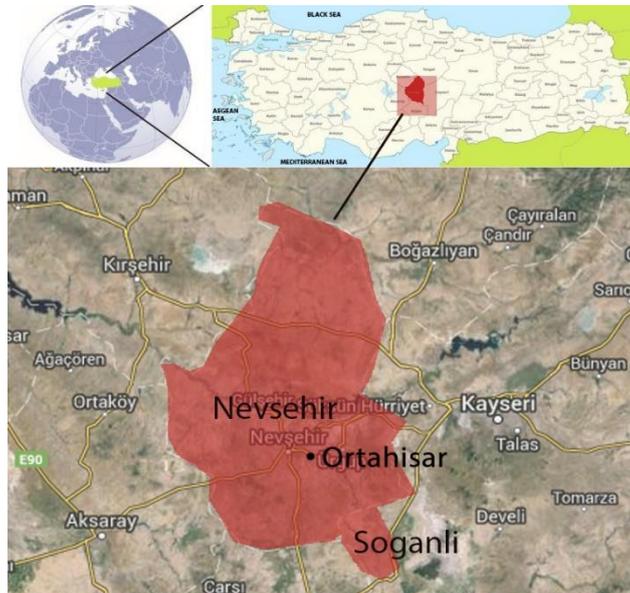
Figure 1. Cappadocia Region's approximate borders

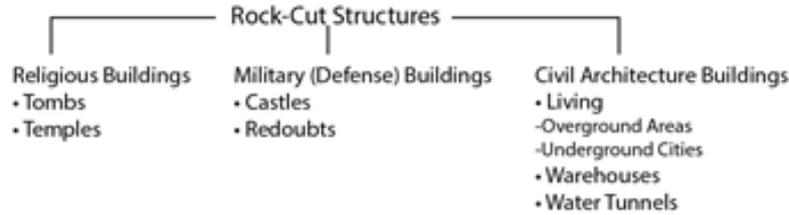
Figure 2. Types of rock-cut structures according to their usage intend [1]

The castle is in the military buildings group as seen in the Figure 2.

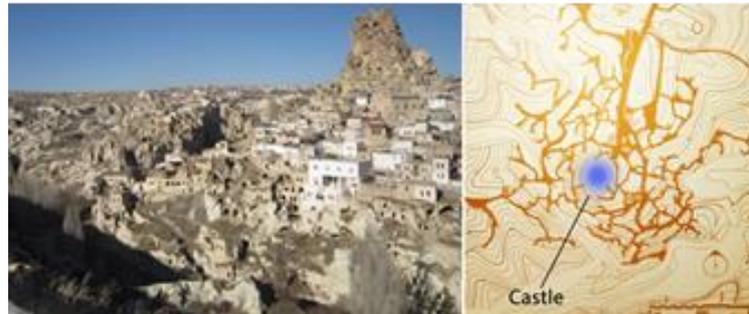
Figure 3. Ortahisar Castle and its place in Ortahisar

Ortahisar Castle is approximately in the middle of Ortahisar Town (Fig. 3.) and it is one of the highest rock-cut structures in Cappadocia Region with over 50 meters elevation. It was used for defending and/or living. In 1916, it was the first town hall of Ortahisar. After a new town was built, it was left and was not used for years. The castle was closed at the beginning of 21th century and after 9 years of its closing, restoration was started in the castle. It was finished in 2013. Some parts of the castle were opened after restoration. There is neither fresco nor mural painting in the castle. The aim of restoration was to stop the rock fallings and to provide safe place for visitors firstly. Some parts of castle dropped in a controlled manner and some kind of additions like steel columns or masonry walls are designed for strengthening the structure. Some cracks are still monitored due to possible movement and some of them filled with mortar.
