Assist. Prof. Dr., Süleyman Demirel University, Faculty of Architecture, Department of Architecture, Isparta, Türkiye, aysegokarslan@sdu.edu.tr

Gökarslan, A. B. (2024). An Example of Conservation and Documentation of Traditional Houses: Isparta Nurten Terlikçi House. *Akademik Tarih ve Düşünce Dergisi*, 11 (6), 4190-4223.

An Example of Conservation and Documentation of Traditional Houses: Isparta Nurten Terlikçi House

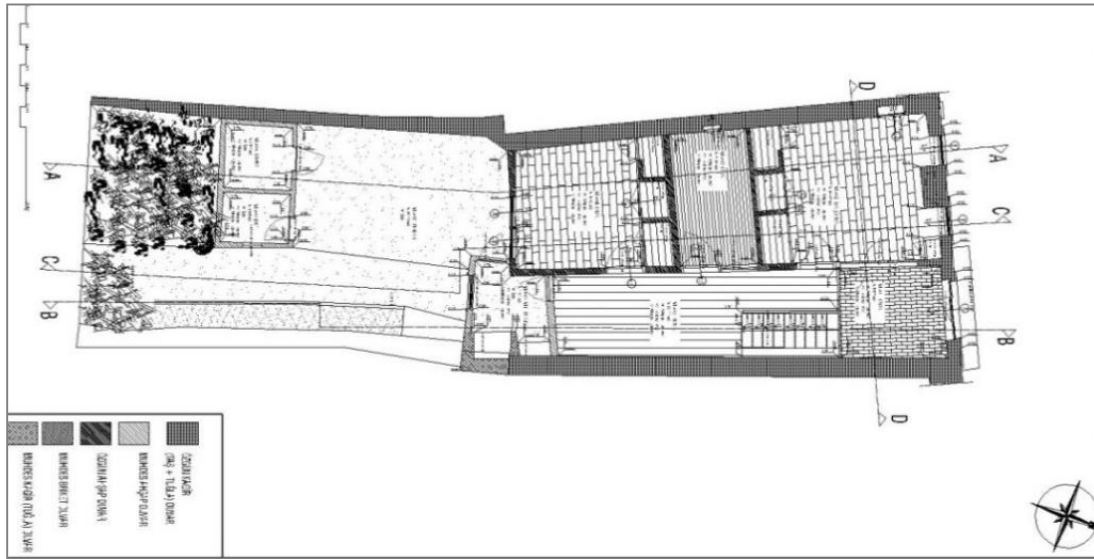
Figure 4. Nurten Terlikçi House upper floor building survey plan (Created by the author)

The upper floor is accessed by a wooden staircase on the east wall of the Sofa Z-05. The house owners have stated that this staircase is an inappropriate accretion. However, it is certain that it belongs to a specific period. This staircase was later turned into a closed space with a wooden joinery incompatible with the original joinery. The house owners stated that the original staircase is located in the area where rooms Z-02 and M03 are located today. It is known that the staircase is a wooden, double-armed staircase, but there is no data on its style (Figure 4).

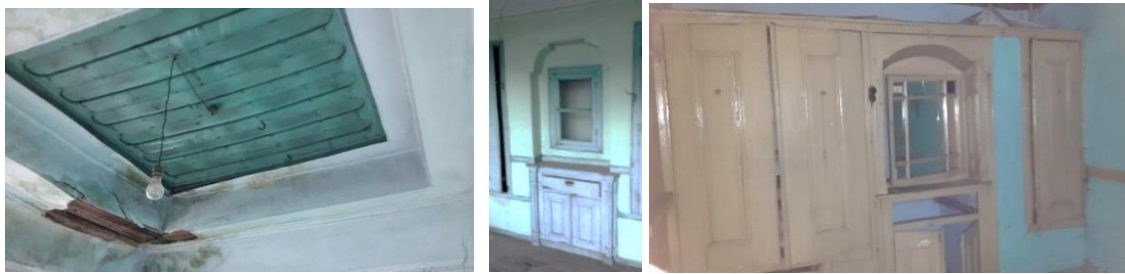
Figure 5. Examples of wooden ornamentation in the building (Created by the author)

The decoration in the building is notably simple. On the exterior, only the dentils at the corner of the front facade, the string courses between floors, and the jambs are of ornamental significance. Some of the interior cabinets and the ceiling of room M-04 have wood and plaster decoration. Some rooms have plaster *çırappa* (niches for lamps). The gusulhane, cupboards, niches and hearths in rooms Z-01, M-02 and M-04 have wooden joinery that is continuous along the wall (Figure 5).

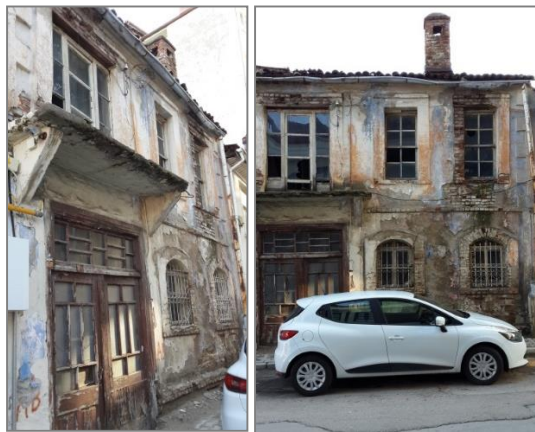
Figure 6. Front facade of the building (Created by the author)

Between the inappropriate accretion eaves and the floor, which was added later on the entrance door, there are brick moldings about 15 cm wide on the eaves and at the water basement level. The facade suffers from plaster flaking, mossing and corrosion due to the installation of various tools. The facade has significant plaster spills and losses on the jambs. Rising damp and moisture transmission from the ground are noticeable up to a height of 150-200 cm. Decay is observed in some of the wooden frames on the façade. Particularly on the entrance door, physical deformation and decay have occurred due to ground moisture (Figure 6). The south (rear) facade of the building facing the courtyard has lost its original appearance. On this facade, which reaches 5.80 m in height, inappropriate accretion walls were constructed to disrupt the original plan organization. The wall of the inappropriate accretion section is covered with metal sheets. It is known that this section was originally covered with wood. On this facade; there is a door and window belonging to the Z-05 sofa on the ground floor and a three-pane guillotine window belonging to the Z-04 room. On the upper floor there are two rectangular guillotine windows belonging to room M-05, a guillotine window belonging to kitchen M-06 and a door leading to the terrace. The rear facade wall connecting the ground floor with the courtyard was completely reconstructed. Wooden joinery incompatible with the original joinery was added. An outbuilding was added to the south facade at a later date. Room Z-04 coincided with this section, partially blocking the guillotine window in this room facing the courtyard. Even if the outbuilding is compatible in terms of material and facade character, the fact that it covers the window suggests that this section is inappropriate accretion.

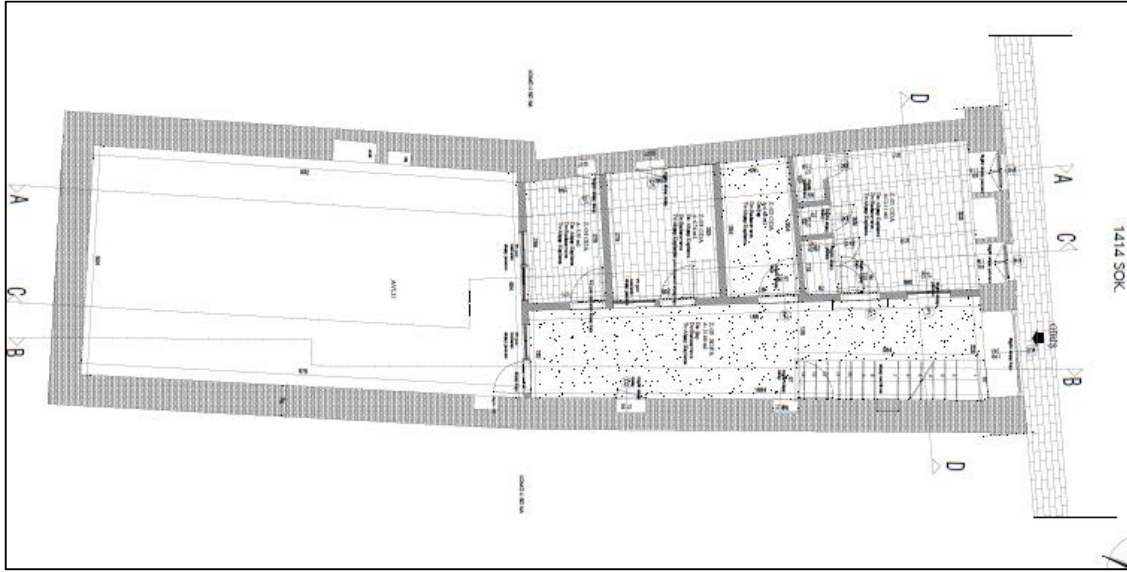
Figure 22. Nurten Terlikçi House ground floor restution plan (Created by the author)

Specifically, the alignment of the outbuilding's mass with the window of room Z-04 on the ground floor, along with the concrete top cover, indicates that it has lost both its aesthetic and structural integrity. Other low-quality addenda include the new rooms created in the upstairs sofa, specifically room M-01 and kitchen M-06. These addenda are constructed with joinery and materials that do not reflect the period. It would therefore be more appropriate to remove them (Figures 22, 23).

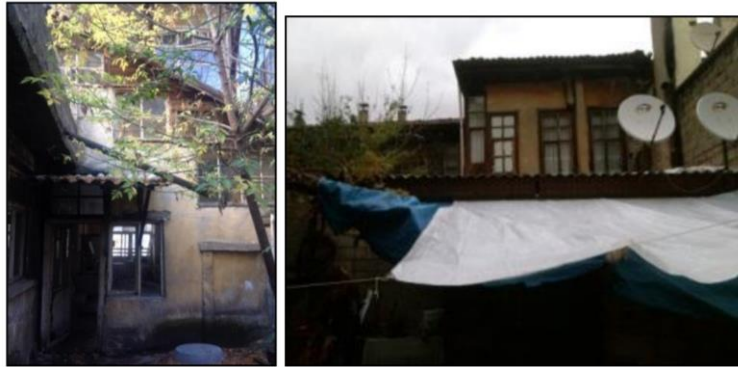
Figure 24. Outbuilding roof in traditional Isparta houses (Created by the author)

An examination of houses with similar floor plans revealed that the stairs are typically positioned in the central room between the rooms facing the sofa. Some houses have a roofed outbuilding in the courtyard (Figure 24). As in example no. 5, in some houses the outbuilding rooms are arranged in rows towards the courtyard. Besides, the 1st and 2nd houses are believed to have belonged to the Greeks and were built at the beginning of the 20th century. However, the other three houses are also located in the Emre Neighborhood, where Greeks live in large numbers.

The covered overhang on the rear façade, which enlarges the M-06 kitchen and provides access to the roof, should be retracted according to the original plan layout. The facade should be restored to its original state, both because of the deterioration of the character of the façade and because of the construction of a plan that is incompatible with the original plan layout. In addition, a mobile removable pergola with tempered glass between the partitions should be added to the section that provides access to the outbuilding. In bad weather conditions, this section should provide access to the kitchen (Figures 23, 24).
