Investigation of the lifetime of the coating applied on the steam turbine blade in terms of corrosion and erosion

Investigation of The Lifetime of the Coating Applied on The Steam Turbine Blade in Terms of Corrosion and Erosion

In this unprecedented study, the amount of corrosion and wear that occurred during the durability/operational life of a turbine blade and its coating, which had been used for 25 years in a Thermal Power Plant, was comparatively examined with an original turbine blade made of the same material that had never been used.

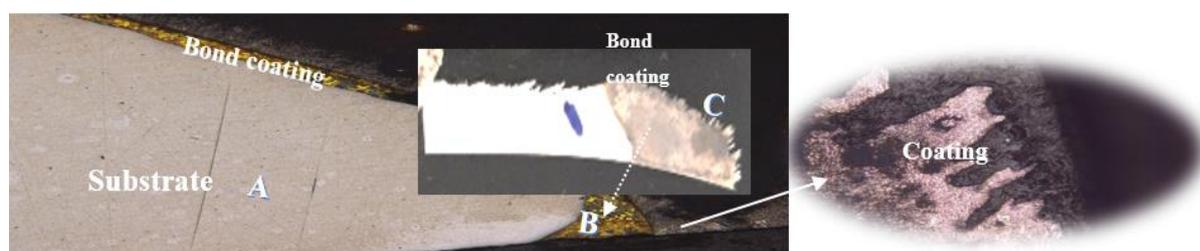
Detailed examination images of the abrasion damage of the used turbine blade are given in Figure X. When the photos are examined, it is seen that the coating in the upper part of the blade (A and B) decreases until the transition coating almost disappears; on the other hand, it is more present in the blade tip part (C). This situation shows that corrosion and wear have a more severe effect on the blade surface (upper) parts.

Figure 1. Images of the cross-sectional macrostructure and microstructure of the used sample

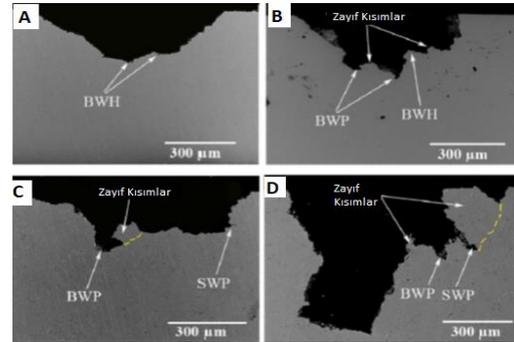
Plastic deformation occurs, and symptoms are observed when erosion is not fast or very low. After this initial damage, wear begins at the weakest points [20]. Sudden cross-section changes or material wall edges are the areas where erosion damage is clearly observed. As a result of cross-section changes and high-pressure flow or water penetration at the ends, erosion craters are usually formed. This crater's sharp corners lead to the formation of narrow pits or lower tunnels. This situation is seen in

Figure 1. After creating these pits, the real destructive wear will occur, and wear will continue as larger pieces break off. If the first wear crater has a flat surface, the wear rate will be lower [9,21].

Figure 1. SEM image of the initial flat and ridged surface characteristic of erosion damage [9] [icmatse2024]
