# Investigation of the lifetime of the coating applied on the steam turbine blade in terms of corrosion and erosion

# Investigation of The Lifetime of the Coating Applied on The Steam Turbine Blade in Terms of Corrosion and Erosion

(Bu çalışma ICMATSE 2024 konferansında sunulmuştur. / This study was presented at ICMATSE 2024 conference.)

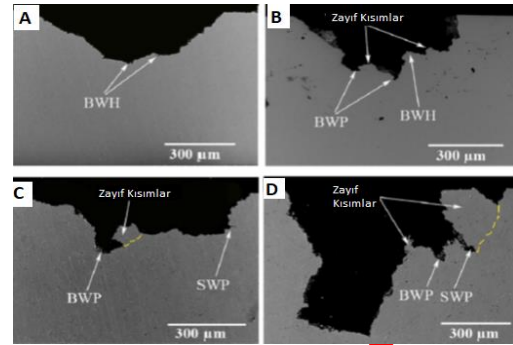
**Figure 1.** SEM image of the initial flat and ridged surface characteristic of erosion damage [9] [ciematse2024]

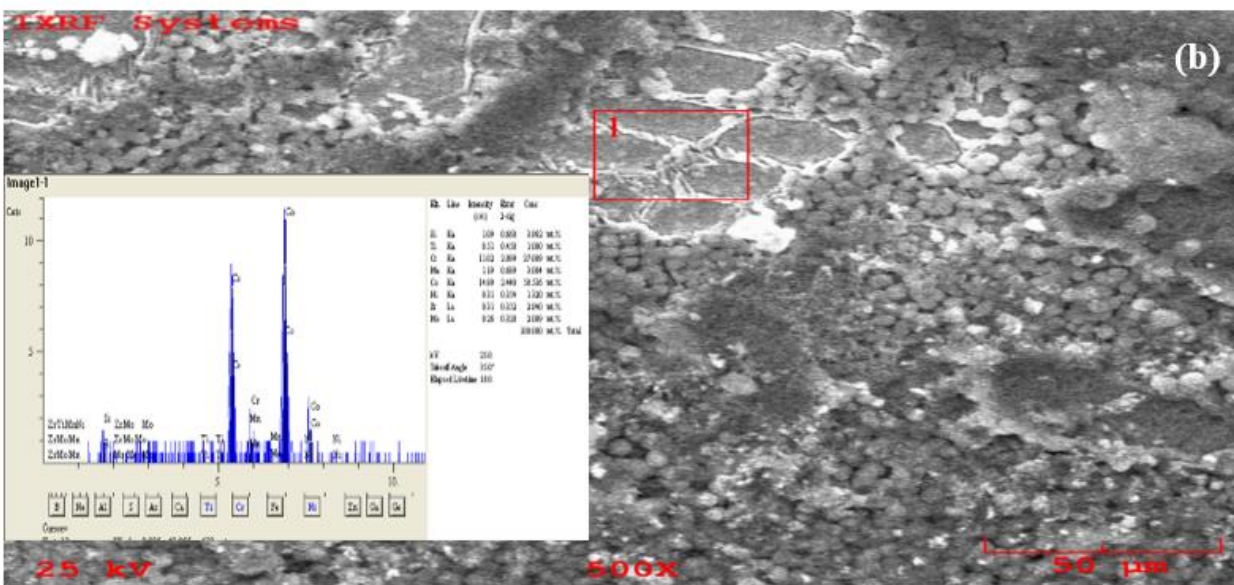
Figures 11-13 show the macro and microstructure images and chemical analysis data obtained from sample C. It was observed that very severe wear occurred both on the blade shoulder tip coating and on the back of the substrate (Figure 11-12). Irregularity and void-shaped defects were detected in the bond coating thickness. The coating has a dendritic structure, and much segregation was observed (Figure 13). Segregation is a point and/or regional composition difference. Thus, the corrosion potential increases in a structure with segregation. In sample C, the most severe wear occurred due to the steam's chemical and mechanical effects (Figure 13.a-c). Figure 12 shows the linear elemental EDS analysis to determine the chemical transition and bonding properties between the bond coating and the coating. When the analysis results are examined, it is understood that there are partial transitions between the bond coating and the coating regions. Therefore, the bond between both coatings is strong, and there will be no separation/breakage/shedding while using the blades [39].

**Figure 13.** SEM image and EDS analysis of bond coating (a) and coating (b) of sample C.
