An Investigation of the Surrounding Environments of Selected High School Buildings in Ankara with Regard to Turkish Standards Related With Accessibility

Cansu DİŞYAPAR^{1,✦}, Can GÜNGÖR²

Sincan Vocational and Technical High School (Example 1)

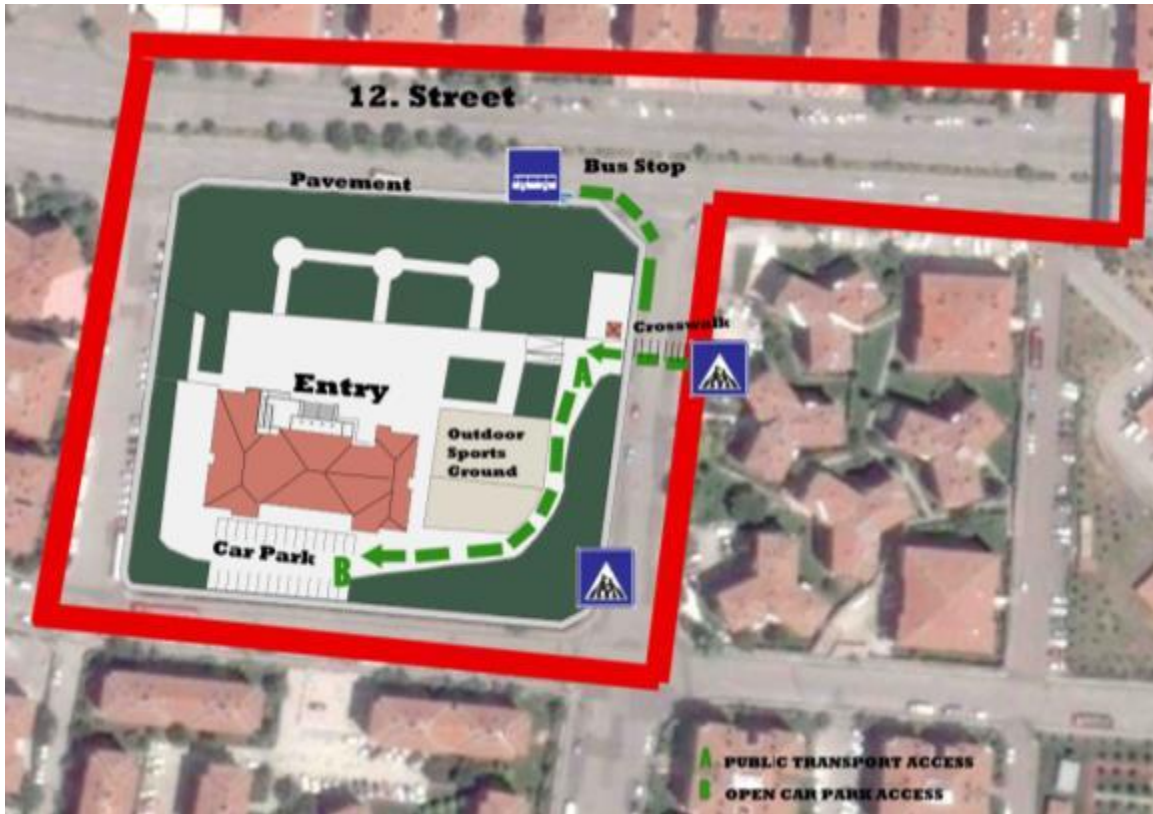
Figure 2 Sincan Vocational and Technical High School (Example 1)

Sincan İMKB Vocational and Technical High School (Example 1)			FORMS					Accessibility Value of Activity Area	Accessibility Value Exceeding Coefficient of the Activity Area	
			TOTAL NUMBER OF ANSWER	19	41	24	124			20
				FORM 1 URBAN FURNITURE	PEDESTRIAN CROSSINGS	BUS STOPS	ACCESSIBLE ROUTE			CAR PARK
P L A C E S	Buildings surrounding environments	BUS STATION	24		82			82	3,42	
		PATHWAY	124			364		364	2,94	
		PEDESTRIAN CROSSING	41	121				121	2,95	
		SCHOOL GARDEN	143	53		364		417	2,92	
		CAR PARK	20				74	74	3,70	
		OUTDOOR SPORTS GROUNDS	124			364		364	2,94	
TOTAL NUMBER OF ANSWER			476	19	41	24	372	20	1422	3,14
Accessibility Value of the form			53	121	82	1092	74	1422		
Accessibility Value Exceeding Coefficient of the form			2,79	2,95	3,42	2,94	3,7	3,16

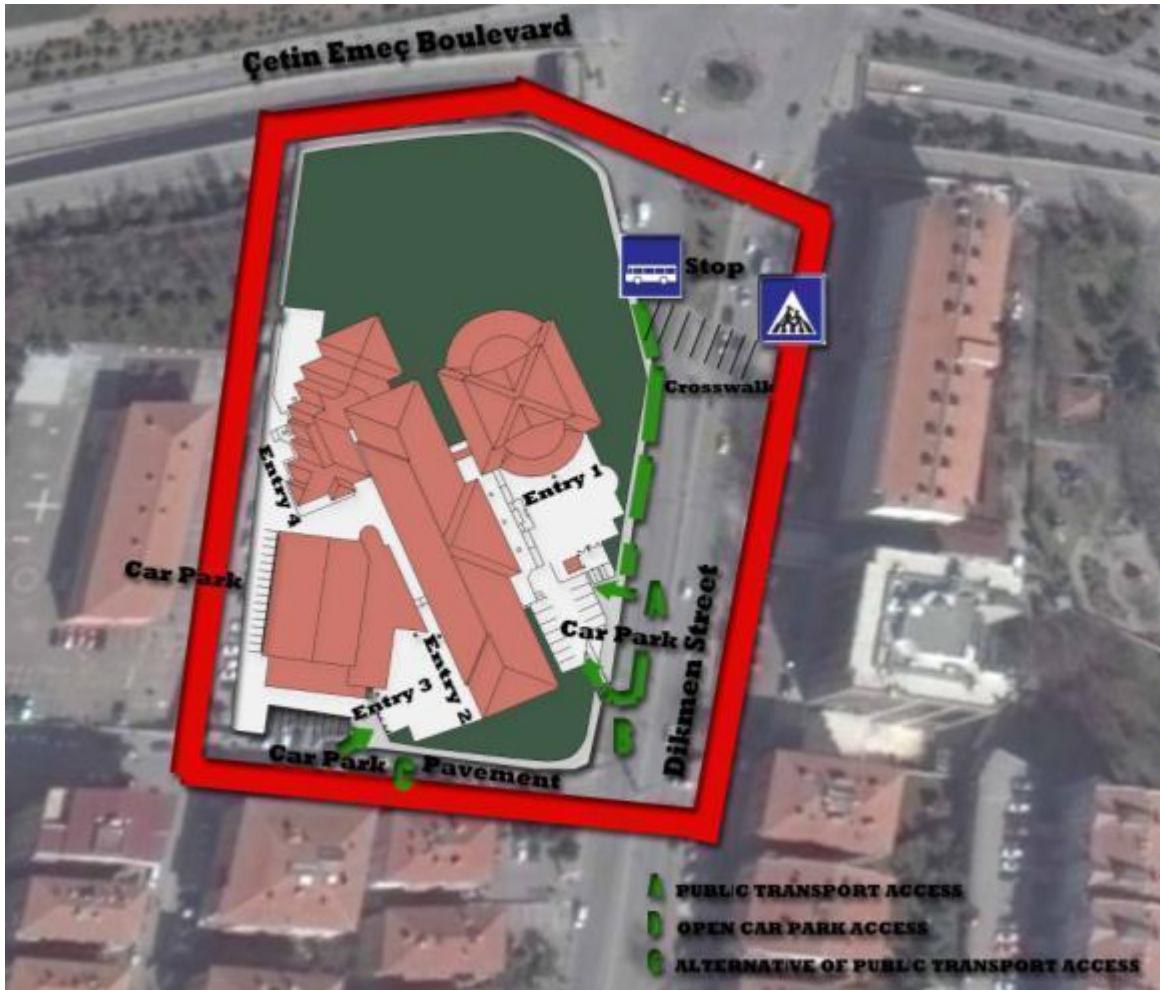
Figure 8 Dikmen Nevzat Ayaz Vocational and Technical High School (Example 2)

Nevzat Ayaz Vocational and Technical High School (Example 2)			FORMS					Accessibility Value of Activity Area	Accessibility Value Exceeding Coefficient of the Activity Area	
			TOTAL NUMBER OF ANSWER	20	43	24	137			21
				FORM 1 URBAN FURNITURE	PEDESTRIAN CROSSINGS	BUS STOPS	ACCESSIBLE ROUTE			CAR PARK
PLACES	Buildings surrounding environments	BUS STATION	24		76			76	3,17	
		PATHWAY	137			463		463	3,38	
		PEDESTRIAN CROSSING	43	157				157	3,65	
		SCHOOL GARDEN	157	52		463		515	3,28	
		CAR PARK	21				77	77	3,67	
TOTAL NUMBER OF ANSWER			382	20	43	24	274	21	1288	3,43
Accessibility Value of the form				52	157	76	926	77	1288	
Accessibility Value Exceeding Coefficient of the form				2,60	3,65	3,17	3,38	3,67	3,29

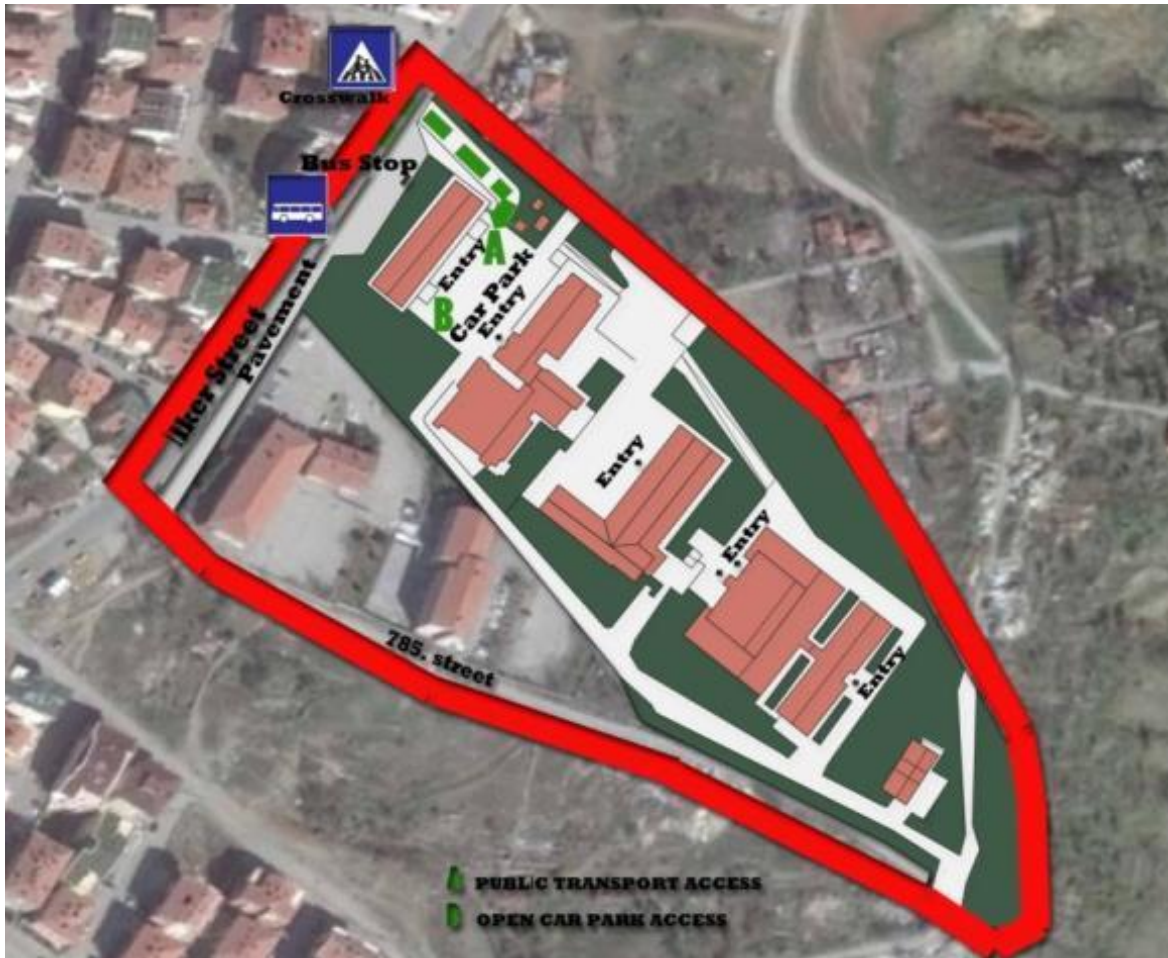
Figure 13 Dikmen Vocational and Technical High School (Example 3)

Dikmen Vocational and Technical High School (Example 3)			FORMS					Accessibility Value of Activity Area	Accessibility Value Exceeding Coefficient of the Activity Area	
			TOTAL NUMBER OF ANSWER	19	40	24	144			21
				FORM 1 URBAN FURNITURE	FORM 2 PEDESTRIAN CROSSINGS	FORM 3 BUS STOPS	FORM 4 ACCESSIBLE ROUTE			FORM 5 CAR PARK
P L A C E S	Buildings surrounding environments	BUS STATION	24		80			80	3,33	
		PATHWAY	144			516		516	3,58	
		PEDESTRIAN CROSSING	40	138				138	3,45	
		SCHOOL GARDEN	163	49		516		565	3,47	
		CAR PARK	21				81	81	3,86	
TOTAL NUMBER OF ANSWER			392	19	40	24	288	21	1380	3,54
Accessibility Value of the form				49	138	80	1032	81	1380	
Accessibility Value Exceeding Coefficient of the form				2,58	3,45	3,33	3,58	3,86	3,36

- **Form 5: Car Park: of Example 3**, have no designated and signed spaces for the disabled peoples' vehicles. No means of accessibility was achieved in either building. Along with that there are no means of designated accessible route to building entrances covered form atmospherically conditions. The material usages are also not convenient. Example 3 has no night time lighting.
