Assessment of engineering geology and grouting applications in Yalnızardıç Dam Site (Antalya, Türkiye)

Research Article

The Yalnızardıç roller compacted concrete (RCC) dam, constructed in 2015, is located in the Mediterranean region of Turkey, intended for electric power production. It is approximately 303 m long and 92 m in height. In this paper, it is aimed to determine the performance of the grouting method, conducted to control the water seepage and improve the foundation of the Yalnızardıç dam. The engineering properties of the site were introduced by geological mapping, drilling, and laboratory tests. The seepage of the foundation was determined by the in-situ Lugeon test method, also referred to as a water pressure test, which is estimate the mean hydraulic conductivity of rock mass. As a result of the tests, high-permeable and permeable zones were determined in the dam axis area. To make a barrier layer for these permeable zones, grout curtains were built in the left abutment, thalweg and right abutment with two lines of grouting holes which is proposed according to the Lugeon test and rock quality designation (RQD) results. Consolidation grouts were built to increase the

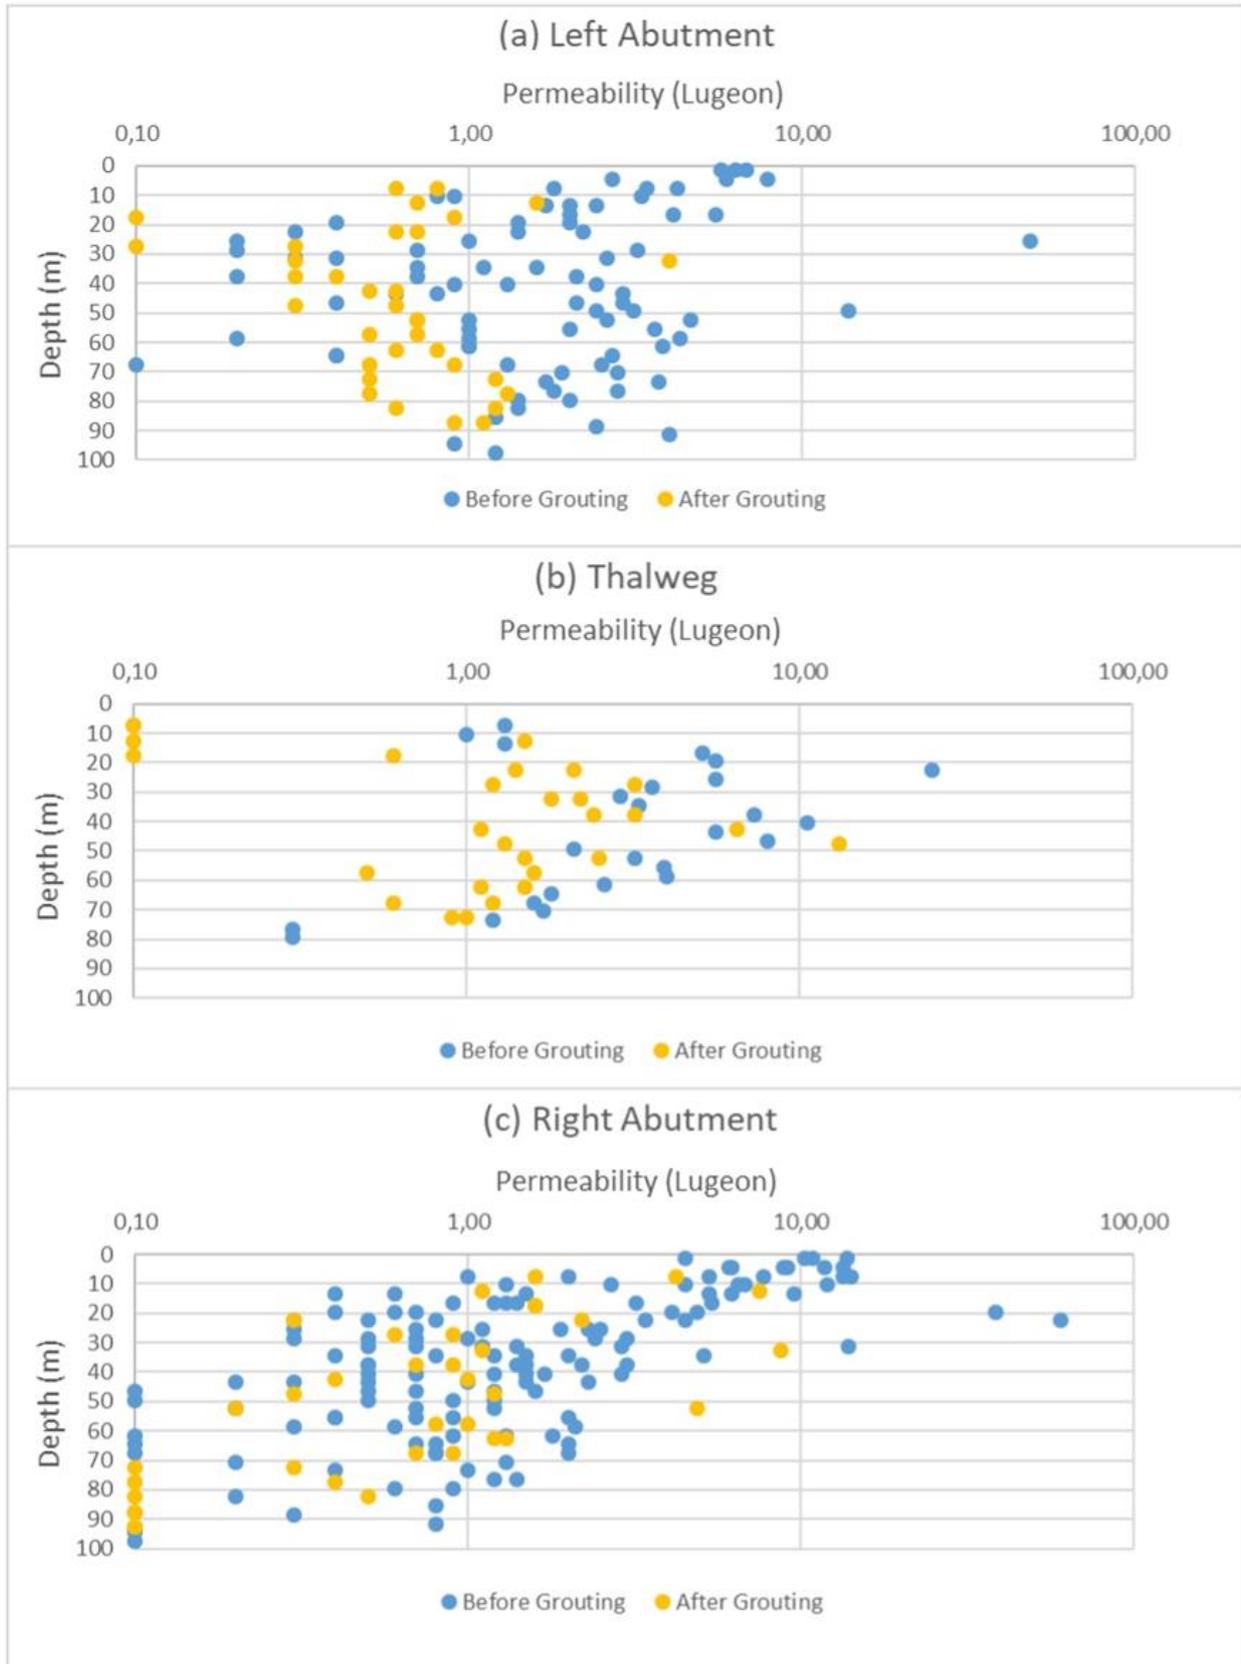
Figure 11. Comparing permeability before and after grouting at the dam axis [23].

To assess the effectiveness of the grouting procedure after the completion of the curtain grouting structure, check boreholes were drilled to intersect multiple boreholes at various angles, and WPTs were performed. The depths of the check boreholes, which were drilled during the grouting works, varied between 75 m and 95 m, depending on the conditions of the area (as illustrated in Figure 10). Table 3 displays the permeability values and their mean values of the control boreholes in the dam axis. The results, as shown in Figure 11a, 11b, 11c,

demonstrate a decrease in permeability in the thalweg, left, and right abutments, indicating the effectiveness of the grouting process. In general, the Lugeon test results in the thalweg exhibited higher values than those of the right and left abutments.

The results demonstrate a reduction in permeability in the thalweg, left abutment, and right abutment, indicating the effectiveness of the grouting process (refer to Figure 11a, 11b, and 11c). Specifically, the Lugeon test results show higher permeability values in the thalweg compared to those of the right and left abutments.

- Prior to the grouting works, it was observed that 33%, 12%, 45%, and 37% of the sections at the left abutment, thalweg, right abutment, and total dam site, respectively, had LU values of less than 1, indicating nearly no flow records. Additionally, 58%, 54%, 36%, and 45% of the sections at the left abutment, thalweg, right abutment, and total dam site, respectively, had LU values ranging from 1-5, indicating low permeability. Finally, 8%, 31%, 18%, and 16% of the sections at the left abutment, thalweg, right abutment, and total dam site, respectively, had LU values greater than 5, indicating permeable and high permeable conditions.

- After the grouting works, it was observed that 84%, 32%, 64%, and 61% of the sections at the left abutment, thalweg, right abutment, and total dam site, respectively, had LU values less than 1. Additionally, 18%, 61%, 31%, and 35% of the sections at the left abutment, thalweg, right abutment, and total dam site, respectively, had LU values ranging from 1-5. Finally, 0%, 7%, 6%, and 4% of the sections at the left abutment, thalweg, right abutment, and total dam site, respectively, had LU values ranging from 5-25, and no values exceeding 25 LU were observed.
