Charpy Impact Response of Notched Aluminum 5754-H111 of Repaired with Carbon/Epoxy and E-Glass/Epoxy

Berkant Dindar^{1*}, İnan Ağır²

In this study, aluminum sheets with three different notch depths were repaired with carbon/epoxy and e-glass/epoxy composites and than were investigated experimentally for their response to Charpy impact. [90/45/-45] oriented triaxial fabrics were used in patch reinforcement materials. Composite laminates were prepared in [90/45/-45/45/-45/90] orientation by placing these three axial fabrics on top each other. Hand lay-up technique was used in the preparation of laminated composites. The reinforcement fabrics wetted by hand lay-up were cured by hot molding at 100 °C and 7 bar pressure. Composite plates were produced in 40x40 cm dimensions. Aluminum plates were also provided in 40x40 cm dimensions. Both aluminum and composites were cut with water jet to obtain samples and patches from these plates. The aluminum and composite elements cut to the desired dimensions, were glued to each other on one-side with a double component methyl methacrylate adhesive. In the experimental stage, some mechanical properties of the composites were determined first. Aft

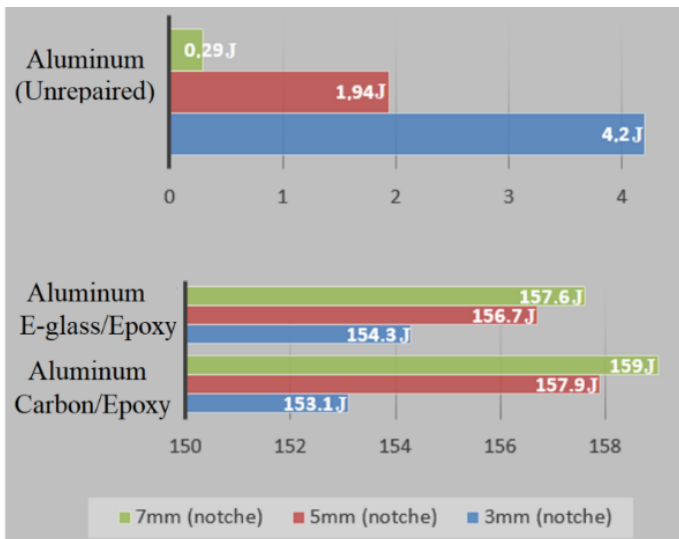
Fig. 6. Absorbed Charpy impact energies.

The Charpy impact test is a strain test used to determine the amount of energy a material absorbs during fracture. Notch toughness of the material is measured with the absorbed energy. It is widely used today due to its ease of use and cheapness. The apparatus attached to a pendulum is dropped from a certain height and hits the notched sample. The energy absorbed by the material is calculated based on the apparatus height before breaking and the apparatus height after the break. The amount of energy absorbed by the test samples was determined and presented in Fig. 6. Energy absorption capabilities of unrepaired samples with notch depths of 3 mm, 5 mm and 7 mm were determined to be approximately 4.2, 1.94, 0.29 J respectively. The energy absorption of the samples repaired with e-glass/epoxy were determined to be 154.3, 156.7, 157.6 J respectively. Finally, samples repaired with carbon/epoxy absorbed 153.1, 157.9 and 159 J of energy, respectively (for 3 mm, 5 mm, 7 mm notches). From the Charpy tests, it was seen that both glass/epoxy and carbon/epoxy patch improved the strength up to 150-160 J at all notch depths.

- While the energy absorption of the unrepaired samples was in the 0.2-4.2 J band, the energy absorption was increased to the 150-160 J band in both composite repairs (E-glass/epoxy, Carbon/epoxy).
- Carbon/epoxy composites are relatively more effective reinforcing the notched plates than e-glass/epoxy composites in Charpy impact energy absorption.
- The tensile strength of carbon/epoxy patches are approximately 53% higher than e-glass/epoxy patches.
- SEM images show that both composite patches (E-glass/epoxy, Carbon/epoxy) have strong fiber matrix interface bonds.
- Different notch and patch types are proposed as a subject for further study.
