Examination of the Relationship between the Location of Wind Plants and the Earthquake Risk: Case Study Türkiye

Anıl Özdemir¹

¹Gazi University, Faculty of Technology, Department of Civil Engineering, Ankara, Turkey

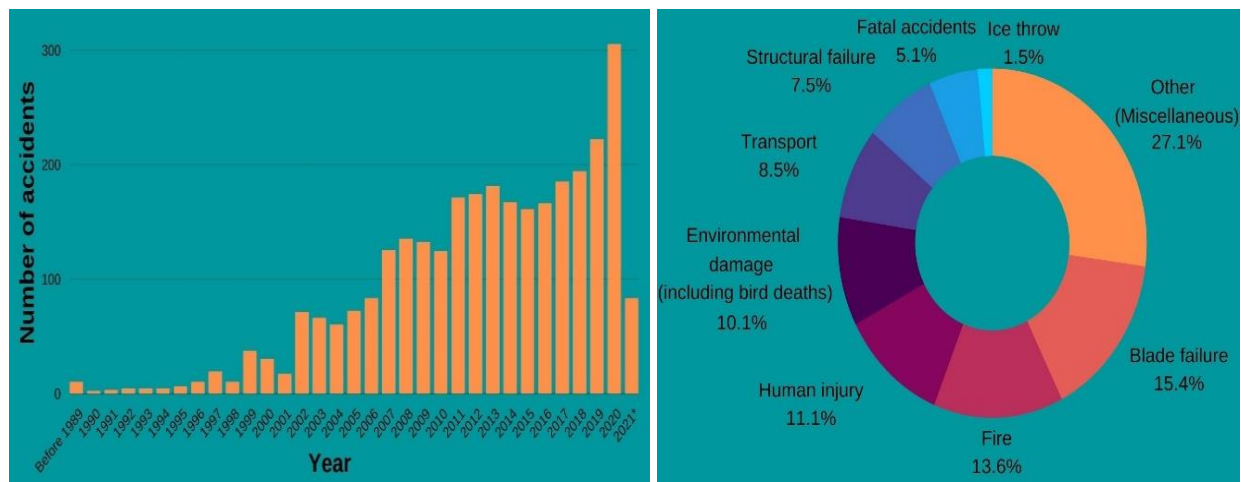
Figure 3 (a) Number of accidents in WPP between 1980 and 2021 **(b)** Failure type distribution of wind turbine incidents recorded between 2006 and 31 March 2021*(a) 1980 ve 2021 yılları arasındaki rüzgar enerji santralleri kaza sayıları b) 2006 ile 2021 yılları arasında kaydedilen rüzgar türbini olaylarının arıza türü dağılımı* [16]

Figure 3(a) presents the number of accidents in WPP between 1996 and 2021*. Figure 3(b) shows that the highest number of cases, 17.9% of the total, is caused by blade failure, followed by fire with 14.5%. Structural failure, including tower collapse and turbine damage, was the fourth-largest type of damage on the list, accounting for 9.2% of total damage. The Caithness Windfarm Information Forum 2021 report caught out that there have been 3033 wind turbine accidents in the last four years
