# Bulletin of the Mineral Research and Exploration

## Investigation of the change in the characteristic properties of epoxy and silane coated natural stone surfaces

Travertine, Silane, Epoxy, Surface Protection, Porous Structure.

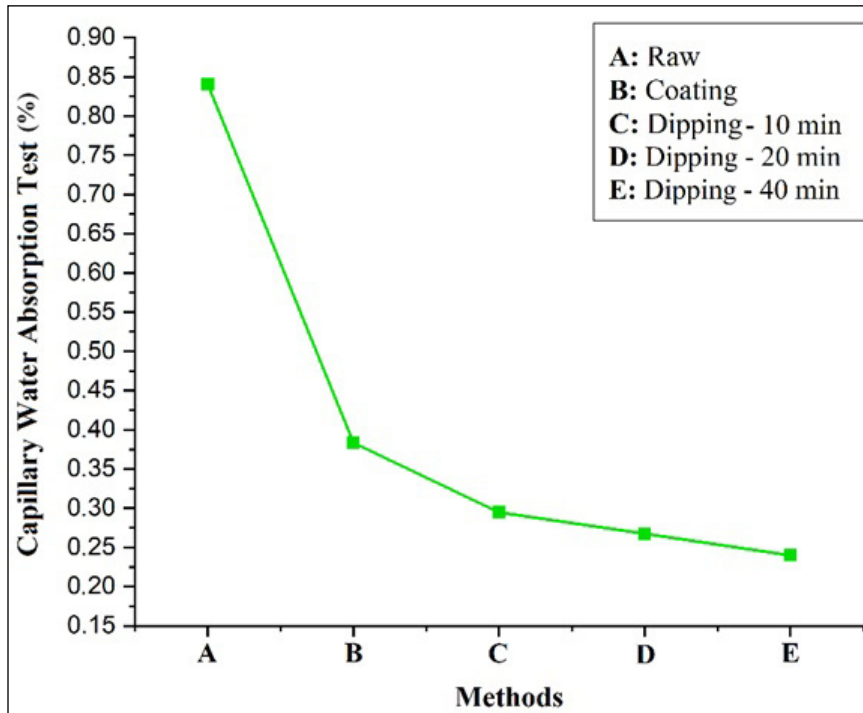
Figure 5- Capillary water absorption test results with silane applications.

with silane and epoxy with different methods were examined. The results are given in Figures 4 and 5.

deviation of 0.04 in silane. The study determined that the capillary water absorption values of silane were more effective than epoxy. Then, the silane immersion time was changed to 20 and 40 minutes, and the results were examined. However, although the results were slightly better than 10 minutes, it was determined that it was not very effective, with 0.268 with a standard deviation of 0.09 and 0.239 with a standard deviation of 0.17 for the study.

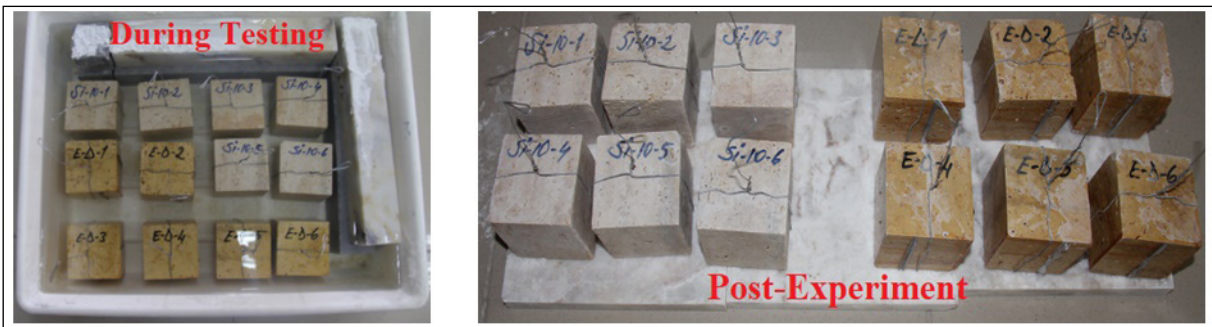
Figure 7- Visuals of samples dipped in epoxy and silane during and after the experiments.

To define the resistance of the travertine samples to be used in the study against salt crystallization and to observe the effect of epoxy and silane on salt crystallization, Salt Crystallization Resistance Tests were carried out according to the TS EN 12370 standard. Figures 6, 7, and 8 show the samples

immersed in epoxy and silane for 10 minutes before, during, and after the study and the study results.

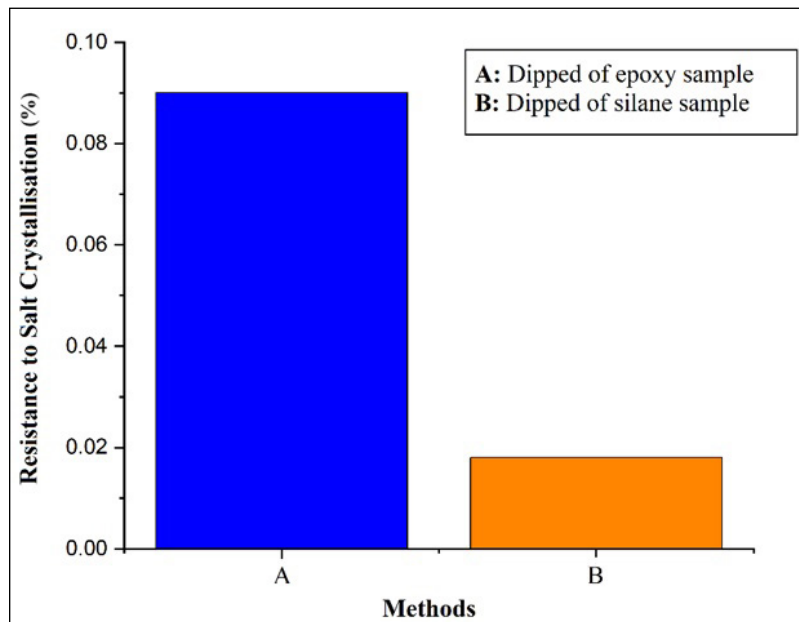
Figure 8- Results of determination of resistance to salt crystallization of epoxy and silane immersed samples.

By the determination of Resistance to Salt Crystallization of Epoxy and Silane, and it was determined that the Average Mass Change (%) of the sample kept in epoxy for 10 minutes was 0.090, the standard deviation was 0.119, the Average Mass Change (%) of the sample kept in silane for 10 minutes was 0.018 and the standard deviation value was 0.021. The results show that the silane-treated samples had higher resistance to salt crystallization. In addition, in the observations made on the samples after the experiment, no decomposition and crack formation were observed due to the exposure of the travertine samples to salt crystallization.

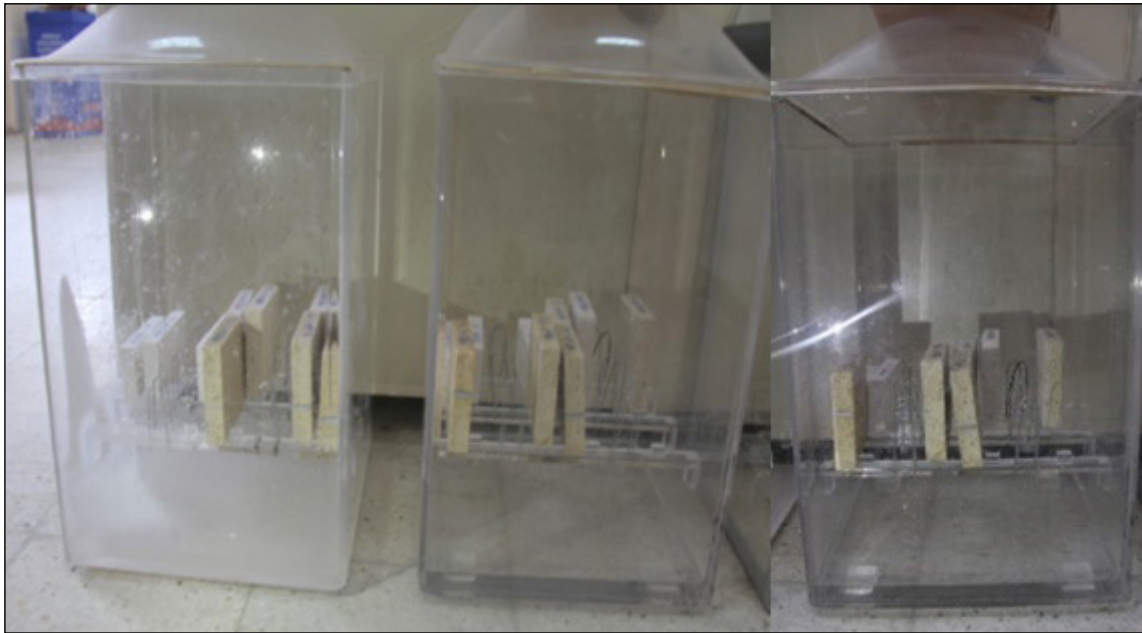
Figure 9- Image of the test for the determination of resistance to ageing by  $\text{SO}_2$  in a humid environment.

Samples taken from the sample group, immersed in epoxy and silane for 10 minutes and then dried at room conditions, were used to determine the resistance to  $\text{SO}_2$  attrition in a humid environment. The study was carried out according to the TS EN 13919 standard in 2022. A visual of the experiment process is given in Figure 9. In Figure 10, the results obtained from the experiments are given.

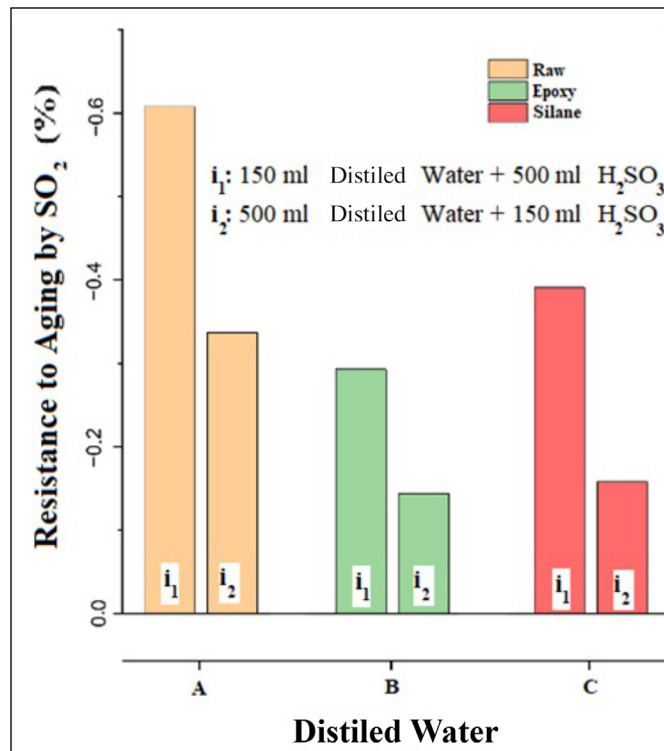
Figure 10- Results of the determination of resistance to ageing by  $\text{SO}_2$  in a humid environment of raw, epoxy and silane immersed samples.

On the raw sample in the resistance to ageing by  $\text{SO}_2$  in a humid environment test, the Average Mass Change (%) in the mixture formed with 150 ml distilled water + 500 ml  $\text{H}_2\text{SO}_3$  was -0.608, and the

In the study carried out with epoxy and silane for the determination of the resistance to  $\text{SO}_2$  attrition in a humid environment, the sample, which was kept in epoxy for 10 minutes, was found in a mixture of 150 ml distilled water + 500 ml  $\text{H}_2\text{SO}_3$  and the Average Mass Change (%) was -0.293. The standard deviation value was 0.049 in 500 ml of distilled water. In the mixture formed with water + 150 ml  $\text{H}_2\text{SO}_3$ , the Average Mass Change (%) was found to be -0.144, and the standard deviation value was 0.182. The Average Mass Change (%) of the sample, which was kept in silane for 10 minutes, was -0.391, and the standard deviation value was 0.138 in the mixture formed with 150 ml distilled water + 500 ml  $\text{H}_2\text{SO}_3$ , and the Average Mass Change (%) in the mixture formed with 500 ml distilled water + 150 ml  $\text{H}_2\text{SO}_3$  was found to be -0.391. It was determined that the standard deviation value was -0.158 and 0.159.

It has been seen by the Determination of Resistance to  $\text{SO}_2$  Attrition in Humid Environment that the epoxy-treated samples gave more durable results than the silane-treated samples. This shows that epoxy-treated

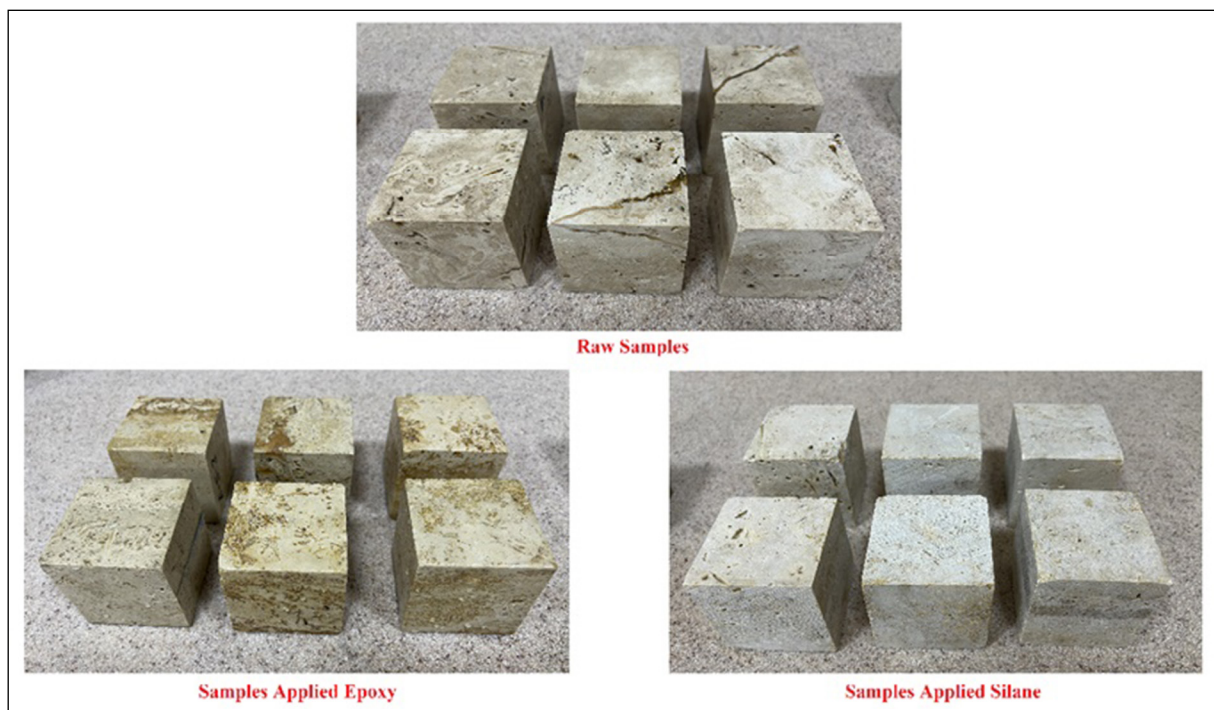
Figure 11- Samples before and after.

surfaces have higher  $\text{SO}_2$  resistance. In Figure 11, the image of the raw sample is given before and after the test. As can be seen from the figure, the color of the processed samples is quite dark, while the color of the raw sample is light. This showed that the sample caused a color change by absorbing  $\text{SO}_2$  due to its porous structure. However, no effect was observed to disrupt the integrity of any part.
