## Low Velocity Impact Damage Response Of Carbon Fiber Reinforced Composites At Low Temperatures

Zafer Özdemir<sup>1\*</sup>, Osman Selim Türkbaş<sup>2</sup> and Dilara Yılmaz<sup>3</sup>

<sup>1</sup>Balıkesir University, Engineering Faculty, Mechanical Engineering Department, 10100, Balıkesir, Turkey.

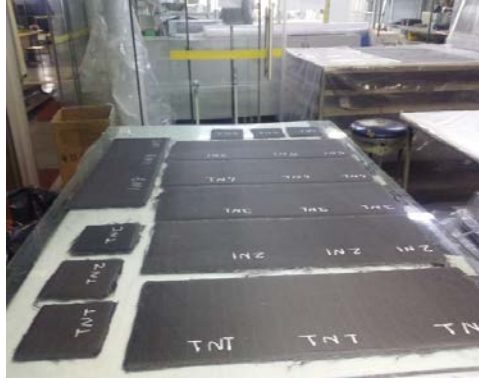
Composite type: Carbon (CFU 10T), epoxy (CR 80) and CH 80-6 hardener (Fig. 1).

**Figure 1.** Composite plates after vacuum and curing process

Carbon fiber and epoxy resin are used for preparation of plates (Table 1) by hand layup process at 23,7°C, % 28 humidity and under 650 mm Hg. pressure, approximately for 30 minutes. The plates have been vacuumed, after that they have been cured at 55°C for 16 hours [3].

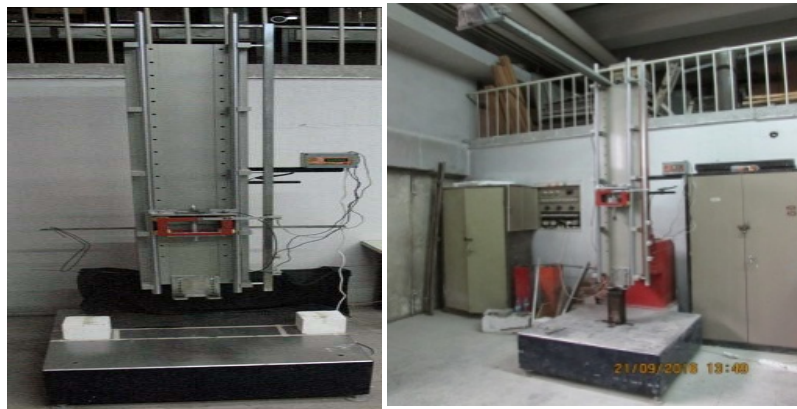
A weight drop impactor test setup was used for impact tests (Fig. 2(a) and (b)). The device has been designed so as to make damage on the materials by a substance dropped from a definite height with low velocity and mass. For this study, all samples were impacted with a 9 kg. drop weight. Since, the drop weight was not changed, the different impact energies were achieved by adjusting the drop height. A pneumatic clamping fixture, with a 76.2 mm. (3in.) diameter opening, secured each sample during impact. The samples were impacted with a 12.7 mm. (0.5in.) diameter striker with a hemispherical tip, constructed by a high strength steel. Impulse software was used to display and store the impact data.

**Figure 2.** (a) Weight Drop Test Setup and Settlement of Sample to the Fixture

**Figure 2. (b)** Weight Drop Test Setup and Settlement of Sample to the Fixture

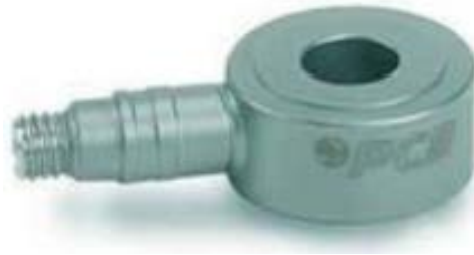
The force sensor 201B03 model (Table 3) ICP manufactured by PCB Group Company is used in tests (Fig. 3.)

**Figure 3.** The Force Sensor

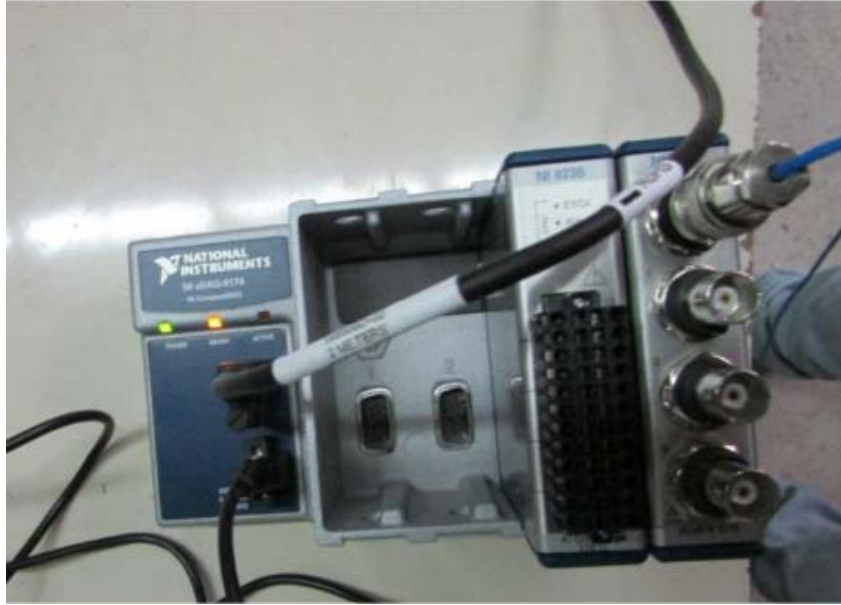
The data collector is the application that collects and delivers the metadata that is analyzed and presented in the GUI (Graphical user Interface) in computer (Table 4). The NI 9233-USB-9162 model data collector is used in tests (Fig. 4.)

**Figure 4.** NI 9233-USB-9162 Model Data Collector and Mounting

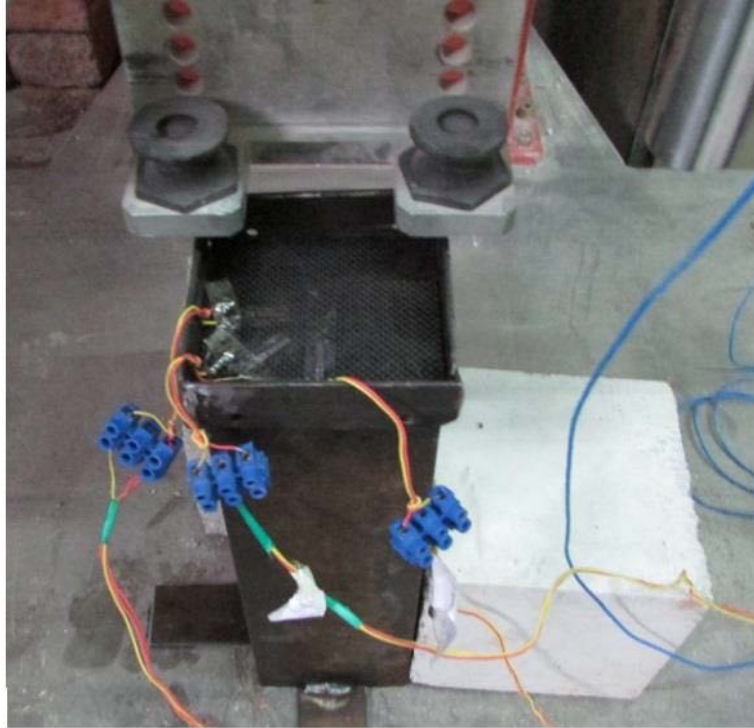
**Figure 9.** *Samples with strain gage*

displacement and deformation that occur. Strain gauges (120 ( $\Omega$ ) and % 3 strain limit) are used to measure the strain for the samples that have been subjected to impact at +22,5°C (fig.9 ve 10). [21].

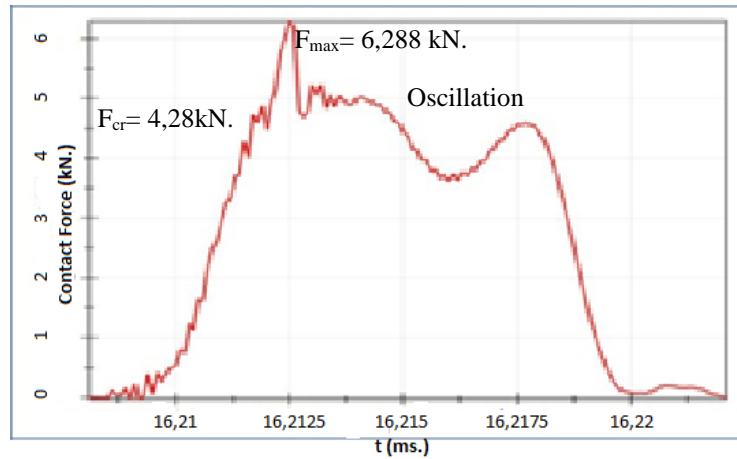
**Figure 12.** Force-time graph of [0/+45/-45/90] oriented sample subjected to low velocity impact test (strain-gauge mounted)

Until striking edge hits the sample, force is zero. Just at the hitting time, the force increases to a very high level and then again after second hit a small force magnitude has been obtained compared to the first hit as seen in Fig. 11. This means a second impact force has been applied. And as seen in Fig. 12., after second impact force a less contact force has been observed. Until the striking end stops, the impact forces continues. For force is the initiating force that makes a permanent damage.

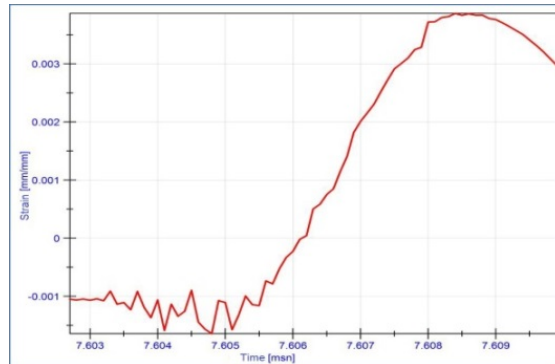
(a)  $[0/+45/+45/90]_s$

(b)  $[90/+45/0/-45]_s$

(c) [+45/0/-45/90]s

(d) [0/+45/90/-45]s

(e) [0/-45/90/+45]s

(f) [+45/0/90/-45]s

**Figure 19.** Strain-time graphs of samples subjected to low velocity impact test at different temperatures a) 1N1, b) 2N1, c) 3N1, d) 4N1, e) 5N1, f) 6N1 (strain gauge mounted samples at 22,5°C)

Strain amount is high at the  $[0/+45/-45/90]_s$  oriented sample and damage area less. Strain amount is low at the  $[+45/0/90/-45]_s$  oriented sample and damage area is more.  $[0/+45/90/-45]_s$  and  $[0/-45/90/+45]_s$  oriented samples area identical to each other so strain values is almost same (Fig. 17). It is observed that if the damage occurs earlier, material has lower toughness and more brittle; and vice versa. The reason why the strain values begin under zero is the compression force observed during impact force applied to the samples.

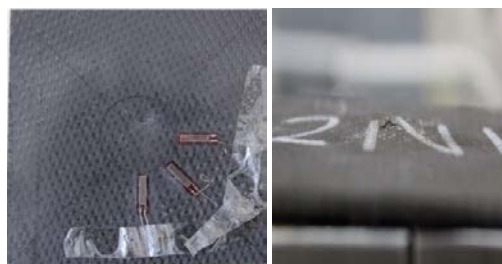
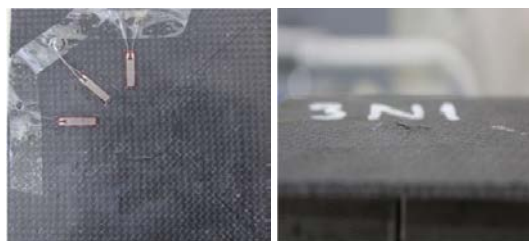
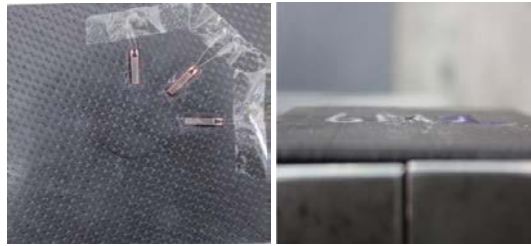
**Figure 21.** *Impact Applied Point (1N1 Sample)*

**Figure 22.** *Impact Applied Point (2N1 Sample)*

**Figure 23.** *Impact Applied Point (3N1 Sample)*

**Figure 24.** *Impact Applied Point (4N1 Sample)*

**Figure 25.** *Impact Applied Point (5N1 Sample)*

**Figure 26.** *Impact Applied Point (6N1 Sample)*

Damage photos (fig. 21 through fig 26. for 1N1, 2N1, 3N1, 4N1, 5N1 and 6N1) observed under microscopy could be seen for all samples from Fig. 27 to Fig. 32.
