Investigation of Leakage and Stability Analysis in Rock Filling Dams: The Example of Kolludere Pond

Mehmet Hayrullah Akyildiz

^{1,2}University of Dicle Engineering Department, Civil Engineering, Diyarbakır, Turkey (e-mail: hayrullah.akyildiz@dicle.edu.tr).

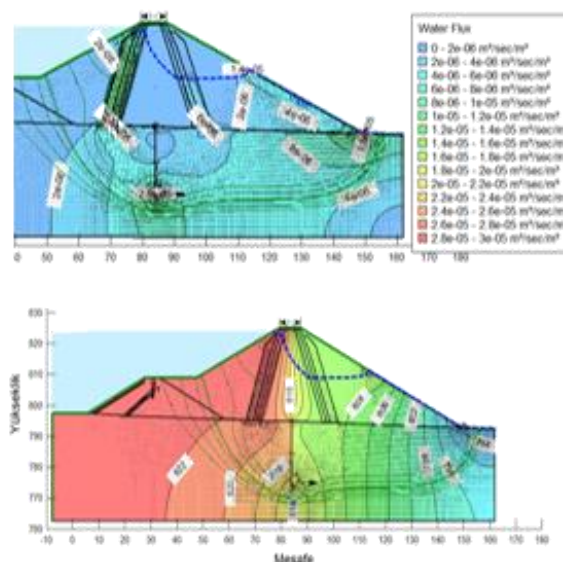
Figure 7. Leakage Analysis in Operational Status Amounts of Water Leaking per Unit Meter, Leakage Analysis Equipotential Curves and Water Pressure Head Distribution

Seep analysis was carried out on the pond body. In this way, water flow lines, amount of leaking water per unit meter, equipotential curves and water pressure height values were determined. In the examination, it was determined that the water pressure heights in the body decreased from upstream to downstream (Fig. 7.).

In this way, it has been determined that the energy of the water pressure is broken while moving through the body of the pond. Another study is the analysis of the amount of water leaking per unit meter through the pond body of the rockfill-type Kolludere pond. The energy breaking of the water on the upstream side while passing through the body and the vertical water flow by increasing its speed while passing through the filter materials was directed towards the pond foundation and gathered around the injection curtain. Therefore, as a result of the analysis, the maximum leaking water amount per unit meter was determined as $2 \times 10^{-5} \text{ m}^3 / \text{s}$ just below the pond injection curtain. It has been determined that the maximum amount of water leaking per unit after the injection curtain passes through the filter materials on the upstream side and the parts located in the downstream heel of the pond body at $1.6 \cdot 10^{-5} \text{ m}^3 / \text{s}$ per second.
