# Corrosion Behavior of Graphene Nanoplatelet-Coated TiB<sub>2</sub> Reinforced AZ91 Magnesium Matrix Semi-Ceramic Hybrid Composites

Engin Cevik<sup>ORCID</sup>, Murat Gundogan, Alper Incesu<sup>ORCID</sup>, Muhammet Emre Turan  
Karabuk University, Department of Metallurgical and Materials Engineering, Karabuk, Turkey

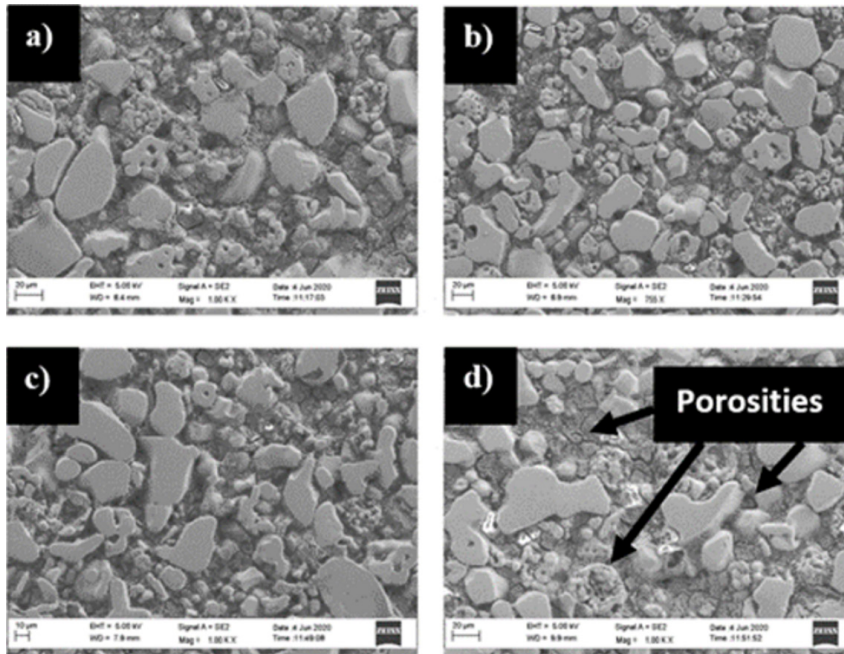
**Figure 3.** a) AZ91+TiB<sub>2</sub>, b) 0.25% GNP+AZ91+TiB<sub>2</sub>, c) 0.5% GNP+AZ91+TiB<sub>2</sub> and d) 1% GNP+AZ91+TiB<sub>2</sub>.

The microstructure images of the produced hybrid composites are given in Fig. 3. Unlike other composite production methods, the pressure infiltration method makes it possible to produce with high reinforcement elements [17]. For example, while the powder metallurgy production method can reach a maximum of 30% by volume, it is observed that agglomeration in the structure increases and porosity reaches unacceptable levels at higher reinforcement rates [18]. When hybrid composites produced with 50% particle reinforcement are evaluated fabricated by pressure infiltration method, it can be deduced that homogeneous particle distribution is achieved successfully in all graphene ratios. However, as the proportion of graphene in the structure increased, the amount of porosity increased by 5% compared to non-graphene reinforced composites due to the adverse effect of wettability between the reinforcement and the matrix (Table 3) [19-20].

With liquid metal infiltration, it has been observed that liquid metal diffusion occurs even between particles that

are very close to each other. This result shows that the infiltration process is successful despite the very high reinforcement content and that the strong interaction between the reinforcement and matrix can be fully achieved. However, micro-cracks can be attributed to the differences in the cooling rate between the reinforcement and the matrix materials are occurred.
