Effect of repair parameters on composite plates under low velocity impact

Abstract: In this study, the impact behavior of patch-repaired layered composite plates was numerically investigated under low velocity impact loads. For this purpose, composite plates designed in different geometric combinations were repaired with patches using various adhesives. Impact behavior of these composites investigated by dropping the strikers with different velocities on the repaired composite plate. The laminated composite was used as the sheet and patch material, and the orientation angles were set as $[0^\circ/45^\circ/45^\circ/0^\circ]$ for the sheet and $[0^\circ/45^\circ]$ for the patch. ANSYS-Ls-Dyna finite element packet program was used for three-dimensional modelling and solution. It was determined that the hexagonal patch type performs better than other patch geometries.

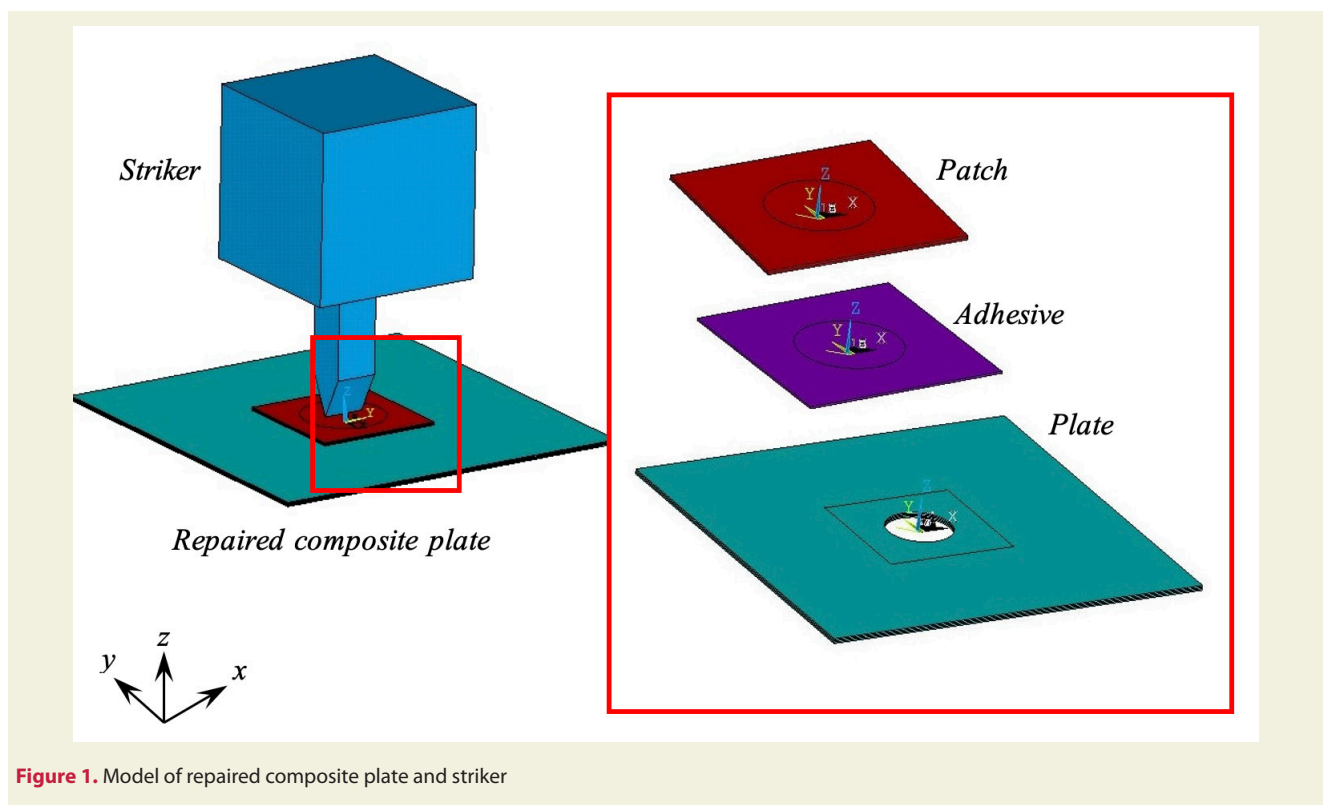
Figure 1. Model of repaired composite plate and striker

In the study, the composite plate with a hole has different geometries in the middle was repaired with a composite patch with different geometries and dimensions (Figure 1). Under low velocity impact, the effects of the impact behavior of plate hole size and shape, adhesive type and thickness, patch size and type on composite plate were investigated within different boundary conditions. In addition, the analyzes were repeated for the strikers of various speeds.

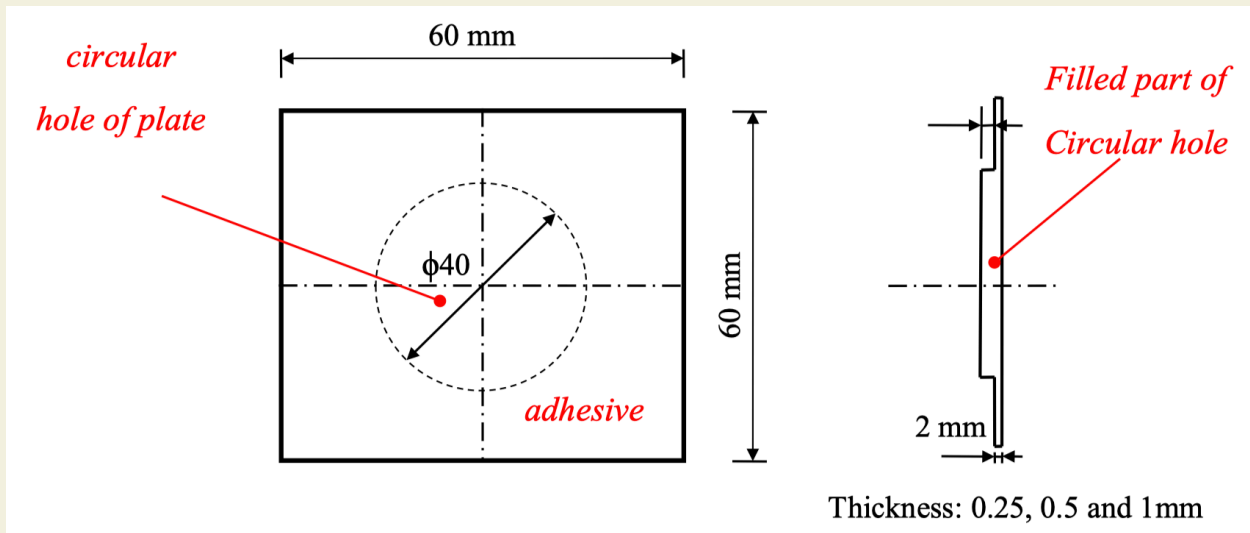
Figure 2. The dimensions of adhesive model.

adhesives was given in Figure 2 and the adhesive thicknesses are 1mm, 0.5mm and 0.25mm. Patches used in the repair of composite plates were two-layered and $[0^\circ/45^\circ]$ alignment angles. Each layer with a thickness of 0.5mm was modeled as circle (radius 30 mm), square ($60 \times 60 \text{mm}^2$) and hexagon (edge length 30mm). In addition, the patch edge sizes were also changed as 50, 70 and 80mm for each square patch.

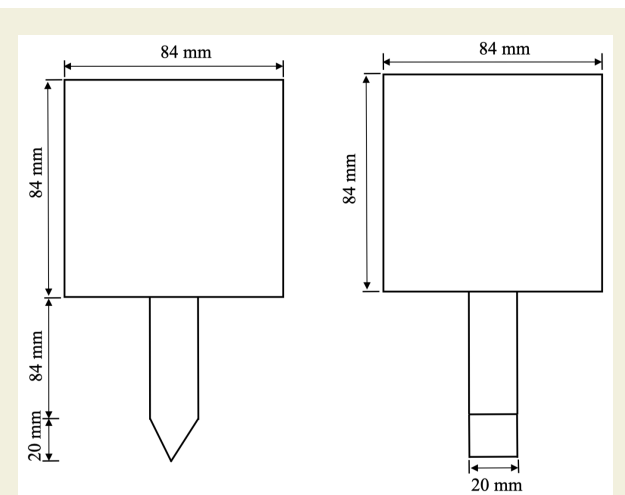
Figure 3. The striker model.

The material properties of the striker model were given in Table 3 and the weight of the striker was set as 5 kg. By taking the density values into consideration, their volumes were calculated and modeled in a way to provide the striker weight (Figure 3) while designing the striker geometries. Strike velocity was selected as 1, 2 and 3 m/h. The boundary conditions of the composite material: four different boundary conditions were used, and these were fixed support on four sides of the plate, pin support on four sides, fixed support on two sides, free support on the other two sides, and finally pin support on two sides.

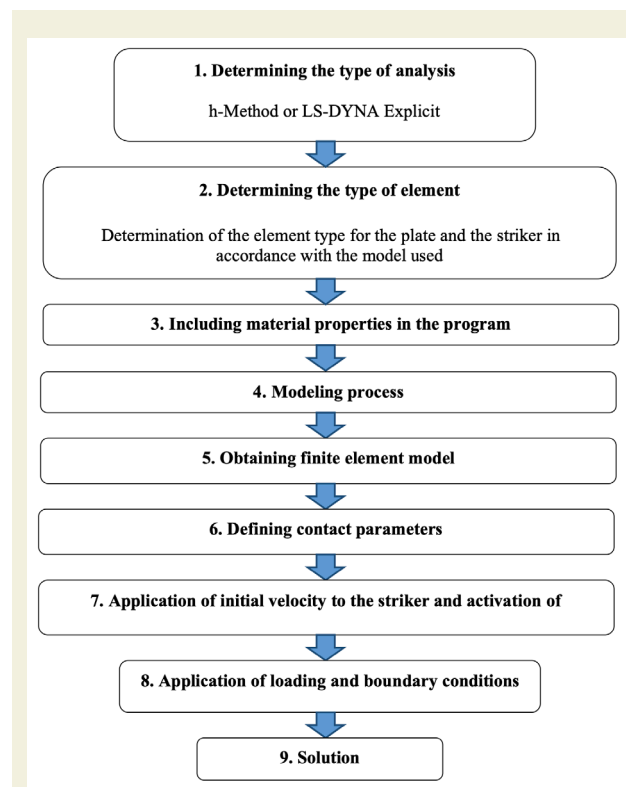
Figure 4. The operational steps of ANSYS LS-Dyna software.

in solving problems. In the finite element model (FEM), the *SOLID 164* element type is used for the striker and composite material. After defining and modeling the material properties of the striker and the plate, finite element division was performed at appropriate frequencies. In addition, surface to surface –Automatic (ASTS) option has been used to define the required contact properties between the striker and the plate. The initial velocity of the striker is 3 m / s, and the acceleration of gravity was modeled in contact with the plate in order to be in contact with the striker. The operational steps of *ANSYS LS-Dyna* software are shown in Figure 4.

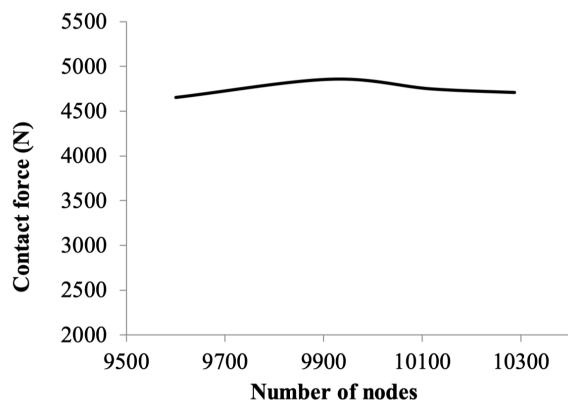
Figure 5. Variation of force with number of nodes.

The graph of the contact force node number depending on the change in the number of nodes is given in Figure 5. The problem for values between 9600 and 10400 nodes was solved in the graph. According to the results obtained, it was observed that the force change was constant for the number of 10280 nodes and thereafter. In the light of this information, the number of node for finite element model solutions was determined as 10280. The finite ele-

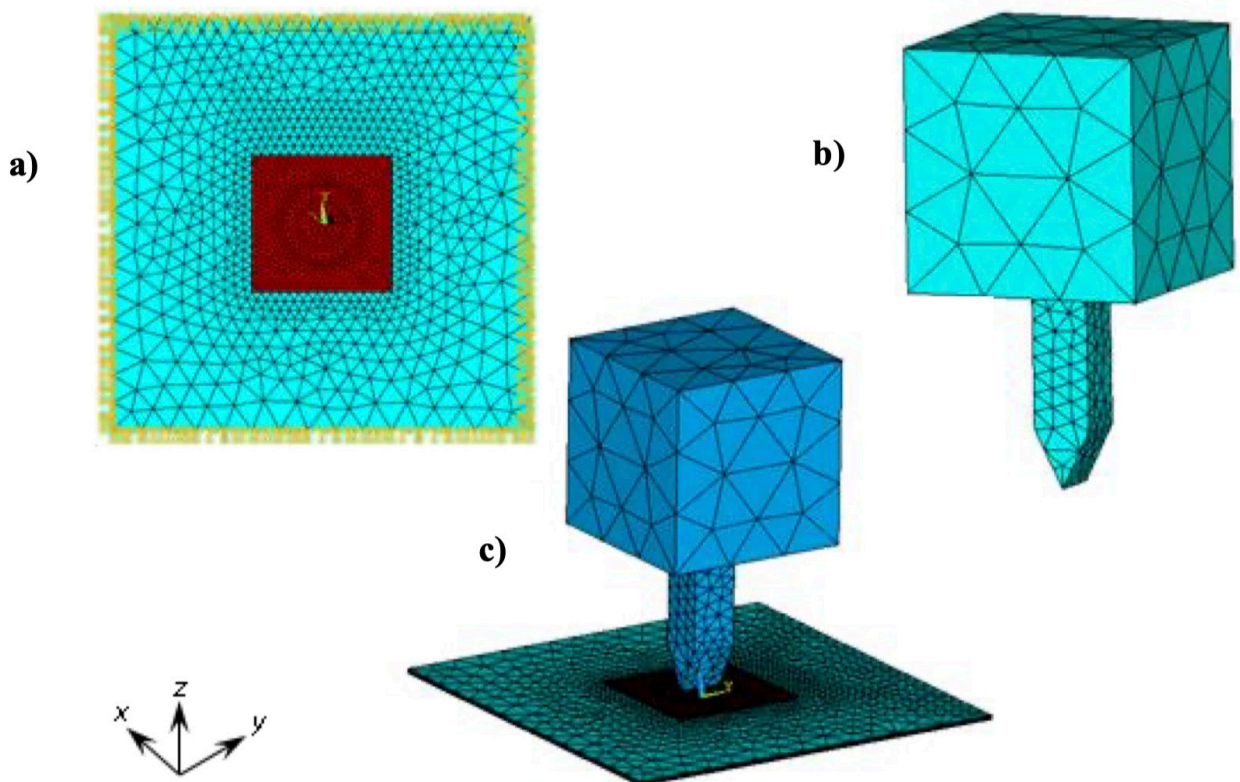
Figure 6. a) Finite element model of four-sided fixed support plate, b) Finite element model of the striker, c) Finite element model of the problem

ment, the striker model of four-sided fixed support patch-repaired plate and the finite element model of the contact with the plate are presented in Figure 6.

In this study, which was carried out in parallel with the experimental study, it was observed that the experimental and numerical results were compatible with each other (Figure 8). In order to examine the effect of the striker velocity on the impact behavior, the striker model, whose geometric details are given in Figure 3, is used. The striker weighs 5 kg and its initial velocity is 1, 2 and 3 m / s, respectively. It is modeled to contact with the plate centers (Figure 6c).

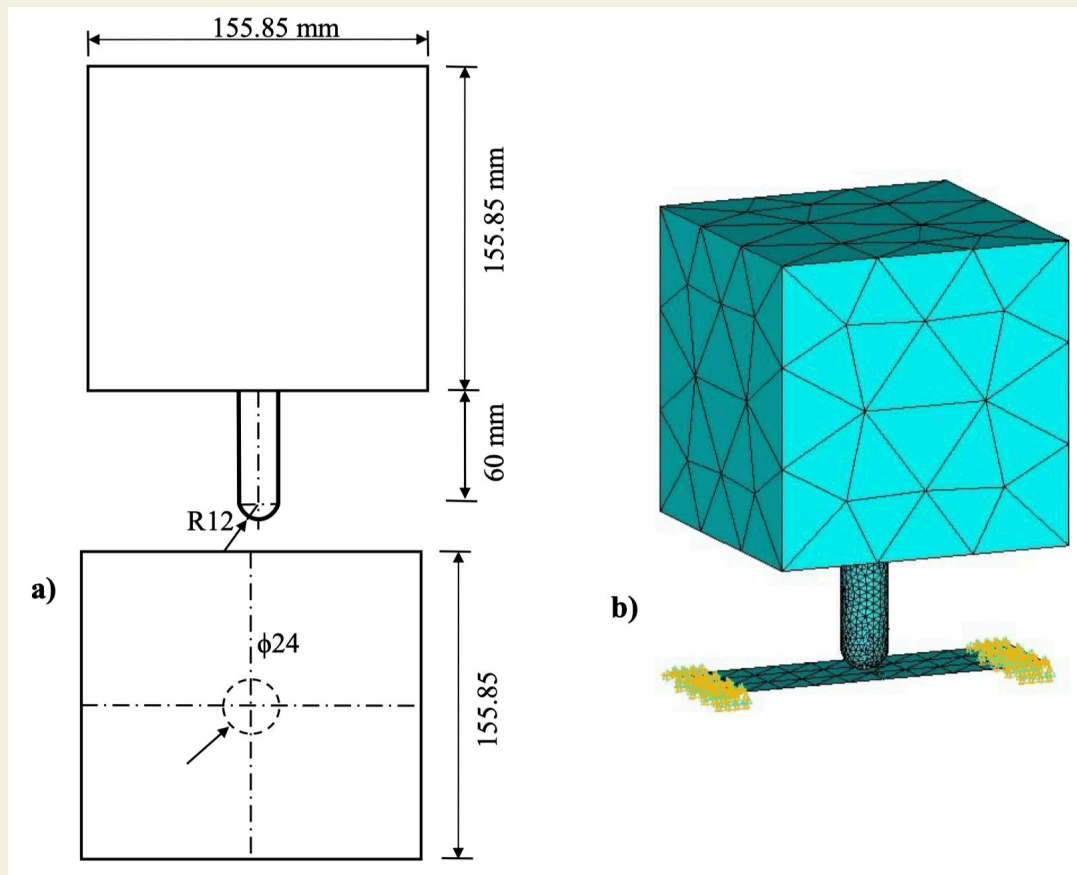
Figure 7. a) The dimensions of striker, b) Finite element of the problem [23]

ing the experimental study in the literature with FEM, *SHELL 163* for composite material and *SOLID 164* element type for the striker were used. The mechanical properties of the composite plate and striker model are given in Table 4. In addition, the geometric features of the striker model and the FEM model of the contact with the plate are presented in Figure 7.

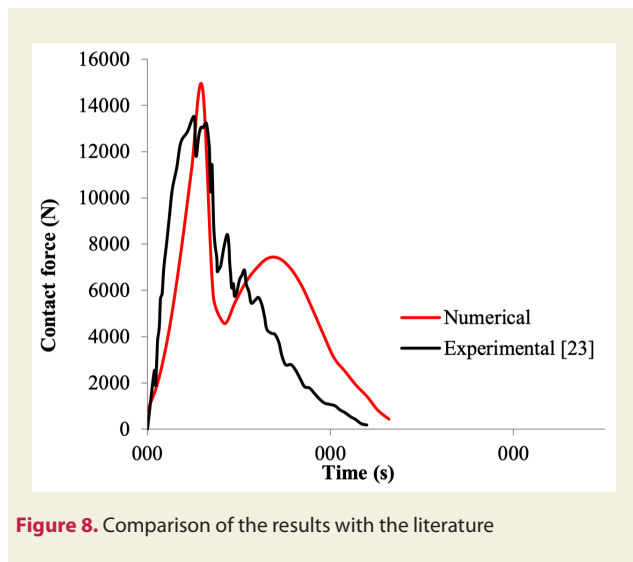
Figure 8. Comparison of the results with the literature

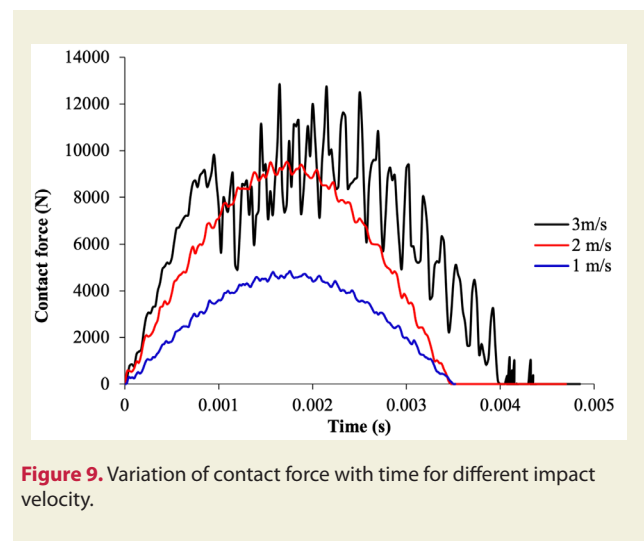
Figure 9. Variation of contact force with time for different impact velocity.

When the contact force-time diagram (Figure 9) is exam-

ined, depending on the impact velocity change, it was observed that the contact force increased in accordance with the increase in impact velocities [12]. It was evaluated that the initial steep increase in load was due to the elastic behavior of the samples and that the slope increased with the velocity. its rising diagram is followed by a decrease in loading (3m / s) corresponding to the initial major deformation. In practical application, minor failures (intralaminar delamination and matrix cracking) caused by impact begin to spread beyond the contact point [12]. The contact force measured with the recoil of the striker contin-

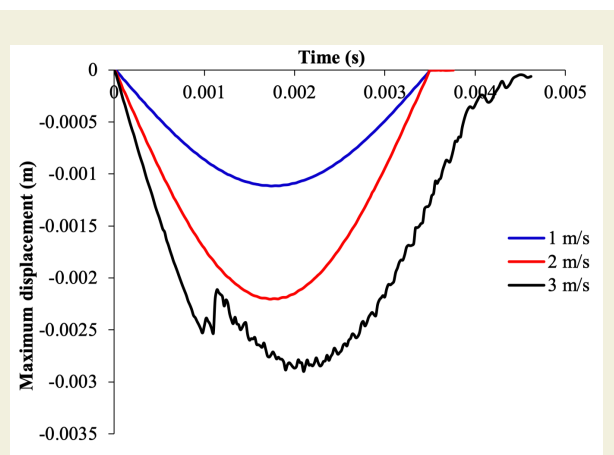
**Figure 10.** Variation of maximum displacement with time for different impact velocity.

Therefore, it was determined that the total energy increased parallel to the impact velocity [23]. When the maximum displacement-time diagram in the direction parallel to the direction of impact (z -axis) of the plate depending on the impact velocity is examined, it has been observed that the displacement due to the impact on the plate increased with the velocity increase [23] (Figure 10).

The maximum displacement in the z direction for 1m / s was approximately 1.1mm, 2.2mm for 2m / s, and 2.9mm for 3m / s. Depending on the change of hole diameter ($\phi 30, 35, 40, 45$ and 50mm), in the layered composite plate with a circular hole in the middle, the contact force time diagram at 0.001s was drawn along with the contact of the striker with the plate (Figure 11). Sudden decreases in contact force were seen, especially at diameters over 40mm. In addition, when the graph was examined, it was observed that the reaction force decreased due to

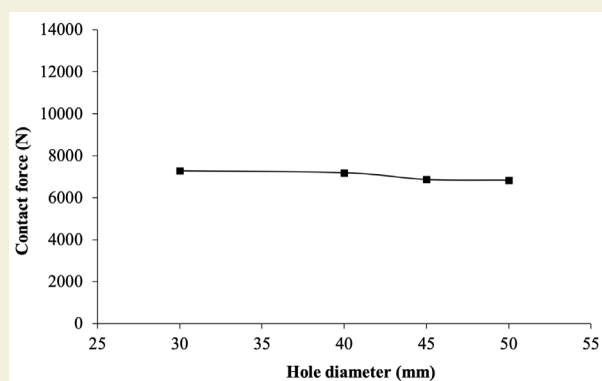
**Figure 11.** Variation of contact force with hole diameter.

the increase of hole diameter. This is because the increase in hole size reduces the overlapping area, resulting in less load transfer across the patch [4].

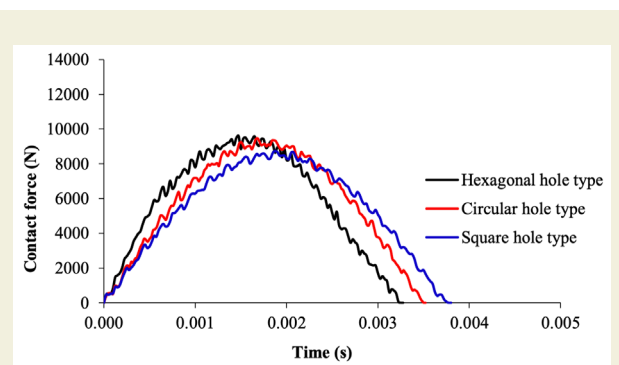
**Figure 12.** Variation of contact force with time for different hole shape

In Figure 12, the contact force time diagram was given depending on the change of hole type (circle, square, hexagon) in the center of the composite plate. The surface areas of these holes are 1256mm², 1600mm² and 1039mm² for circle, square and hexagonal holes, respectively. Therefore, the same situation with the change of hole diameter is also seen here. Because of this, as the hole cross-sectional area decreased, the contact surface of the patched plate increased and accordingly the load carrying capacity increased. Three different adhesive materials were used in the patch repair of the plate with a circular hole in the middle.

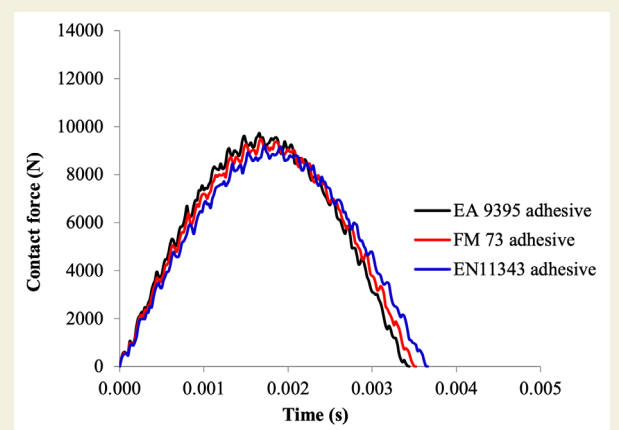
**Figure 13.** Variation of contact force with time for different adhesive material

Figure 13 shows the effects of the adhesive materials on the force time diagram. The elasticity modules of the adhesives used in descending order; EA9395 > FM73 > EN11343. When the graph is examined, it has been observed that the contact forces related to this have increased [26].

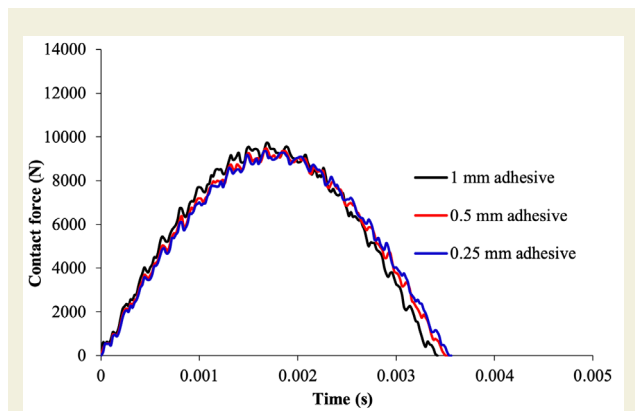
Figure 14. Variation of contact force with time for different adhesive thickness.

The adhesive material used for patch reinforcement is FM 73, and a solution was made for different thicknesses (0.25, 0.5 and 1mm) of this adhesive. According to the results, just as the thickness of the adhesive increases, the

reaction force also increases (Figure 14). Cheng et al. [1] repaired carbon fiber composites with adhesives of different thicknesses and passed them through low-velocity impact tests. They determined that the maximum impact force increased parallel to the thickness of the adhesive. Composite plates with a circular hole in the center were repaired by using square patches of different sizes (50x50, 60x60, 70x70 and 80x80mm²). When the effect of patch size on contact force was examined, it was observed that the contact force decreased as the patch size increased (Figure 15).

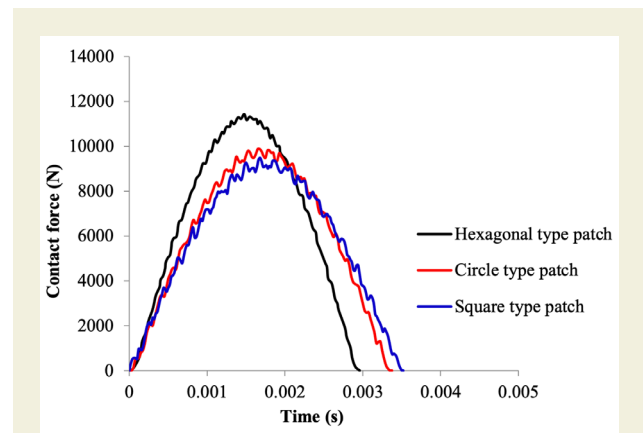
Figure 16. Variation of contact force with time for different patch size.

Tie et al. [8] used circular patches of different radius in order to examine the effect of patch size on the contact force and determined that the contact force decreased as the radius diameter increased. In order to examine the effect of patch type on impact behavior, solutions were made by using square, circle and hexagonal patches (Figure 16). When the graph was examined, the results of the circle and square patch types were similar, and higher contact force was obtained in the hexagonal patch repaired plates. However, when the force oscillation amplitude in the graphs was evaluated, it was observed that the minimum impact force change occurred in the hexagonal patch and the maximum force oscillation occurred in the square patch. This indicates that the hexagonal patch repaired structure absorbs less impact energy than the others.

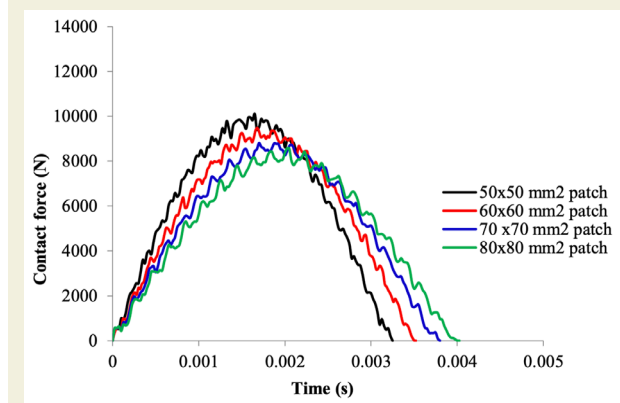
Figure 15. Variation of contact force with time for different patch size.

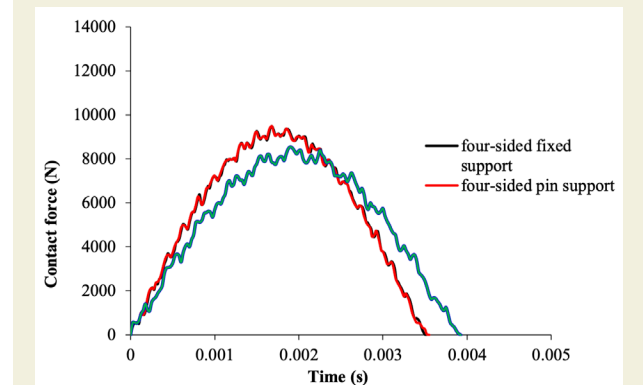
Figure 17. Variation of contact force with time for different support type.

The effect of four different support conditions on the impact behavior was evaluated: four-sided fixed support, four-sided pin support, two-sided fixed support – two-sided free, two-sided pin support and two-sided free (Figure 17). According to the results, it was determined that the contact force values of four-sided pin support and four-sided fixed support were close to each other. The same situation is true for two-sided fixed –two-sided free support and two-sided fixed- two-sided free support. In addition to this, % 9.86 more contact force was obtained in 4 side supports (pin or fixed) compared to 2 sides supports. Figure 18-20 shows the graphs of the maximum tensile and compression stresses in the striker direction (z-axis) for the striker velocity of 1, 2 and 3m / s, respectively. As a result of the contact of the striker with the plate, compression stresses were occurring on the patch contact surface and maximum tensile stresses were occur on the opposite surface. When the stress bar is examined, it has been determined that the tensile-compression stresses taking place in the striker plates increase in accordance with the striker impact velocity and energy.

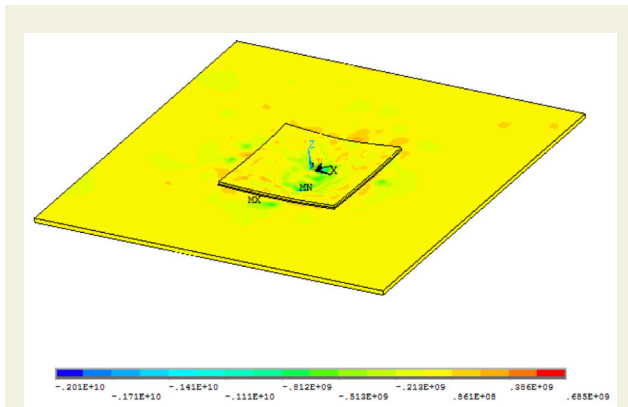
Figure 18. Stress distribution at the direction of striker.

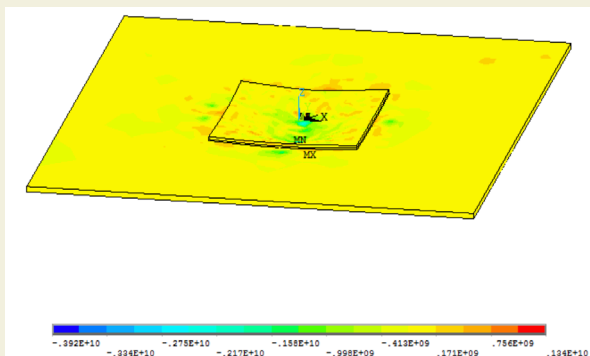
Figure 19. Stress distribution at the direction of striker.

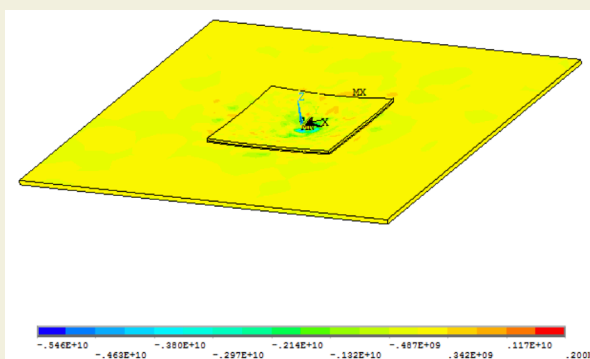
Figure 20. Stress distribution at the direction of striker.
