THE CHURCH AT DEREĞZI - A PRELIMINARY REPORT

JAMES MORGANSTERN

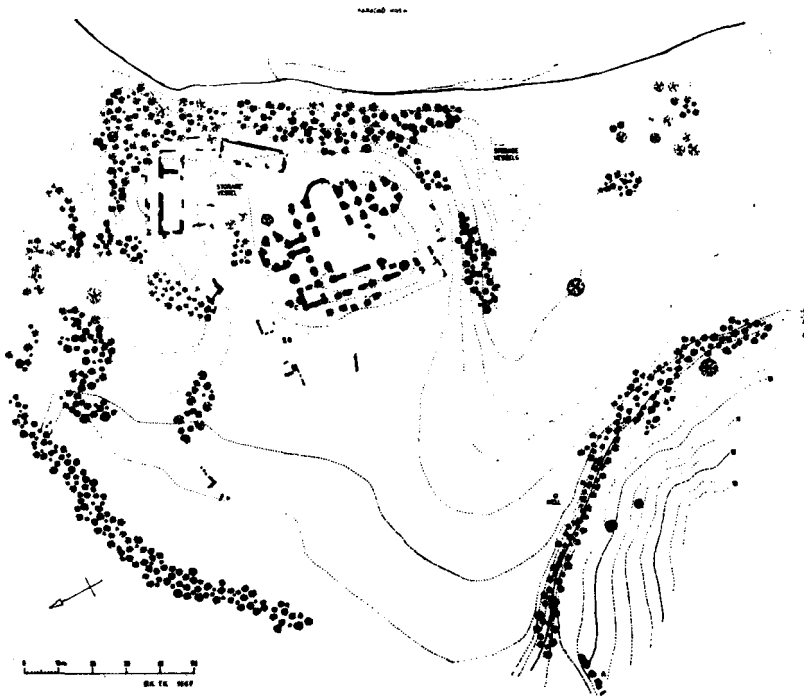
Fig. B. The Church at Dereagzi. Site Plan (Preliminary).

octagon and south of the south octagon. Somewhat further from the church additional evidence of habitation survives (beyond the limits of fig. B): a cluster of six storage vessels ca. 170 m. to the northeast at the edge of a field sprinkled with pottery sherds and terracotta fragments, a small complex of foundations ca. 110 m. to the north, and a stone wall on the south bank of the Karadağ River ca. 1 km. to the southwest⁴². While most walls rise only a few centimeters above the present ground level, the north face of wall (A) stands to a height of ca. 4.50 m., and others, ca. 1.00 m. The masonry, with few exceptions, consists of stone and mortar (fig. 8). Of particular interest are a space (B), located ca. 15.00 m. northwest of the church, terminated to the east by an apse, and a vaulted gate-like structure (C), north of the north tower. Today only part of the apse of space (B) is visible, and that, only centimeters above present ground level; the masonry is stone and mortar. Its dimensions and its function are uncertain⁴³. The gate-like structure (C) is preserved to a height of ca. 1.50 m.; the masonry consists of stone, brick, and mortar. The date of the settlement walls and foundations and their precise temporal relationship to the church complex remain uncertain⁴⁴. Before these questions can be answered, further investigation is necessary.

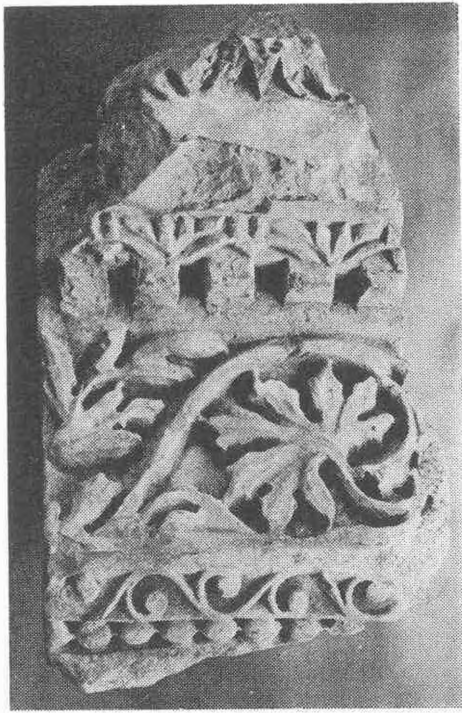
Fig. 7 Architrave.

fragment of a large architrave (fig. 7)³¹. It was found in 1965 by Bay I. Dediler, ca. 25-30 m. west of the church. Its exact provenance is not known. The architrave (39 cm. × 26 cm. × 13-30 cm.) consists of two basic portions: a base and an upper portion which projects forward from the base. The base is composed of a plain central moulding (damaged) decorated by stylized palmette festoons at the top, set between an egg-and-dart (damaged) and a plain moulding supported by a row of dentils. The face of the projecting upper portion is decorated by a string of astrigals and a somewhat stylized running tendril, surrounded by thin fillets (damaged). The underside is overgrown by a luxuriant series of grape leaves. The material is again a marbled limestone. While the treatment of the leaves is somewhat more generalized and the undercutting less pronounced, the fragment from Dereğzi is very reminiscent of sculpture from the church of St. Polyeuctos in Istanbul, dateable to the years 524-527³².

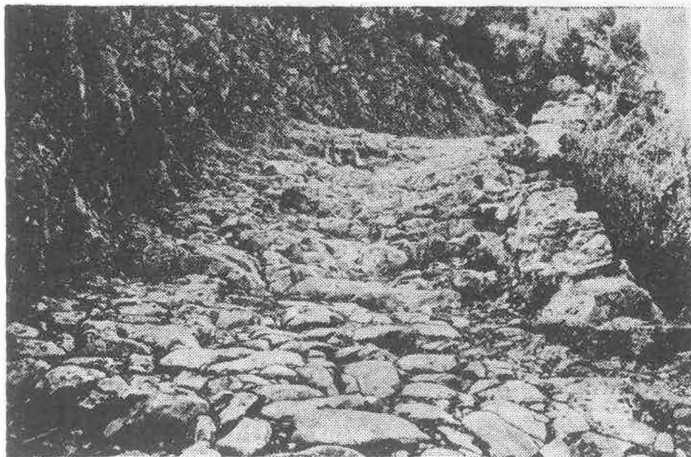
Fig. 10 Road above West Bank of Karadağ River.

At the base of the hill on which the fort is located additional traces of civilization survive. Pottery sherds, bits of terracotta, and a few marble fragments dot the fields to the north of the hill⁴⁶. To the east, above the west bank of the Karadağ River, two ancient roads, rock-cut, revetted, and ca. 2-3 m. in width, cling to the site of the hill (fig. 10). It is presumably these roads and another, a few kilometers downstream above the east bank of the Demre River, which once linked the settlement at Deragazı to Demre (Myra)⁴⁷.
