An Interpretative Rehabilitation of a 16th-Century Mosque: The Case of Turali Bey's Mosque in Tuzla

Abstract

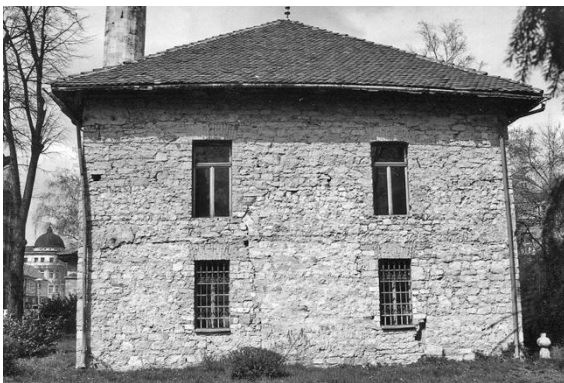
Figure 6. The rear elevation after the stucco removal (Photo by Edin Jahić)

The Turali Bey Mosque was only known to have been refurbished in 1967-8 during the Yugoslav period (1945-91) [8]. The mosque's walls have been plastered and painted, the wooden parts within have been painted, and windows and doors have been replaced. Perhaps the northern corner of the mosque was partitioned off at the same time for the purpose of ablution. Although necessary, this has degraded the integrity of the interior. Likely, more serious work was not done in the next three decades. One of the significant activities that led to the final renovation of the Turali Bey Mosque is a Project of research, conservation and restoration work done in 1997 by the Institute for protection of the cultural, historical and natural heritage of Bosnia and Herzegovina [5]. The research works were carried out in several stages. The terrain was excavated in some spots to determine the original state of the walls and historic windows. The old paving stone tiles under the former porch were found at a depth of 1.45m. The stucco was fully scraped off the façades (Figure 6) when the old upper windows' arches (*kemer*) were uncovered (Figure 7). To determine the state and nature of the material used, the plaster was also removed from the *mihrab* and the entrance portal partially (Figure 8). The cracks have been recorded in the plaster of the walls and ceiling inside (Figure 9). It has been also found that the minaret deviates significantly from the verticality and requires utmost attention. Finally, the Turali Bey Mosque was designated as a National Monument by the Commission to Preserve National Monuments in 2005.

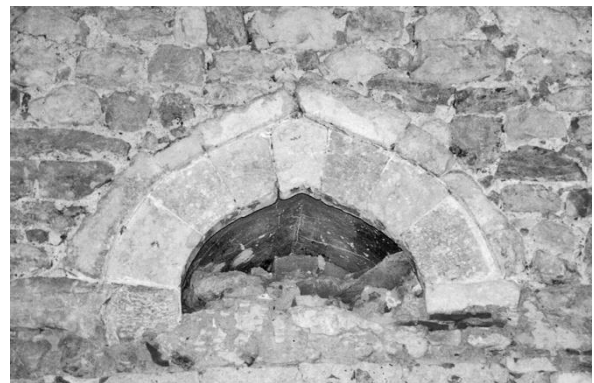
Figure 7. Uncovered arch over the original upper window (Photo by Edin Jahić)

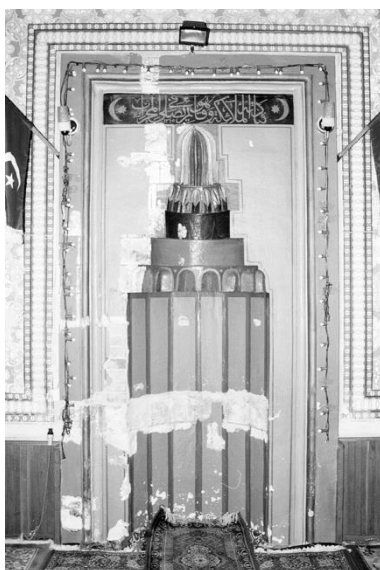
Figure 8. Mihrab during the research works (Photo by Edin Jahić)

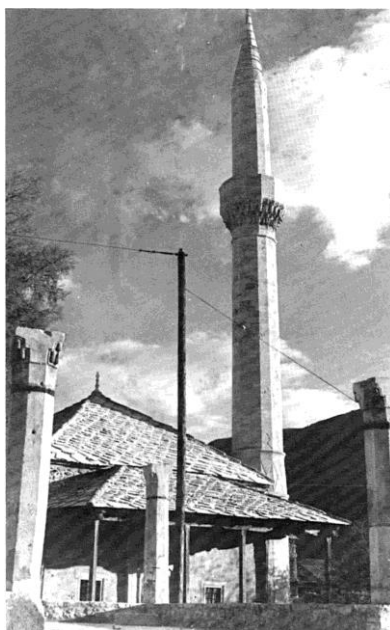
Figure 10. Roznamedži Ibrahim Efendi Mosque in Mostar. An example of mosque with pyramidal roof over the square prayer room and pitched roof over the porch.
(Source: Hasandedić, 2005)

Mosques with pitched wooden roofs have a square or slightly elongated rectangular plan. They mostly have a porch with sofas in front of the entrance. The minaret is almost necessarily on the right of the entrance on its pulpit (*küip*). Two types of pitched roofs predominate in this type of mosque. The first has a single hip roof over the mosque along with the porch. The second form consists of a higher pyramidal roof over the walled room while a lower pitched roof covers the porch. Turali Bey Mosque undoubtedly belonged to the latter one. This type of mosque is more widespread in Herzegovina than in Bosnia [10]. Typical examples are the Mosque of Dervish Pasha Bajezidagić, Roznamedži Ibrahim Efendi Mosque (Figure 10), and Neziraga Mosque in Mostar, Junuz Čauš Mosque in Konjic (before 1579), Sultan Bayezid Mosque in Nevesinje (before 1512). It is typical for mosques in Herzegovina that roofs were covered with stone tiles (*ploča*), while in Bosnia curved clay tiles (*čeremit*, *kiremit*) and wood board (*šimla*) prevailed. The wooden dome in the roof structure is a unique feature of mosques with a pitched roof. This kind of dome can be found in just a few mosques. A few of them are Tabačica Mosque and Šarića Mosque in Mostar [10], Junuz Čauševa Mosque in Konjic, Handanija Mosque in Prusac, and Ferhadija Mosque in Tešanj.

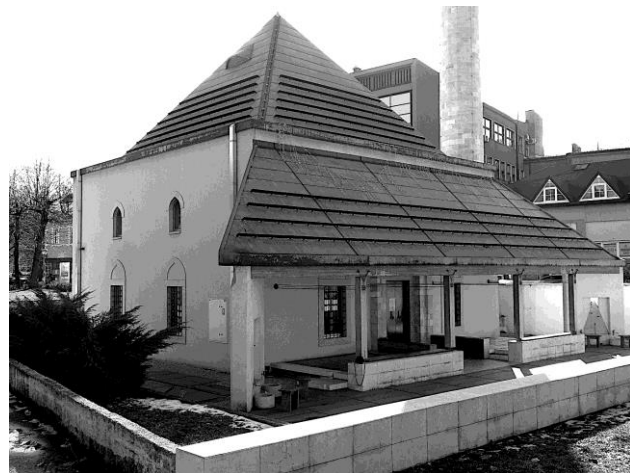
Figure 12. Front view of Turali Bey Mosque showing the new porch (Photo by Edin Jahić)

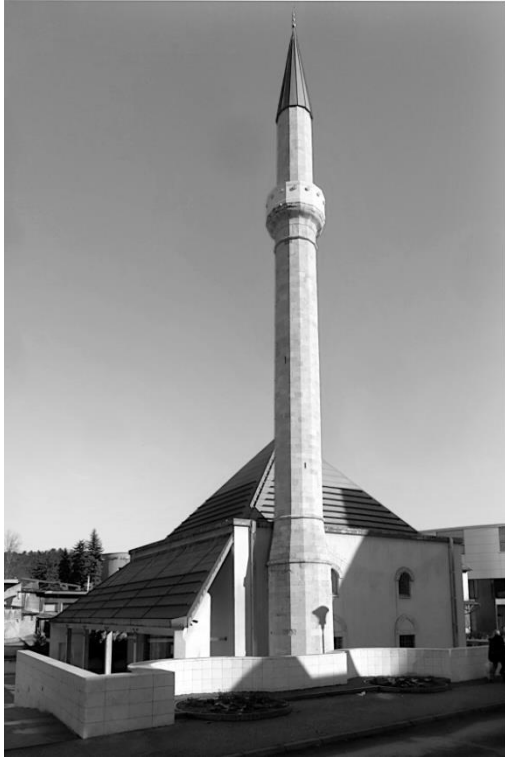
Figure 13. Street view of Turali Bey Mosque showing the porch and minaret
(Photo by Edin Jahić)

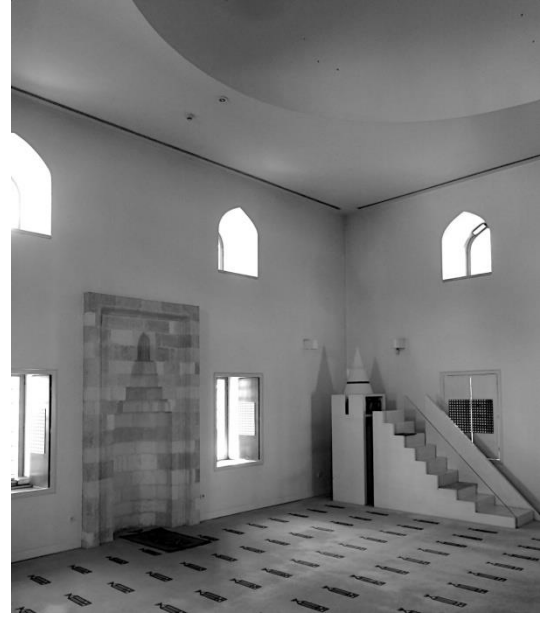
Figure 14. Interior of Turali Bey Mosque showing the reconstructed mihrab and the new minbar
(Photo by Edin Jahić)

Since the mosque was closed for use for several years, the Islamic Community in Tuzla initiated activities to rebuild the mosque. The works were completed in 2012 and the new Turali Bey Mosque was opened in 2013 (Figure 11). The basic idea of the designer⁴ was based on the establishment of the level of the terrain that existed before 1890. In front of the entrance is a stone-paved plateau with two access ramps (Figure 12). The level of the walls has been restored to its original condition. Thus, the lower parts of the walls were excavated and the upper parts, which were subsequently upgraded, were now removed. The walls are plastered and whitewashed both inside and outside. The windows have the same arrangement: eight rectangular walls on the lower level and six smaller arched windows on the upper level. The interior floor has been restored to the original level. The mosque is now topped with a new pyramidal roof of somewhat reduced dimensions, but with no eaves. The upper ends of the walls hide the gutters. A modern porch with sofas is placed in front of the entrance. An old refurbished entrance portal has been reinstalled, but this time without painting. The sloping roof above the porch is supported by four wooden pillars and two massive walls containing fountains for ablution. Instead of clay tiles, the roof surfaces are lined with non-corroded sheet steel. Since it deviated from verticality, the minaret was rebuilt in exactly the same shape and height (Figure 13). Inside the mosque, a modern *mahfil*, *minbar*, and *kürs* were installed. The roof construction contains a dome of the same shape as before. The old refurbished *mihrab* was reinstalled in the *kibla* wall, but with no painted decoration (Figure 14).
