Effects of Porosity on CFRP Repair Performance with Aerospace Applications

Abstract

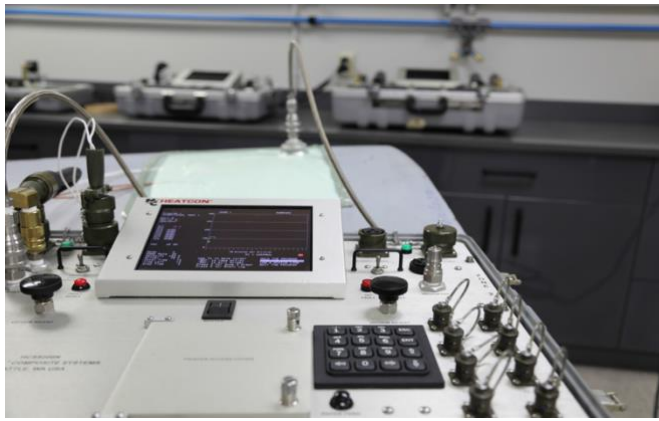
Figure 2. Bagging and curing process with the heat blanket (HEATCON) (HEATCON, 2023).

The curing procedures were meticulously executed in strict accordance with the guidelines provided by the resin manufacturer. Subsequent to the curing process, five distinct sample types were prepared, each incorporating an additional ply. These plies were applied in a wet state, featuring 12.5 mm overlaps, utilizing parent prepreg structure to perform repair. Furthermore, the samples were created by strategically adding an extra ply on the tool side. Those samples crafted using the wet method were subjected to a curing process within a vacuum environment at 650 mmHg, employing a heat blanket (HEATCON) system (see Fig. 2).

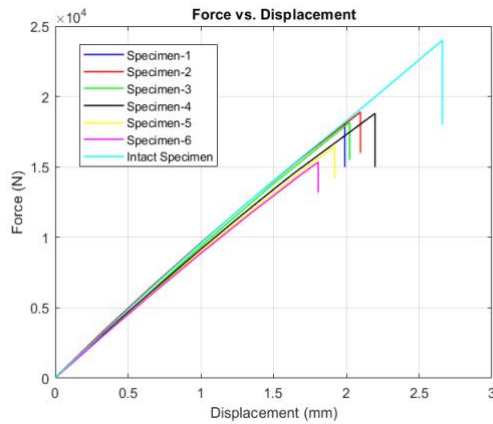
Figure 4. Force and displacement test results of the specimens.

In Fig. 4., it can be observed representative tensile force-displacement curves obtained from our experimental tests, focusing on both the repaired and intact specimens. These curves are based on crosshead displacement measurements.

The intact specimen displays a consistently linear elastic response, reflecting its structural integrity. In contrast, the repaired specimens initially exhibit a response that is quite similar to the intact one, with comparable stiffness up to approximately 1.8 mm of displacement. However, as the displacement increases further, we observe a notable decrease in the load-displacement slope for the repaired specimens. This phenomenon is followed by an abrupt and distinct ultimate failure point, without any substantial plastic deformation in any of the specimens.

It's worth noting that, it is observed the distinct sound of fiber breakage, confirming the observations. The observed deviation in slope for the repaired specimens strongly implies a cohesive failure within the adhesive material employed in the repair process. This outcome underscores the significance of adhesive quality and compatibility when reinforcing composite structures, as the reduction in slope indicates a potential weakness in the bond between the repair material and the parent composite structure.
