## **Experimental Study of Evolution of Breach Resulting from Piping at Upper Part of Earth-Fill Dam**

Piping and overtopping are the most important causes of earth-fill dam failure. Such dams may erode under seepage, causing a reduction in the structural strength. The aim of this study was to investigate the temporal evolution of the breach and flow rate from the breach resulting from the piping in earth-fill dams. The experiments were carried out at Hydraulics Laboratory of Civil Engineering Department within İzmir University of Economics. The dam was constructed by using a mixture consisting of 85 % sand and 15 % fine (low plasticity clay). In the first scenario a circular tunnel with a diameter of 2 cm was created along the centreline at 6 cm below the dam crest whereas in the second one it was located at the upper edge. Six cameras at different locations recorded the evolution of the progress of the breach formation. The pump flow rate was measured by magnetic flow meter, and the continuity equation was used to calculate the flow rate values from the breach. The time-varied values of the total breach areas were determined using the Gauss Area formula. The image

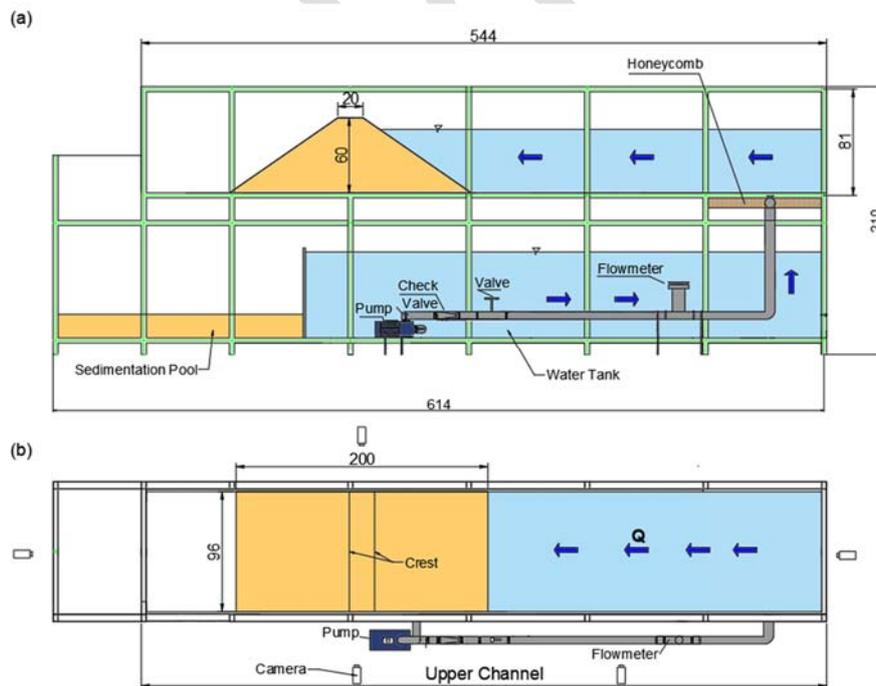
*Figure 1 - Experimental system (a) side view, (b) plan view (All dimensions are in cm)*

The experimental dam was built in a rectangular channel of 1 m wide, 0.81 m high and 5.44 m long, as shown in Fig. 1. The dam having a height of 0.6 m, a bottom width of 2 m and a

crest width of 0.20 m was built in the upper channel. The slopes of the upstream and downstream sides were set to 1:1.5. Water circulated between the lower reservoir and the upper channel by means of a pump. Soil mechanics tests were carried out in the laboratory before the construction of the dam.

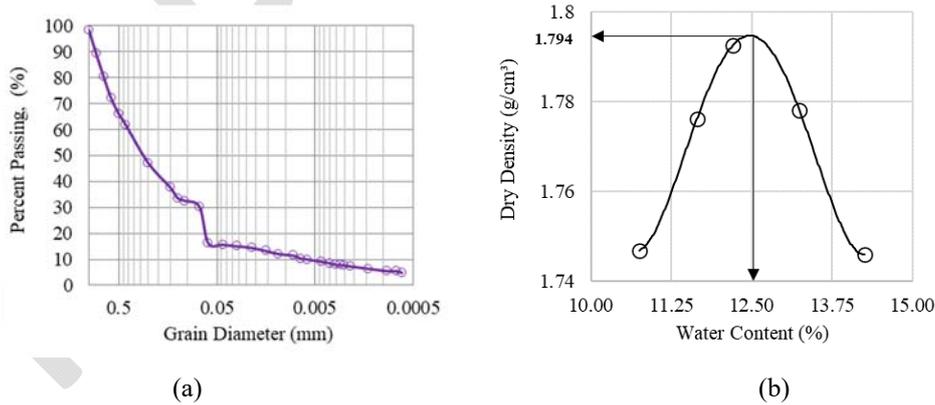
Figure 2 - a) Grain size distribution of soil mixture with sieve analysis and hydrometer analysis b) dry density versus water content graph

The grain-size distribution curve for soil mixture obtained from sieve analysis (ASTM D-6913) and hydrometer analysis (ASTM D-7928) is given in Fig. 2a. Some characteristic diameter values are as follow;  $D_{10}=0.006$  mm,  $D_{30}= 0.075$  mm,  $D_{50}= 0.3$  mm, and  $D_{60}= 0.4$  mm. The coefficients of uniformity and gradation were found as  $C_u =66.7$  and  $C_c =2.34$ , respectively. The soil classified as Clayey Sand with a corresponding symbol SC according to Unified Soil Classification System. The specific gravity for the mixture was found as  $SG= 2.63$  (ASTM D854 – 23).

Proctor test (ASTM D-698) was performed to obtain the maximum dry unit weight and the optimum water content (Fig. 2b). From Fig. 2b,  $\gamma_{dry,max}= 1.794$  gr/cm<sup>3</sup> and  $w_{opt} = 12.5$  %. In the experiments, the energy was reduced by 50 % in order to facilitate the occurrence of piping. The applied compaction energy was 309 kJ/m<sup>3</sup>. Hence, the number of blows applied for each layer during the construction of the dam was 13 instead of 25. In the experiments, the bulk density of 1.997 g/cm<sup>3</sup> was satisfied for each layer. Before the compaction, each layer was 14 cm thick and after the compaction it was reduced to 10 cm.

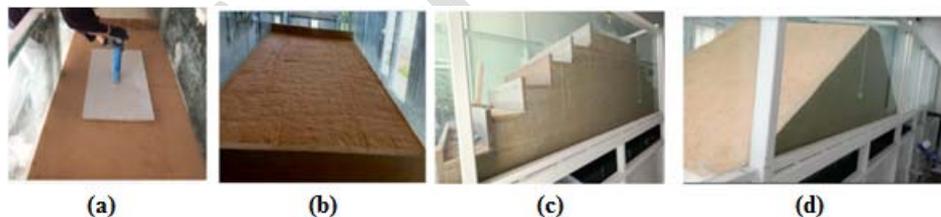
Figure 3 - Some construction stages: (a) Compacting by proctor hammer, (b) After compaction of the first layer, (c) After compaction of the last layer, (d) Final shape

The dam was constructed layer by layer. Each layer of 14 cm was compacted so that its thickness becomes 10 cm by using Proctor Hammer and plate. Some construction stages and finished shape of the dam body are given in Fig. 3.

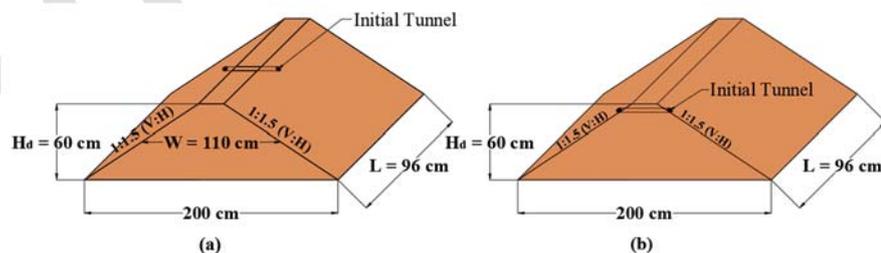
Figure 4 - Schematic views of the dam body corresponding to seepage a) along centerline b) at corner

In order to generate the formation of the breach, a circular hole of 2 cm diameter lying from upstream to downstream was created at 54 cm from the bottom of the dam body (Fig. 4).

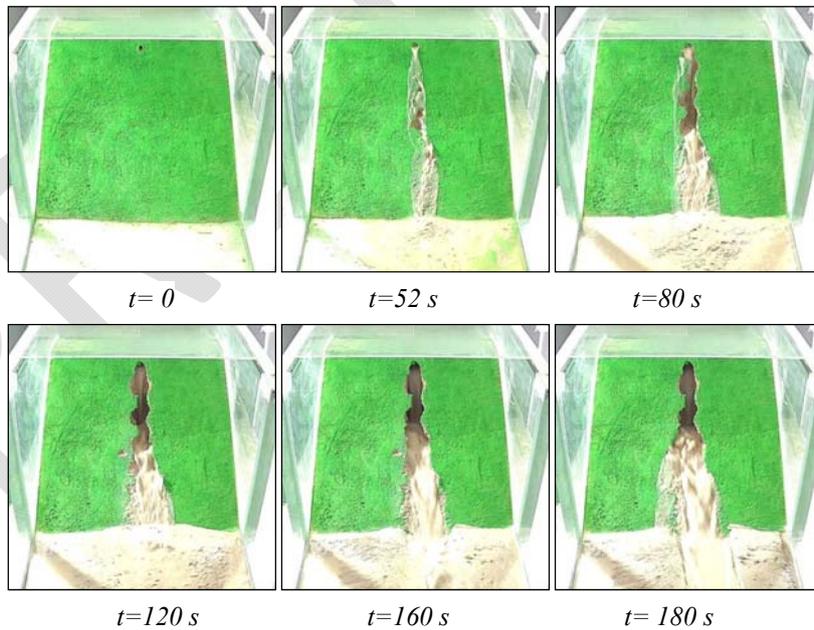
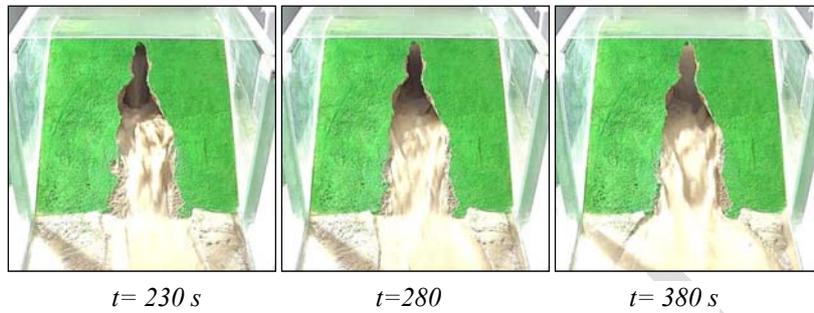
*Figure 5 - The temporal development of the central breach at downstream*

The temporal developments of the breach recorded by the cameras located at downstream and upstream of the dam are given in Fig. 5 and Fig. 6, respectively. The time  $t=0$  corresponds to the starting of the seepage [15, 19]. As seen in Figures 5 and 6, there was headcut erosion proceeding from downstream to upstream. The breach formation started at downstream side first and progresses backward to upstream side.

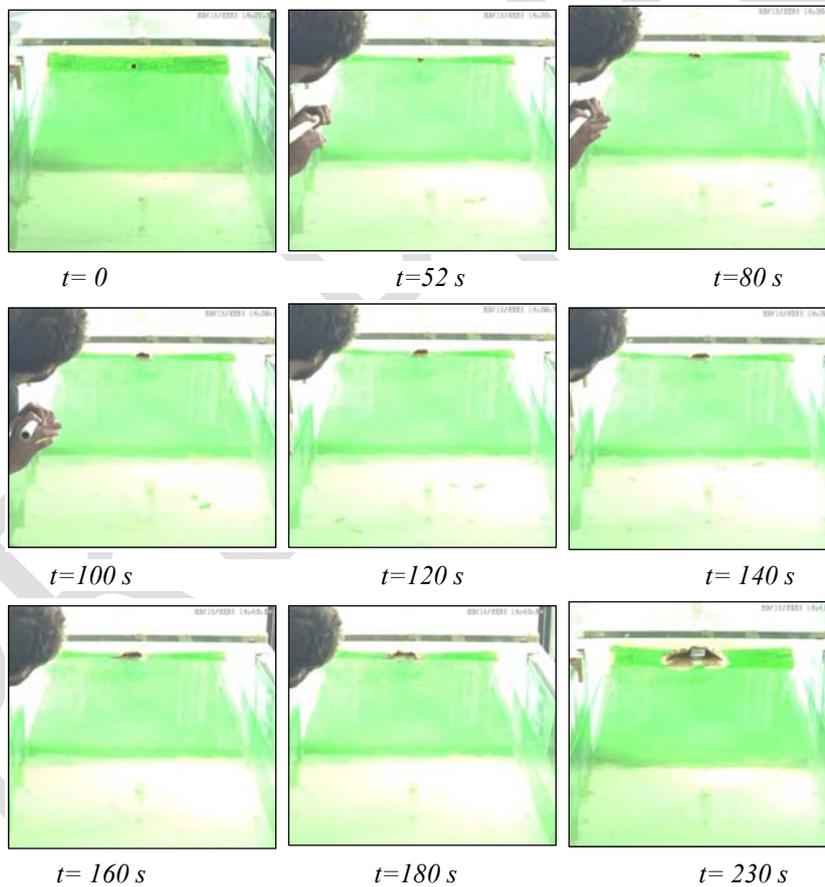
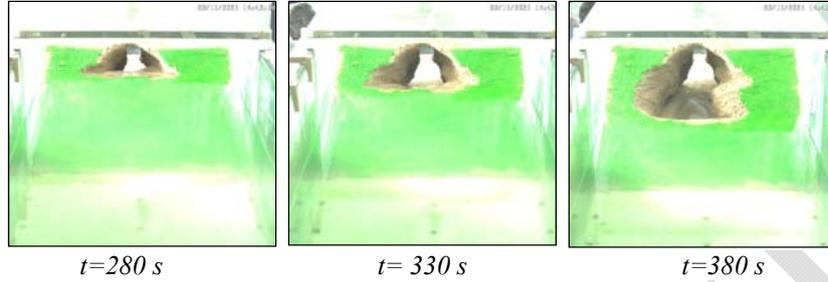
Figure 6 - The temporal development of the central breach at upstream

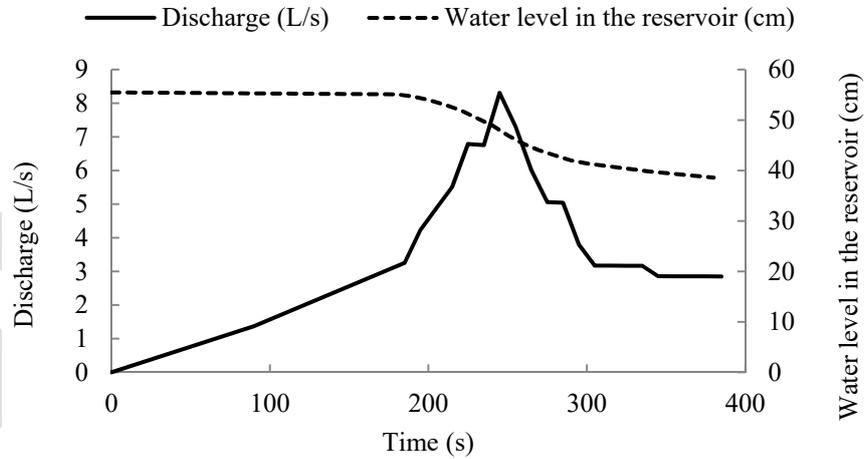
Figure 7 - Time-varied water level in the upstream reservoir and average discharge from the central breach

The time-varied water level in the upstream reservoir and average discharge from the central breach are given in Fig. 7.

The maximum discharge from the breach was calculated as  $Q_{\text{max}}=8.31$  L/s at  $t=245$  s.

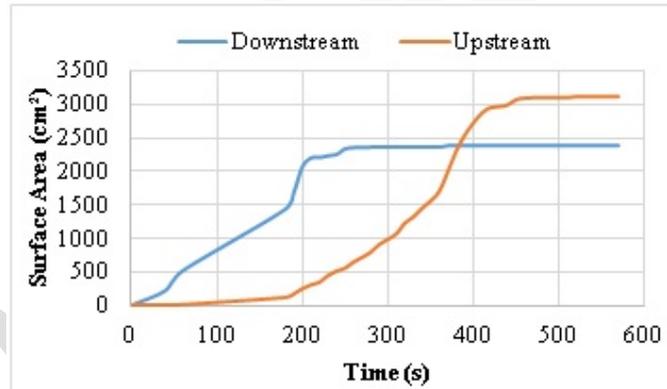
Figure 8 - Temporal variations of the central breach area at downstream and upstream

The temporal variations of the central breach area at downstream and upstream are presented in Fig. 8.

During the experiment, the breach initiated on the downstream side and then evolved towards to upstream side. As expected, there was a delay in the evolution of the breach at upstream side. At downstream the breach reached its maximum value at  $t=370$  s and remained nearly constant while at upstream side the evolution of the breach continued, and its maximum value was greater than that at downstream.

The maximum breach surface area at the upstream was found to be  $A_{\text{umax}} = 3128.7 \text{ cm}^2$  at  $t=520$  s.

At downstream  $A_{\text{dmax}} = 2379.3 \text{ cm}^2$  at  $t=370$  s and remained unchanged afterwards.

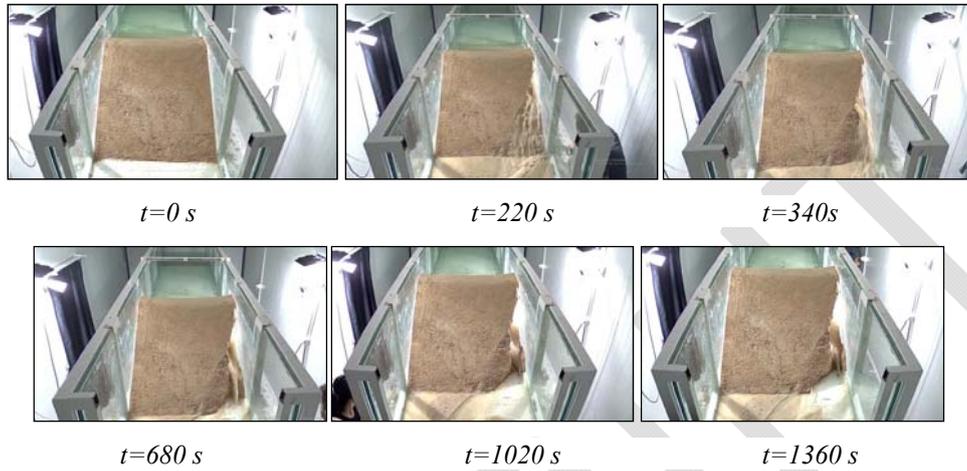
Figure 9- The temporal development of the corner breach at downstream

cameras located at downstream, upstream and lateral side of the dam are shown in Figs. 9, 10 and 11, respectively. The time  $t=0$  indicates the beginning of the seepage [14, 19].

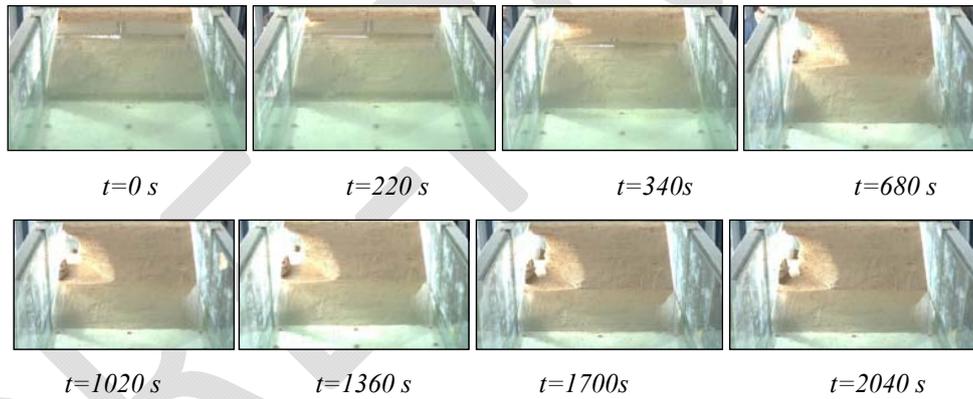
Figure 10 - The temporal development of the corner breach at upstream

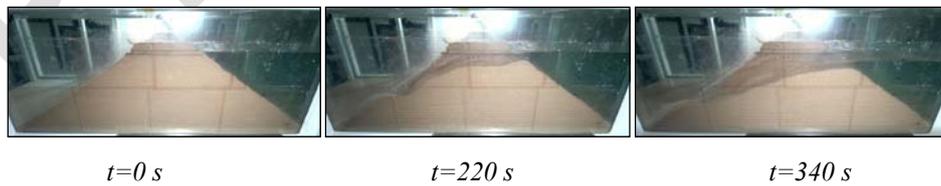
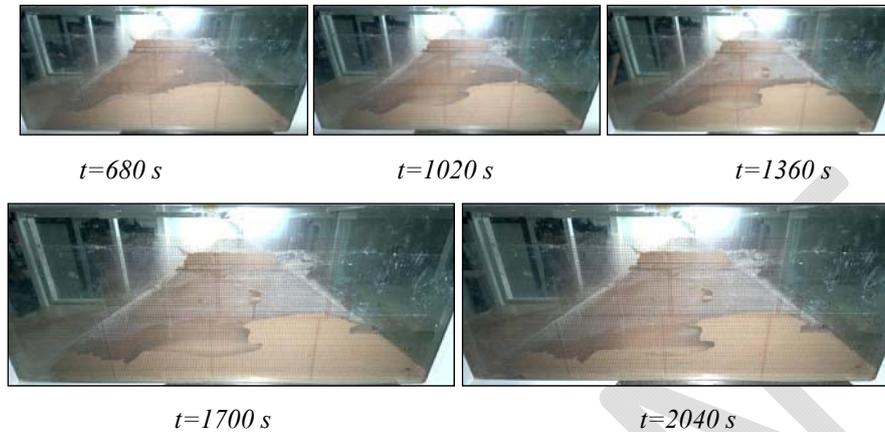
*Figure 11 - The temporal development of the corner breach at lateral side*

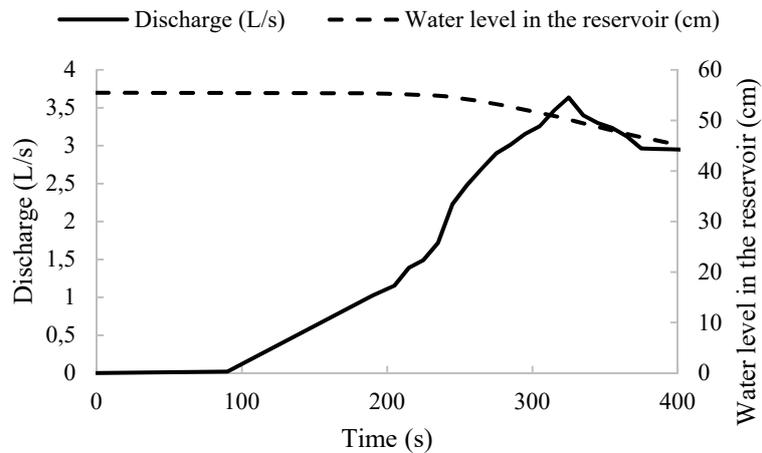
*Figure 12 - Time-varied water level in the upstream reservoir and average discharge through the corner breach*

The time-varied water level in the upstream reservoir and average discharge from the corner breach are given in Fig. 12.

The maximum discharge from the breach was calculated as  $Q_{\max}=3.64$  L/s at  $t=320$  s. The peak flow rate was found to be quite smaller compared to that found in the 1<sup>st</sup> scenario (8.31 L/s) and this value was reached later (320 s instead of 245 s.).

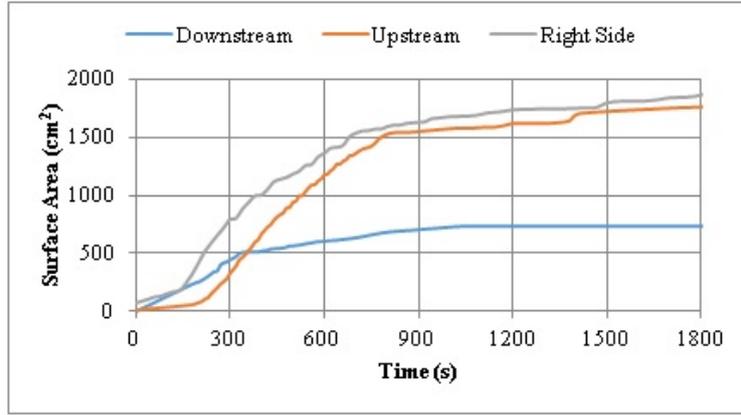
Figure 13 - Temporal variations of the corner breach area at downstream, upstream and lateral side

The temporal variations of the corner breach area at downstream, upstream and lateral side are presented in Fig. 13.

Likewise, it was observed that the breach started at the downstream side and then developed towards to upstream side. The delay in the development of the breach at upstream was found to be smaller compared to the 1<sup>st</sup> scenario. The breach surface area of the upstream was recorded at a maximum level of  $A_{u\max}=1760 \text{ cm}^2$  at  $t=1800 \text{ s}$ . At downstream  $A_{d\max}=732 \text{ cm}^2$  at  $t=1080 \text{ s}$  and remained unchanged, also  $A_{lat\max}=1875 \text{ cm}^2$  at  $t=1800 \text{ s}$ .

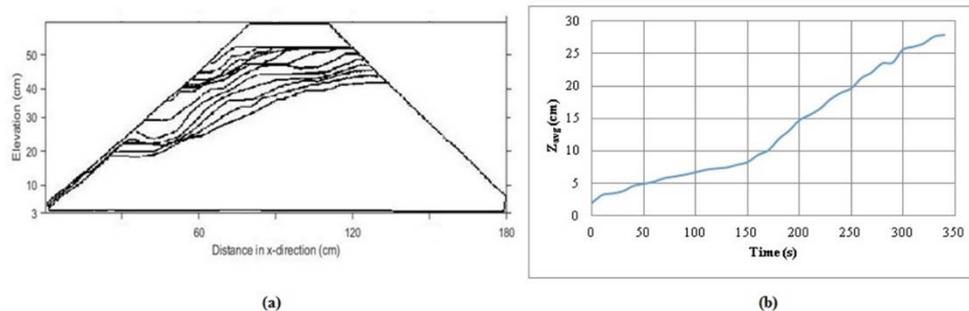
Figure 14 - a) Bottom erosion lines for every 30 seconds (starting from  $t=10 \text{ sec}$ ) b) Temporal variation of the average erosion depths for case 2

Fig.14 illustrates the bottom erosion lines and the average erosion depths corresponding to the 2<sup>nd</sup> case.

As seen from this figure the average breach depth developed rather slowly in the first half of the experiment period while it developed nearly twice as fast in the second half. Besides, when the first half of the experiment period was completed, the edge of bottom erosion line reached the upstream surface of the dam, and then it was observed that there was an increase in the development of breach depth at the second half of the period.

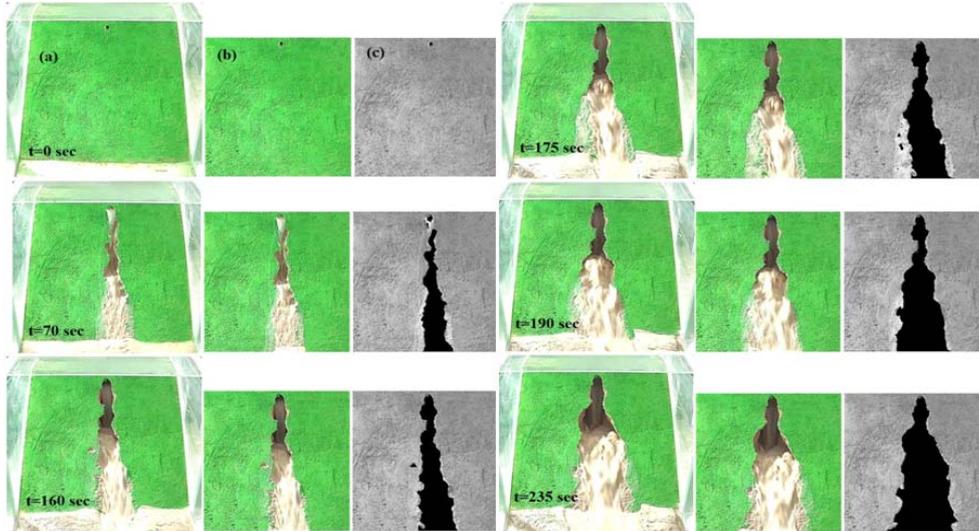
Figure 15 - Time dependent image processing using Matlab Colour Thresholder for downstream – HSV. a) Original picture from experiments. b) Cropped Image c) After Colour Thresholding for case 1

The time dependent image processing using Matlab Color Thresholder for downstream and upstream sides of the dam corresponding to the 1<sup>st</sup> case are given in Figs. 15 and 16, respectively.

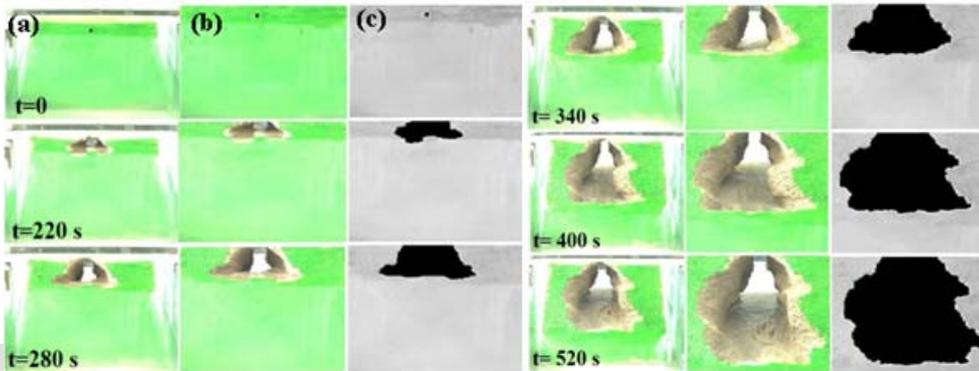
Figure 16. Time dependent image processing using Matlab Colour Thresholder for upstream - HSV. a) Original picture from experiments. b) Cropped Image c) After Colour Thresholding for case 1

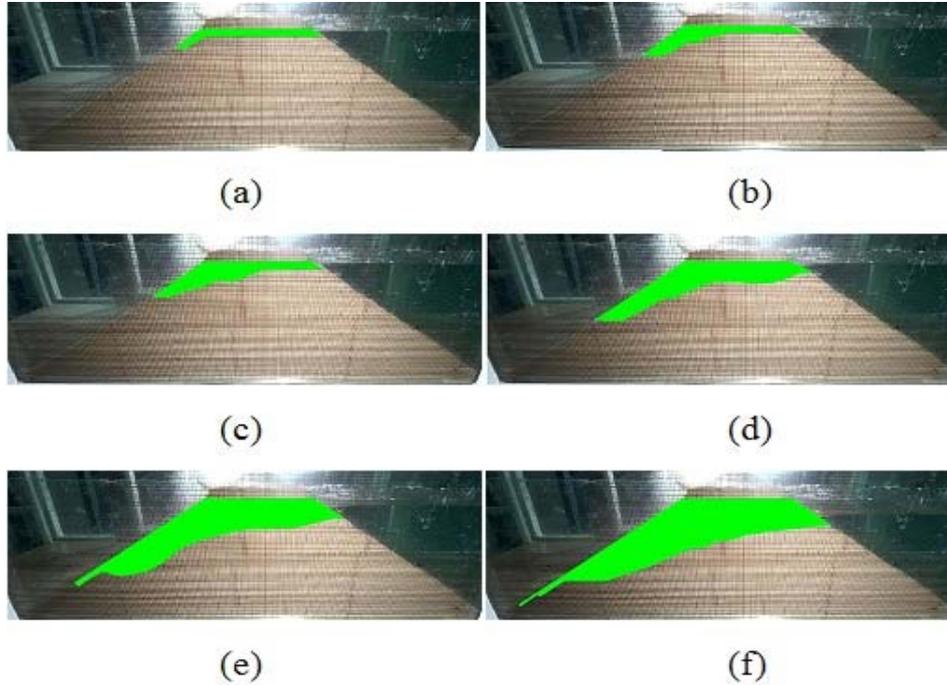
*Figure 17 - The evaluation of eroded side area at different time instants a)  $t=10$  sec, b)  $t=70$  s, c)  $t=130$  sec, d)  $t=190$  sec, e)  $t=250$  sec, f)  $t=310$  sec for case 2*

Figure 17 represents the evaluation of eroded lateral area at different time instants for the 2<sup>nd</sup> case.

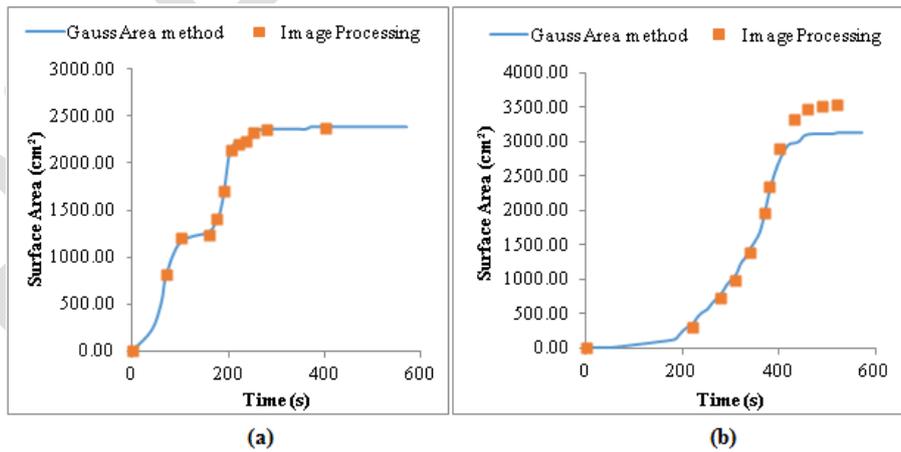
*Figure 18 - Comparison of Gauss Area method and Image Processing results for case 1 a) at downstream b) at upstream*

The calculated breach area values were compared with those obtained from the Gauss Area method (Figs. 18 and 19).

A very good agreement was found between the area values obtained from these two different approaches for both cases 1 and 2. Consequently, it was demonstrated that either of these approaches can be used to determine the time-dependent breach areas.

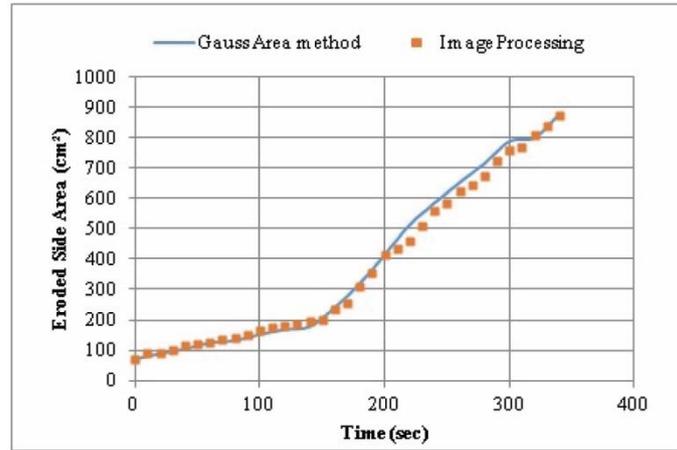
Figure 19 - Comparison of Gauss Area method and Image Processing results for the 2<sup>nd</sup> case

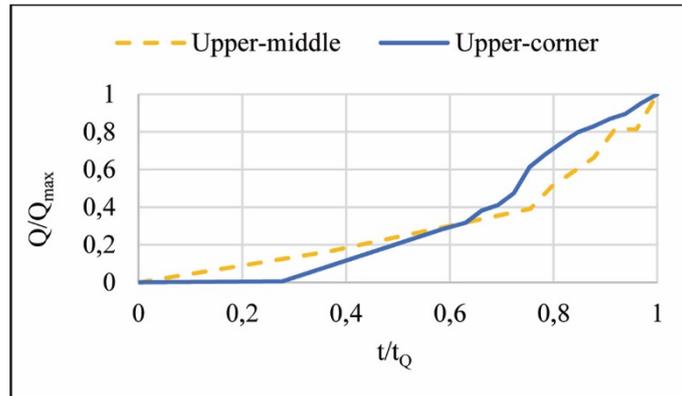
Figure 20 - Dimensionless flow rates versus dimensionless times curves

It was revealed that the dimensionless flow rates versus dimensionless time could be considered as two segment lines with two different slopes and two different stages, the first slope being smaller. The first stage lasted much longer in the 1<sup>st</sup> scenario.

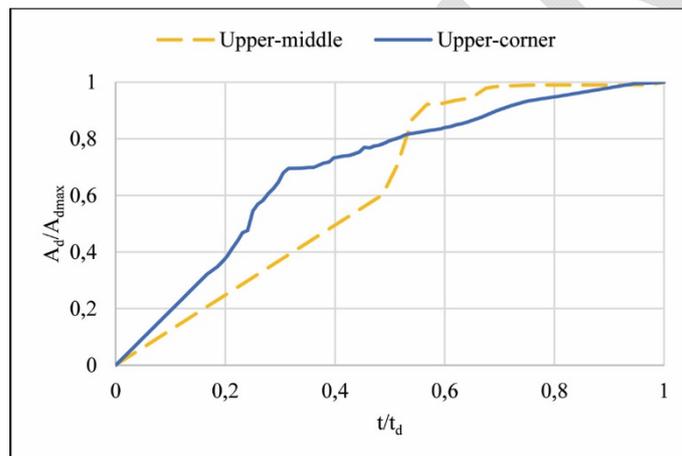
Figure 21 - Dimensionless breach areas at downstream versus dimensionless times curves

The dimensionless breach areas versus dimensionless time in the 2<sup>nd</sup> scenario could be approximated to two segment lines while in the 1<sup>st</sup> scenario the linear behavior appeared only in the first stage.

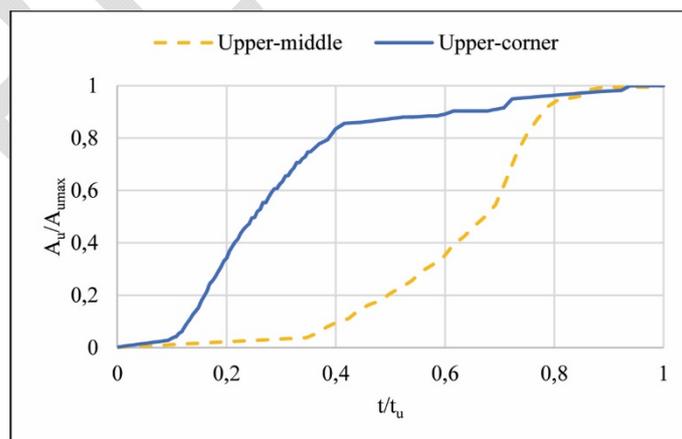
Figure 22 - Dimensionless breach areas at upstream versus dimensionless times curves

The tendency of the dimensionless curves at upstream were found to be very different in the 1<sup>st</sup> and 2<sup>nd</sup> scenarios. The evolution of the dimensionless breach areas was nearly exponential in the 1<sup>st</sup> scenario whereas the evolution can be considered as combination of the straight

lines when the seepage initiated at corner. Besides, the upstream breach area was significant when  $t=0.4 t_u$  in the 2<sup>nd</sup> scenario while at this time the breach area was quite small and then increased significantly.

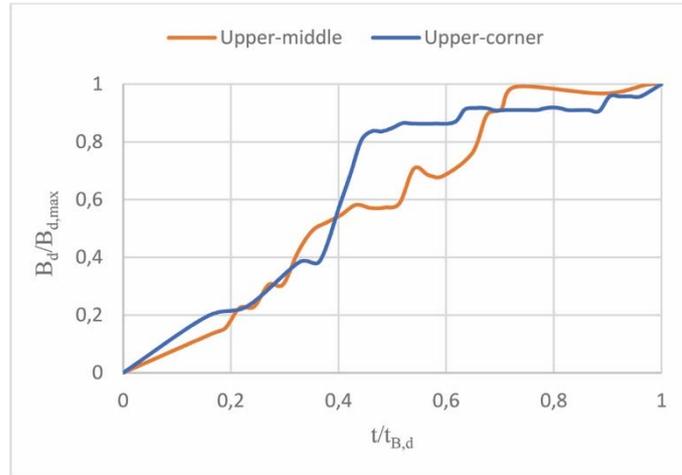
Figure 23 - Dimensionless breach widths at downstream versus dimensionless times curves

When  $t= 0.50 t_{B,d}$  the breach width at downstream was almost  $B_d= 0.85 B_{d,max}$  in the 2<sup>nd</sup> scenario, while  $B_d= 0.58 B_{d,max}$  in the case of the 1<sup>st</sup> scenario.

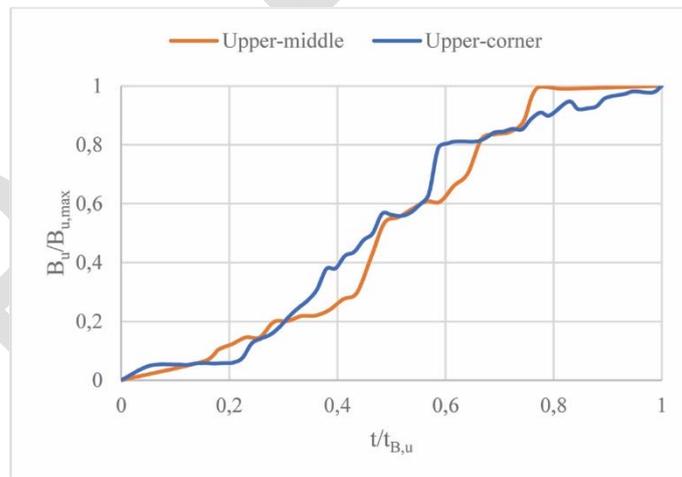
Figure 24 - Dimensionless breach widths at upstream versus dimensionless times curves

When  $t= 0.50 t_{B,u}$  the breach width at upstream was approximately  $B_u= 0.48 B_{u,max}$  in both cases. In the 2<sup>nd</sup> scenario, the dimensionless breach width developed continuously but in the 1<sup>st</sup> scenario there was no change in dimensionless breach width beyond  $t= 0.76 t_{B,u}$ .
