## EXPERIMENTAL FAILURE ANALYSIS OF WET-PATCH-REPAIRED U NOTCHED COMPOSITE PLATES

*In this study, it was achieved failure analysis of wet-patch-repaired composite plates, experimentally. U notched composite plates were repaired with wet patch and then static tensile load was applied to composite plates. The patch thickness, single and double patch repair and fiber orientation angle of composite plates effect on the failure load were investigated. The composite plates having eight plies woven glass fiber and epoxy matrix resin, woven glass fiber and epoxy based adhesive were used as materials. The wet patches were obtained by epoxy adhesive impregnated to the woven glass fibers. As a result of experimental study, it was determined that the failure load was increased with increasing patch thickness. Also, it was seen that the double patch was more effective repair technique than single patch and the fiber orientation angle increasing was decreased the failure load of the composite plates.*

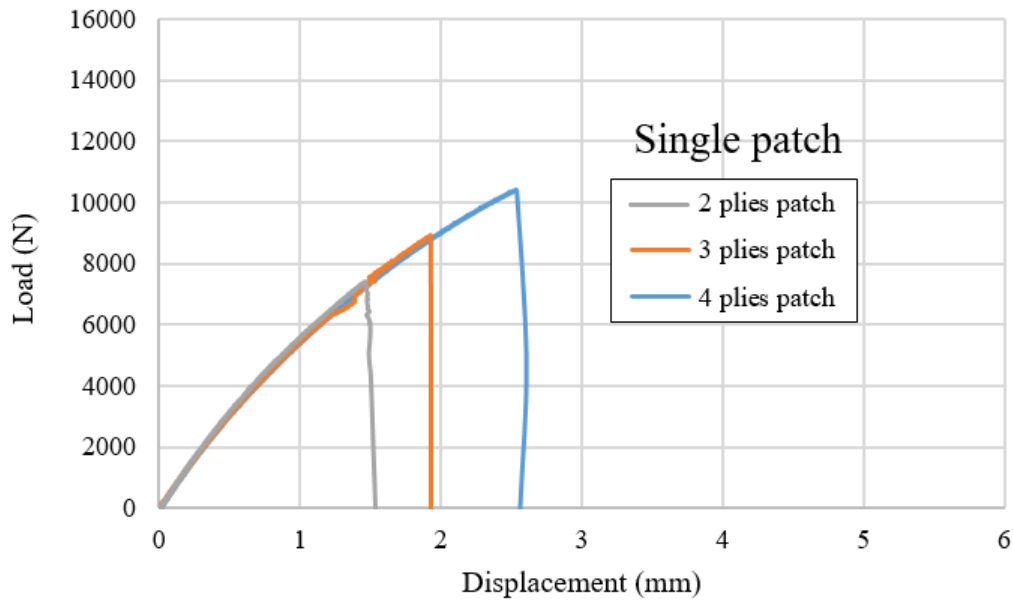
**Figure 3.** The load-displacement graphs for single patch repaired composite plates with increasing of patch layer number.

As seen in the figure 3, the increase in the number of patch layers (plies) was increased the failure loads and displacement. Also, approximately linear increase in load values can be seen in figure 3. The minimum failure load was obtained for 2 layer (plies) of patch as 7428 N and the maximum failure load was obtained for 4 layers of patch as 10418 N.

- The failure load and displacement in failure load values were increased with increasing count of layer numbers for single patch repaired composite plates and double patch repaired composite plates.

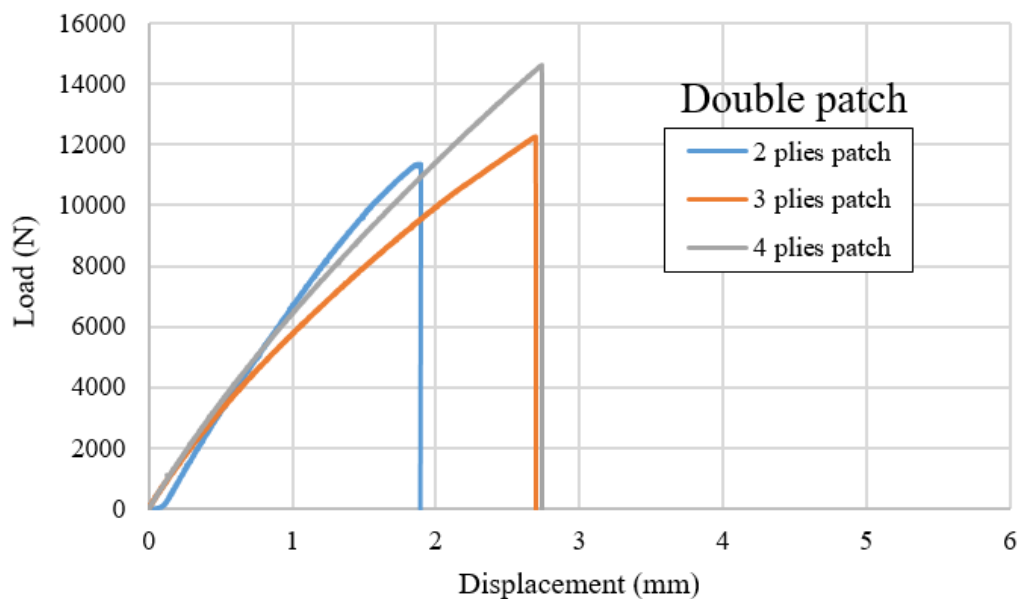
**Figure 4.** The load-displacement graphs for double patch repaired composite plates with increasing of patch layer number.

As seen in the figure 4, the failure loads were increased with increasing number of layers of patch. The minimum failure load was obtained for 2 number of patch as 11362 N and the maximum failure load was obtained for 4 number of patch as 16432 N. The failure load variations for single patch repaired composite plates were presented in figure 5 with increasing of fiber reinforced angle of composite plates.

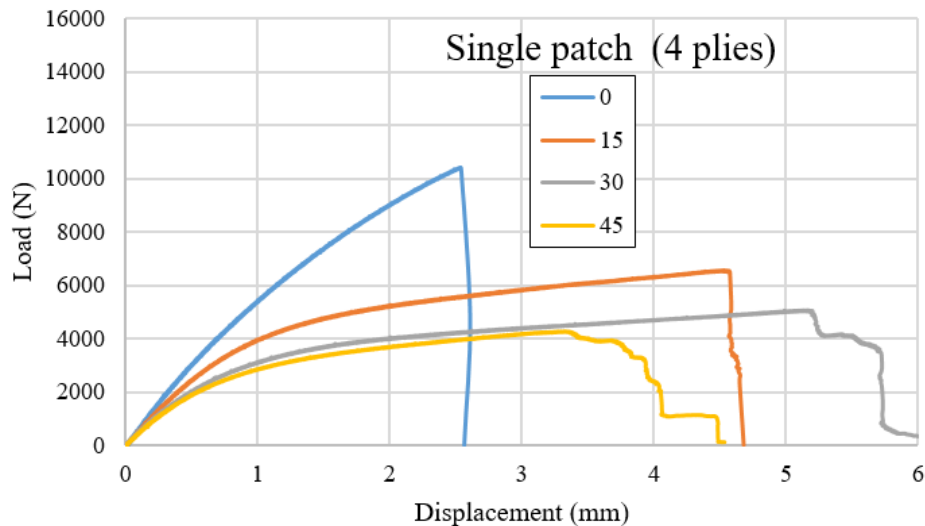
**Figure 5.** The load-displacement graphs for single patch repaired composite plates with increasing of fiber reinforced angle of composite plates.

As seen in figure 5, increasing of the fiber reinforced angle of composite plates was decreased the failure loads. The maximum failure load was obtained for 0° fiber reinforced angle values as 10418 N and the minimum failure load was obtained for 45° fiber reinforced angle as 3624 N. When the fiber reinforced angle values was increased, the failure loads of composite plates were decreased [11].

- The fiber reinforced angle increasing was decreased failure load of composite plates. But, the fiber reinforced angle increasing was increased displacement values of failure plates and the maximum elastic load in the load-displacement graphs was reduced.

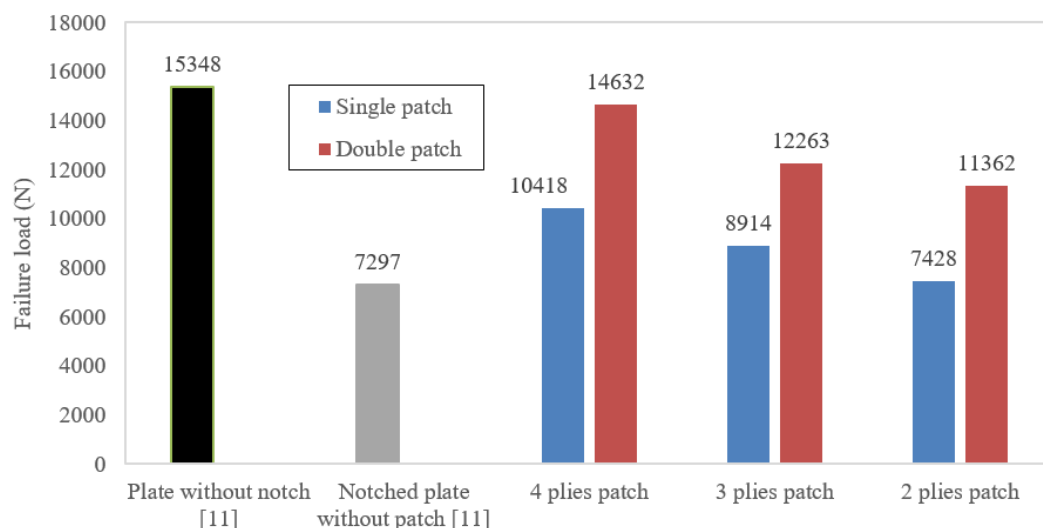
**Figure 6.** The effects of the number of patch layers on failure loads on single and double patch repaired composite plates.

The patch layer number effect on the failure loads were investigated for 0° fiber reinforcement angle. The U notched composite plates were repaired with 2, 3 and 4 patch layer. It can be seen that the patch layer number increasing was increased of failure load in figure 6. The minimum failure load was

obtained for two layer and single patch repaired composite plates as 7428 N and the maximum failure load were obtained for four layer and double patch repaired composite plates as 14632 N. When the failure load of un-repaired (notched) composite plates was compared to single and double patch repaired composite plates, it can be seen that, the failure load was increased between 2% to 100% ratios. The figure 7 was showed that the failure types of adhesively patch repaired composite plates.

- The failure loads of double patch repaired composite plates were bigger than the single patch repaired composite plates. This situation was not influenced by the increasing in the number of patch layers.

- The failure loads of all repaired plates (single and double patch) were smaller than the un-notched composite plates, however it was bigger than the un-repaired (notched) composite plates. The failure load of four patch layered and double patch repaired composite plate was close to un-notched composite plates.

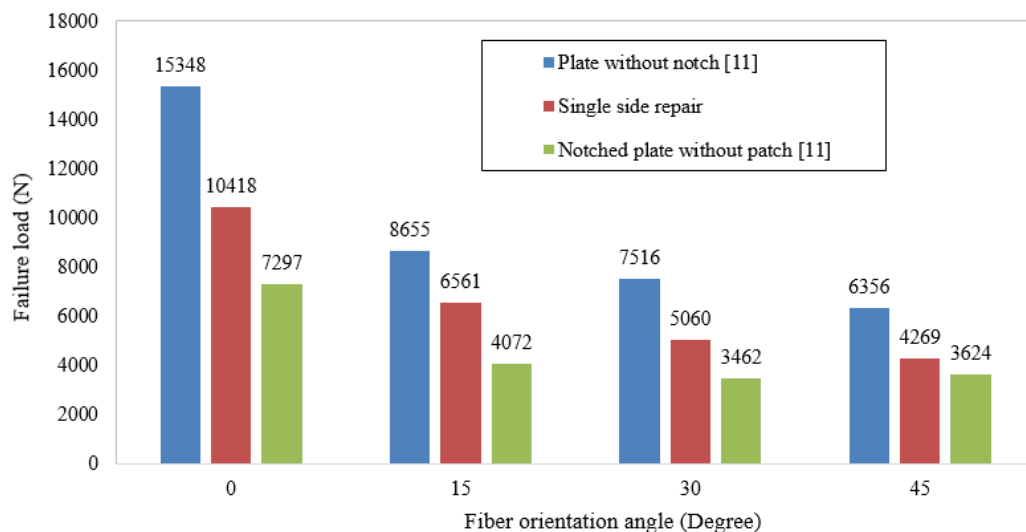
**Figure 8.** The fiber reinforced angle effects on the failure loads of single-patch repaired composite plates.

The failure loads were decreased with the fiber reinforced angle increasing and this situation could be seen in the figure 8. The minimum failure load was obtained for 45° fiber reinforced angle as 4269 N and the maximum failure load was obtained for 0° fiber reinforced angle as 10418 N. When the

repaired composite plates were compared the un-repaired (notched) composite plates, the failure loads were increased between 18 % and 61% ratios.
