Investigation of Surface Roughness and Tool Wear in Helical Plunge Milling of AISI 1045 Material

Fikret SONMEZ*

*Manisa Celal Bayar University, Hasan Ferdi Turgutlu Faculty of Technology, Department of Mechanical Engineering, 45400, Manisa, Türkiye*

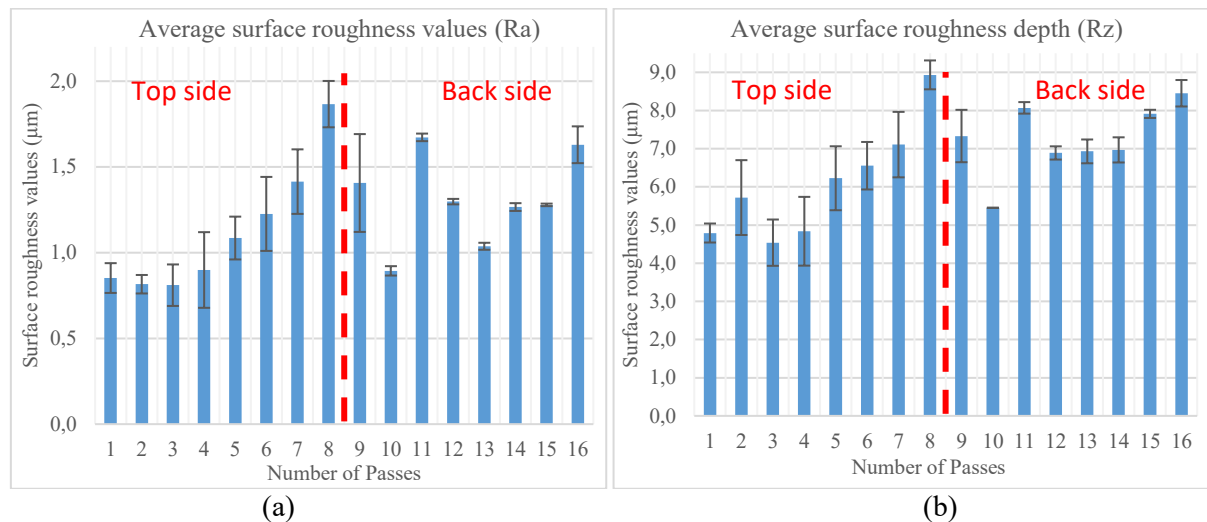
Figure 3. The surface roughness values a) Ra b) Rz

Surface roughness is one of the most important aspects of machining. In general, the lower the surface roughness, the higher the quality of the machined part. For this reason, surface roughness is the focus of many investigations. In this study, after each machining operation, the plots generated using the values obtained from the surface roughness measurements are shown in Figure 3.

Figure 3 clearly illustrates the change in surface roughness in both Ra (Figure 3a) and Rz (Figure 3b). The surface roughness values increase with each pass at the top of the workpiece. The rate of increase is almost the same for both Ra and Rz. This can be explained by tool wear. Generally, as the tool wear increases, the surface quality decreases, and the surface roughness increases. Interestingly, however, the surface roughness values of the back side of the workpiece are controversial. Figure 3a shows that lower surface roughness values can be seen. In particular, in the 10th and 13th passes in Figure 3a, the surface roughness values (Ra) were observed to be low. Rz values are also meaningful when evaluating the surface roughness values of the workpiece. Compared with the Ra values, the Rz values become more reasonable. These controversial results can be explained in several ways. First, after machining the top side, the thermal and dynamic conditions on the back side may have become more stable [19]. Second, tool wear may have caused the sharp corner of the cutting tool to dull and the cutting edge to round, which could result in improved surface roughness [20]. Third, even though the same clamping method was used, slight variations in orientation may have led to reduced vibration or deflection during cutting [21]. Fourth, BUE formations were observed during the experiments. As the tool continues to cut, the BUE may either break off or stabilize, potentially resulting in smoother cuts on the backside [22].

These unexpected surface roughness values could possibly be the result of a change in the vibration behavior of the workpiece, the breaking and re-stabilization of the built-up edge (BUE), or the dulling and rounding of the cutting tool's sharp corner. The Rz/Ra ratio was found to be consistent and in the range of five to seven.
