Journal of Scientific Reports-A

RESEARCH ARTICLE

Investigation of glass fiber reinforced aluminum honeycomb panel repair performance according to aviation standards

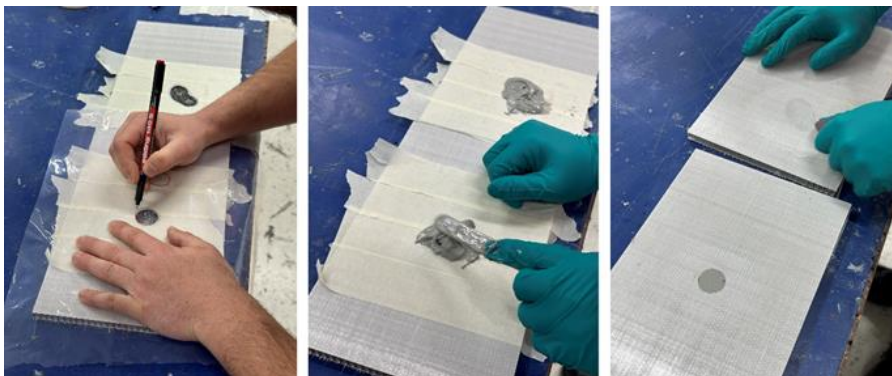
After the damaged area has been removed, the surface is carefully cleaned to remove burrs and dust. A template is then created on the damaged region using tape, which will serve as a fabric pattern for subsequent stages of the repair process. To address the core deficiency in the damaged area, the procedure involves filling the void with BMS 5-28, Type 19 filler material, as specified in the repair manual. This filler material can cure either in 7 days at room temperature or in 5 hours at 52 °C, depending on the chosen curing conditions. The filler material consists of two components that must be mixed in the prescribed ratio of approximately 20:1 (base material to activator). It is crucial to ensure that the entire damaged area is completely filled, and the filler level should be leveled with the surface of the sample. Once the filler material is applied, it is allowed to cure until it hardens. Following the curing process, the surface is shaved to achieve a smooth and level finish. During the shaving operation, safety precautions must be followed: safety goggles should be worn to prevent exposure to dust, or a vacuum device should be employed to minimize airborne particles. The shaving process continues until the filler material is even and flush with the surface of the sample. These steps are illustrated in Figure 7.

Fig. 7. Template creation, filler material application, and shaving process.

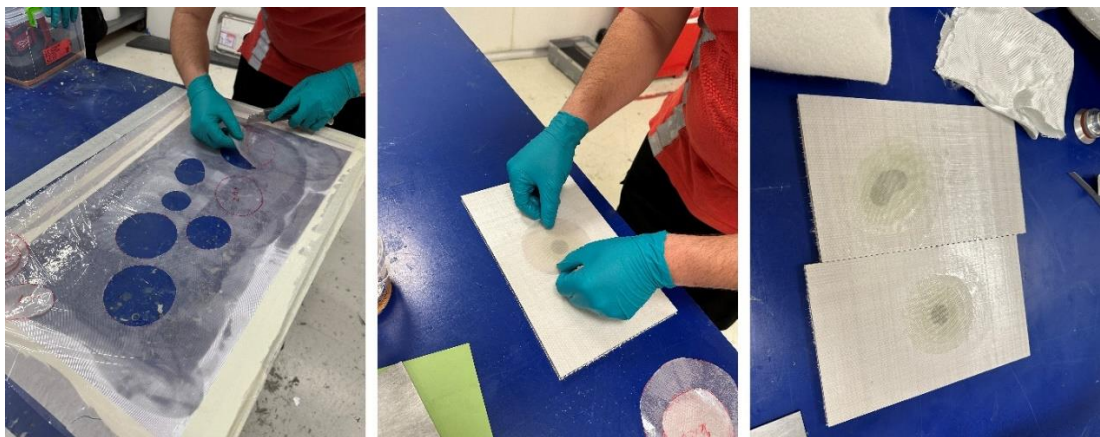
After the impregnation process, the templates are carefully cut from the fabric, and the laying process begins immediately. Prior to initiating the laying process, resin is applied to the surface to be treated. The fabric layers are then applied sequentially, one at a time, to complete the repair. These procedure steps are illustrated in Figure 9.

Fig. 9. Removal of fabric templates and fabric laying process.

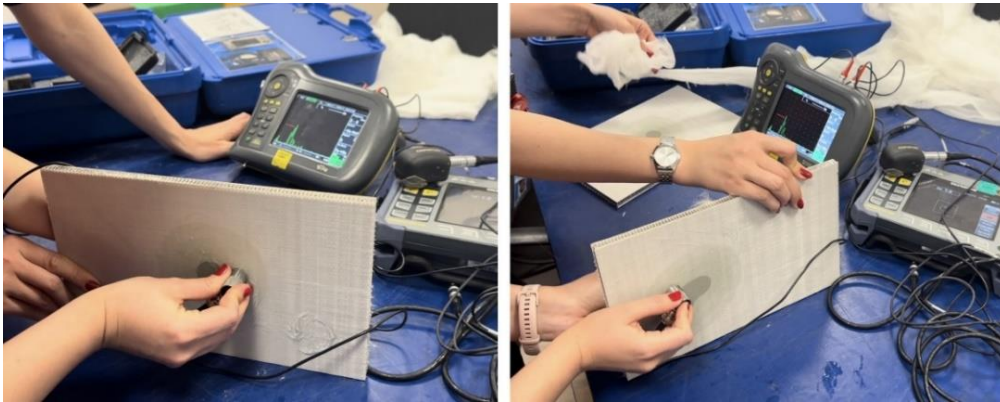
not suitable for the transmission test, the test is only applied to areas without filler material. The test is conducted over the entire repair area. According to the procedure, to determine whether the repair is suitable, the signal must be transmitted with a minimum efficiency of 40%. The signals for the specimen are shown in Figure 15. It has been determined by authorized personnel that the specimens successfully passed the transmission test.

Fig. 15. The signals for the specimen.

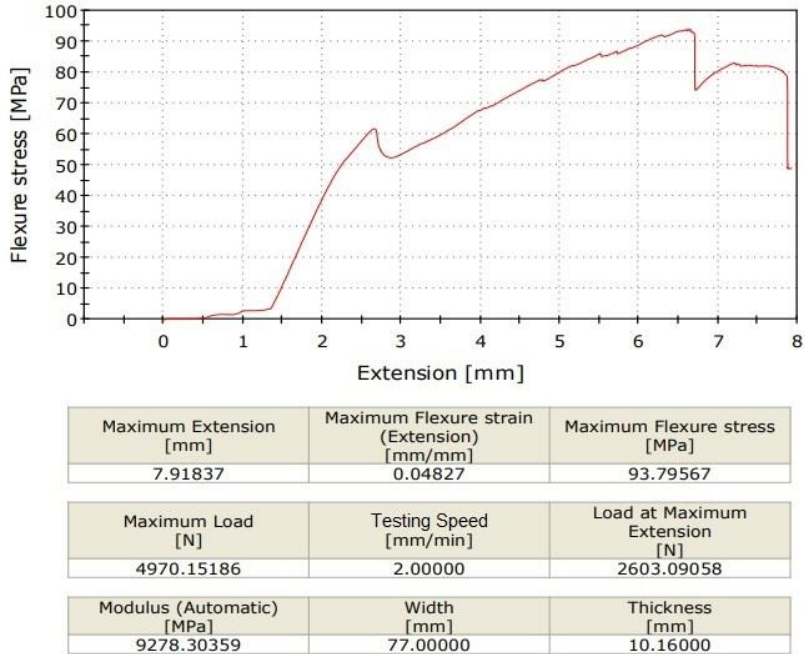
The study proposes a new repair technique applied to aluminum honeycomb structures, which are widely used in aviation and aerospace engineering applications, subjected to artificial damage. The repair procedures were executed in accordance with the maintenance protocols established by the manufacturing companies, with the objective of restoring the material's original strength characteristics. During the repair phase, the latest revision of the Structural Repair Manual (SRM) provided by Boeing was utilized as a reference. Following the repair, various non-destructive testing (NDT) methods were employed to assess the presence of discontinuities. Firstly, a three point bending test was conducted on an undamaged glass fiber reinforced aluminum sandwich material in accordance with ASTM standards. Upon analysis of the results, it is evident that the material initially exhibited a linear increase within the elastic region, where stress and strain maintained a proportional relationship. Following approximately 2.5 mm of elongation, plastic

deformation commenced beyond the yield point, which was represented as a peak in the graph. After this point, permanent shape changes occurred.

Fig. 18. The bending test result of the undamaged specimen.

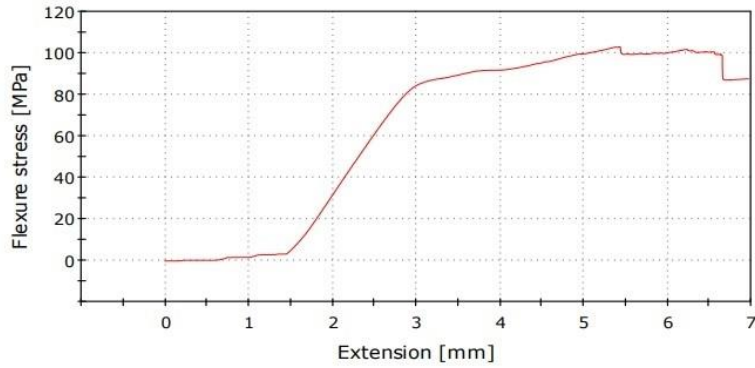
Maximum Extension [mm]	Maximum Flexure strain (Extension) [mm/mm]	Maximum Flexure stress [MPa]
6.96142	0.04244	102.94234
Maximum Load [N]	Testing Speed [mm/min]	Load at Maximum Extension [N]
5454.82617	2.00000	4638.45068
Modulus (Automatic) [MPa]	Width [mm]	Thickness [mm]
9700.80211	77.00000	10.16000

Fig. 19. The bending test result of the specimen with facesheet repair.

Secondly, conducting the three point bending tests on the surface repaired and both surface and core repaired glass fiber reinforced aluminum sandwich materials (Figure 19 and 20), it was proved that repaired specimens displayed bending stress and elongation behavior comparable to that of the undamaged specimen. However, a closer examination of the curves at the yield points revealed a sharp drop in the original specimen, while no such abrupt decrease was observed in the repaired specimens. It was deduced that the presence of filler material may contribute to this observed difference. The results presented in the study shows that the repaired specimens achieved values similar to those of the original specimen. Additionally, the graphs indicate that composite sandwich structures retain resistance to applied forces even following fracture. As a reviewer of this manuscript, it is evident that this research may provide valuable insights for future investigations and contribute to the advancement of repair methodologies for similar structures and to the development of safe and effective repair processes in the aerospace applications by enhancing the quality of maintenance repair applications.

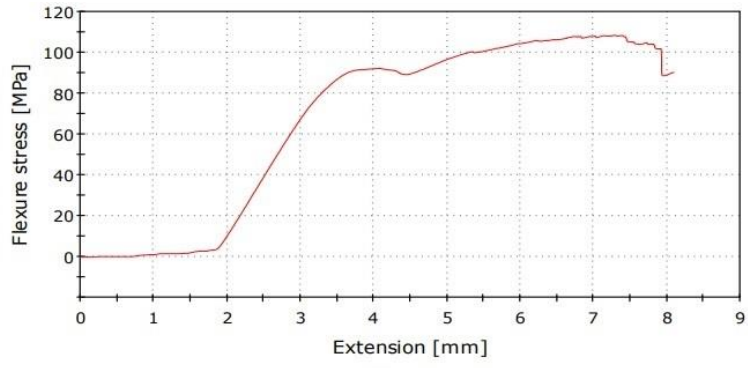
Maximum Extension [mm]	Maximum Flexure strain (Extension) [mm/mm]	Maximum Flexure stress [MPa]
8.08741	0.04930	108.37933
Maximum Load [N]	Testing Speed [mm/min]	Load at Maximum Extension [N]
5742.92725	2.00000	4782.02490
Modulus (Automatic) [MPa]	Width [mm]	Thickness [mm]
9524.30724	77.00000	10.16000

Fig. 20. The bending test result of the specimen with both facesheet and core repairs.
