RETROFITTING FOR RESILIENCE: SEISMIC REHABILITATION AND LIFE CYCLE COST ANALYSIS OF A REINFORCED CONCRETE SCHOOL IN NICOSIA AFTER THE 2023 TURKEY EARTHQUAKES

ABSTRACT: In 2023, Turkey was hit by a devastating doublet of earthquakes, measuring 7.7 and 7.6 in magnitude, resulting in widespread destruction of residential and public infrastructure. In the aftermath, the Turkish Republic of Northern Cyprus initiated a project aimed at rehabilitating educational facilities. This paper investigates the rehabilitation efforts carried out at Atatürk Technical High School in Nicosia. To assess the building's seismic resilience, a nonlinear time-history analysis was performed using 11 mainshock-aftershock sequences to evaluate its lateral load resistance and potential plastic deformations. As part of the rehabilitation, shear walls and steel X-braced frames were added to the lateral load-resisting system, with their effectiveness being examined. Post-retrofit results demonstrate substantial improvements: maximum roof displacement and drift ratios decreased by 70 to more than 90% for different blocks and directions, and plastic hinge formation shifted predominantly to the Immediate Occupancy

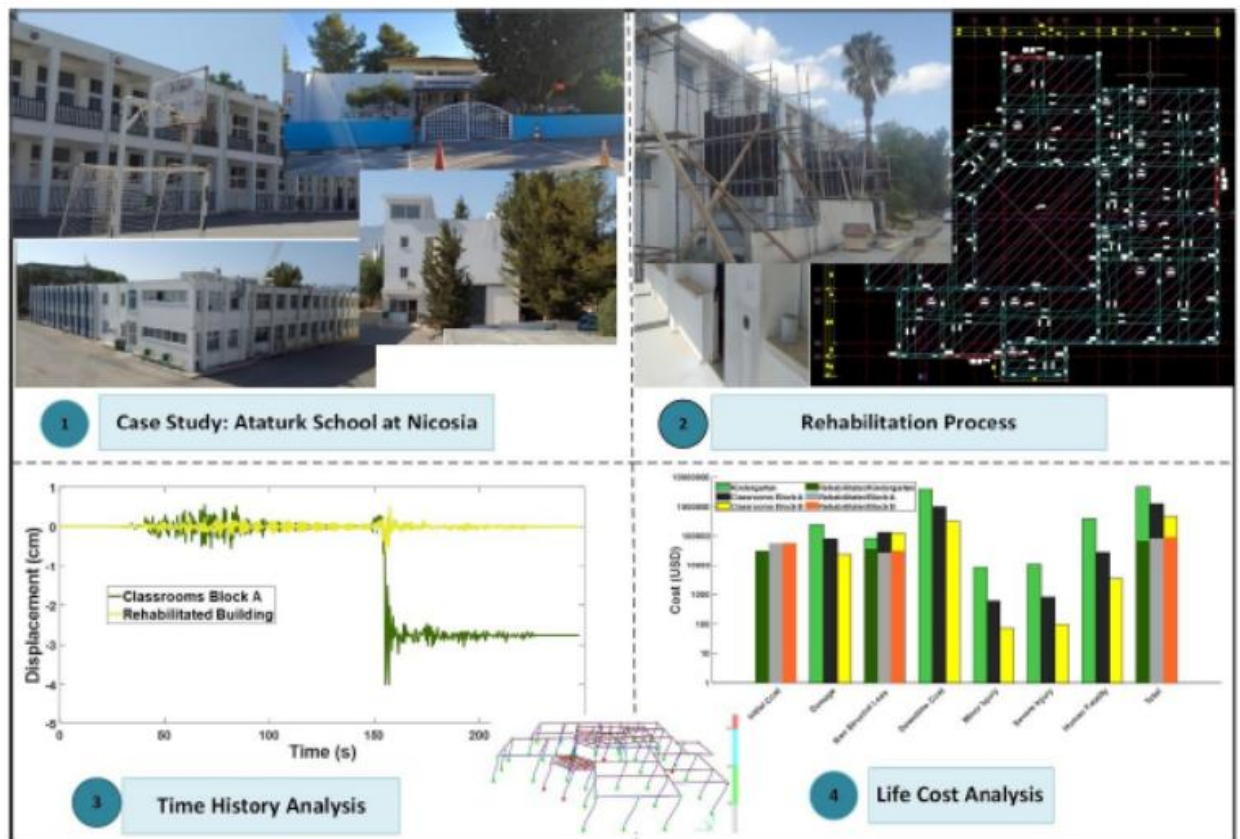
Process of rehabilitation and life cycle cost analysis

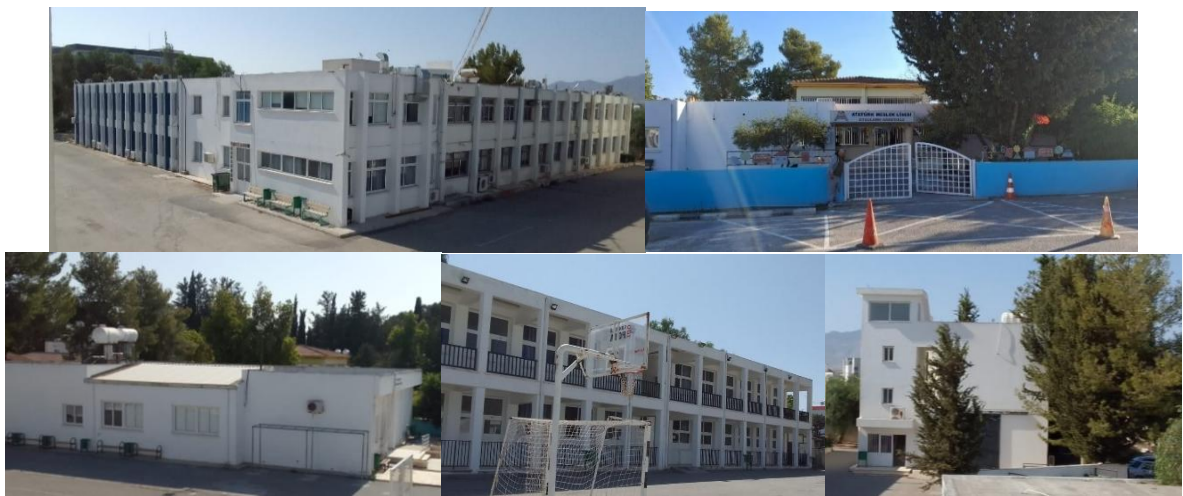
Figure 1. Ataturk Technical High School; a) Main building, b) Kindergarten c) Hairdressing School, d) Classroom Blocks, e) Atelier

The study focuses on a school in central Nicosia, North Cyprus. The school comprises six separate blocks, each built at various times, adhering to different building codes and material standards. These blocks include the main building, the Hairdressing School, Classroom Blocks, the Atelier, and the Kindergarten, as depicted in Figure 1.

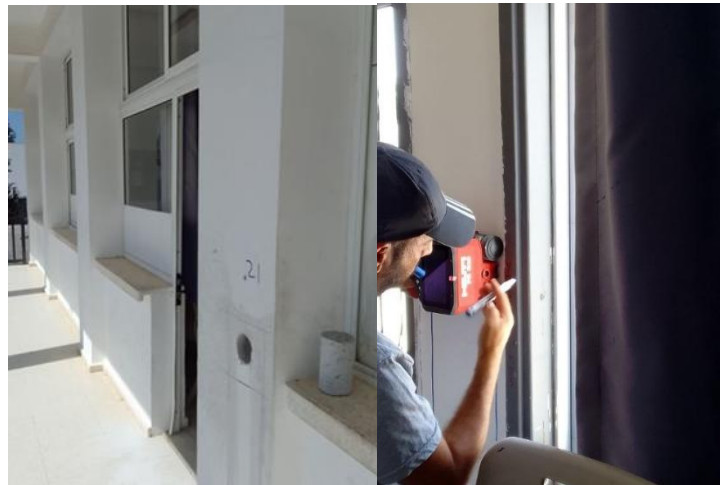
**Figure 4.** Laboratory test for validation; a) Extracted concrete cores for compression test; b) Scanning concrete rebars

The dimensions of the beams and columns were sourced from the government's records, as detailed in Table 1. Laboratory tests, illustrated in Figure 4, were performed to verify this data. The results indicated that the beams in the three blocks are stronger than the columns, which is suboptimal for structural design. Ideally, columns should have a greater moment of inertia to ensure that flexural deformations occur in beams rather than in columns.

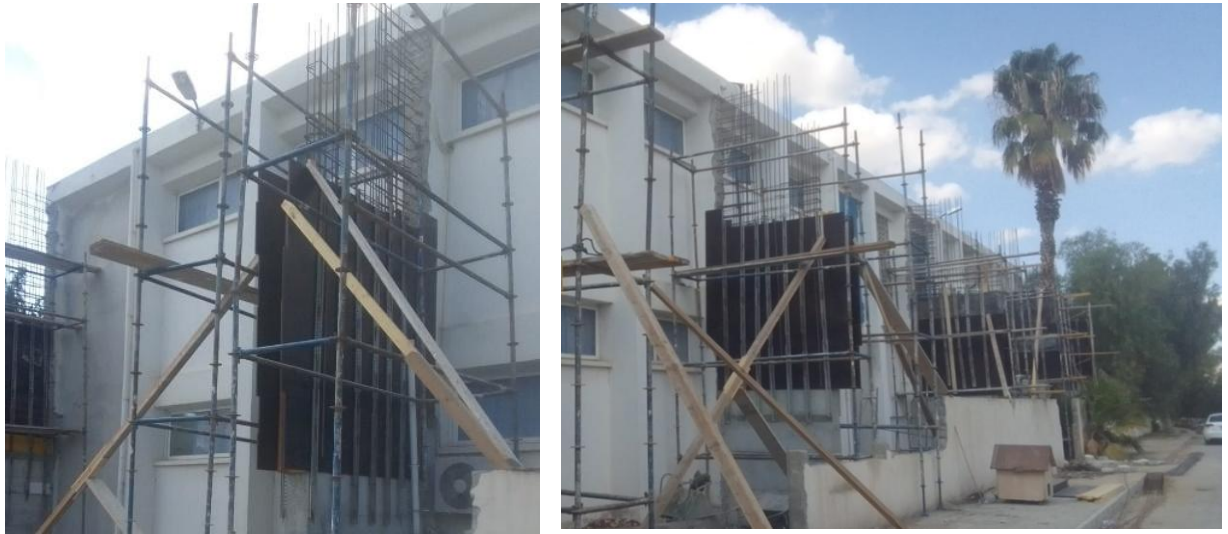
Figure 7. Shear wall added to classroom, a) Block B, b) Block A

The implementation of the shear walls and hollow steel tube sections in these structures is depicted in Figures 7 and 8.

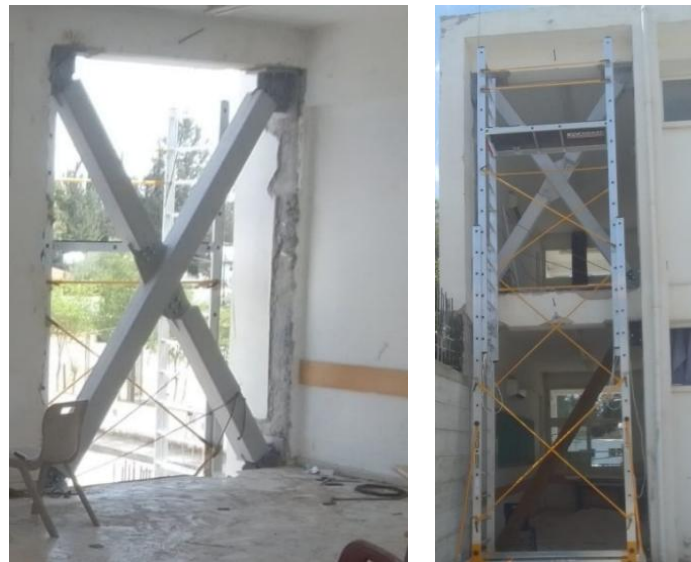
Figure 8. Tube 200x200x12.5 X-braced frames added to classroom, a) Block A, b) Block B
