REHABILITATION OF HIGH STRENGTH REINFORCED CONCRETE CORBELS USING BASALT FIBER FABRIC

ABSTRACT: This paper presents an experimental study on the mechanical behavior of damaged reinforced concrete corbels rehabilitated by Basalt Fiber Fabric (BFF). The main research aim of the study is to investigate the effectiveness of basalt fiber fabric on rehabilitation of reinforced concrete corbels, which were damaged because of elevated temperatures and overloading, by examining load restoring capacity and ductility. Totally nine corbels that had been damaged before were selected for the study. The initial failure of the corbels had been because of overloading after heating them to several temperature levels (250°C, 500°C, and 750°C). These corbels had been produced from high strength self-compacting concrete with one concrete class (80 MPa) and three different amounts of steel fiber ratios (0%, 0.5%, 1%). However, shear span value for all corbels is same (90 mm). Experimental results show that use of basalt fiber fabric on damaged corbels increases the load carrying capacity and ductility significantly as compared to the corresponding values of corbels before initial failure. Besides, the

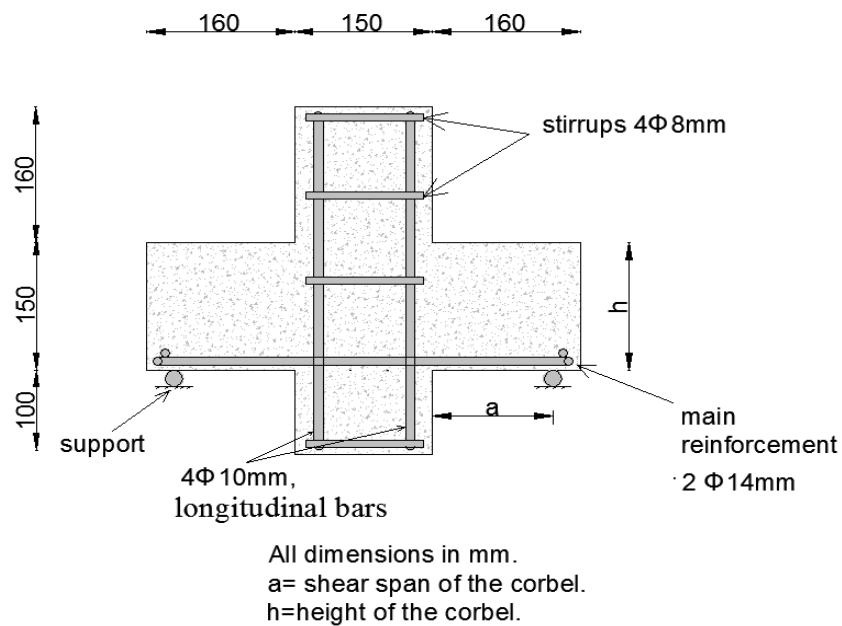
Figure 1. Corbel detail

All corbels have the same geometry and steel reinforcement arrangement which are shown in Fig. 1. The cross-section dimensions of both column and corbels are 150mm x 150mm. Column part of the column had been reinforced with four 10 mm diameter steel bars for longitudinal reinforcement and of four 8 mm diameter steel bars for stirrups. Besides, two 14 mm diameter deformed steel bars were used for the main reinforcement of all corbels and the concrete cover distance for all corbels is 20 mm. All corbels were supported by roller supports during loading tests.

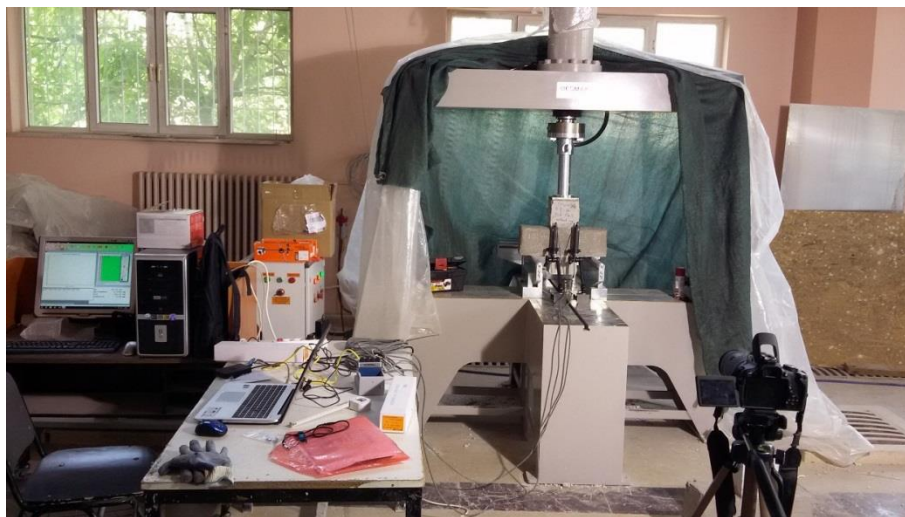
Figure 4. Corbel Specimen Setup

All corbels were tested before and after the rehabilitation process under three-point loading tests Figure 4. Tests were carried out via 500 kN capacity displacement-controlled loading machine. The corbels were loaded with rate of 0.3 mm/min. Deflection of corbels was measured by two linear-variable-displacement-transducers (LVTDs). Load and displacement values were recorded at every 0.2seconds.
