The Restitution of “Çifte Hamam” in Ahlat According to Final Excavation Outcomes

Key words: Hamam, Double bath, Ancient Ahlat City.

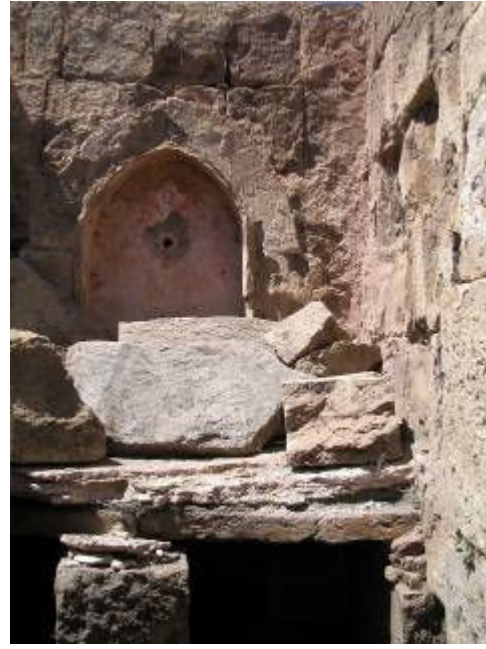
Figure 3. The water pipe and halvet niche

Having been under the ground as a whole when excavation thereof was commenced by Prof. Dr. Prof.Dr. Haluk Karamağaralı in 1970's, it is situated right outside the bastion remains at the northeastern side of the wall. The structure is positioned as *Çifte Hamam* on the north-south axis. As a result of the excavations led by Prof.Dr. Haluk Karamağaralı, men's section, water depot, and the wall separating the men's section from the women's section have been unearthed. At the southeastern corner of the unearthed area, *sıcaklık* (caldarium) section with the *göbek taşı* (central platform) at the center, the iwans surrounding it, as being located at the reciprocal axes, and the *halvets* (private rooms) at the corners are appertained to the men's section. At the relatively better-sustained men's section, while the walls and vaults were found to have been built by cut-stone, the domes and the transitions elements were found to have been built by brick. It is understood from the remnants that, all spaces, including the floors, were plastered with mortar. Bath basins, emplaced inside the pointed arc niches at the *halvets*, are seated on the plastered floor. It is understood from the water drains visible inside the walls, and from the single tap holes, that these bath basins were drained only with water warmed enough to take bath. (Figure 3).

⁶See: Figure 3; Men's section is at the *halvet*, located at the southeastern corner; base, conveying feet, *sal* stones, plasters and wall junction.

¹⁰ See: Figure 3, the same information is available in the excavation report, dated 17.08.1972.

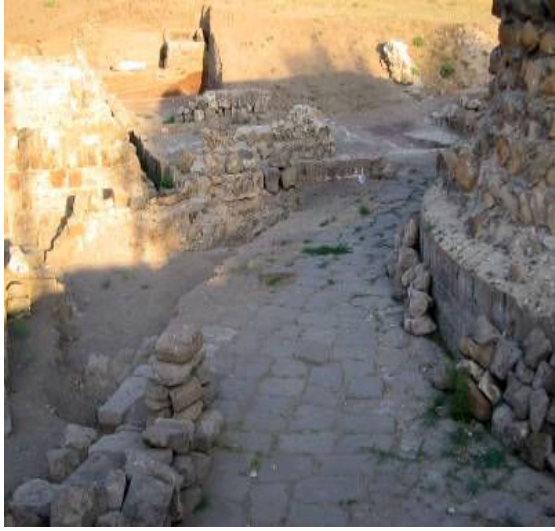
Figure 4. The Street near the Bath

Having the bath excavation restarted in the year 2009, the original street, curving along the part of the city wall at the southwest of the bath, was tidied out with its floorings unearthed; it was thereby clarified how the units of the bath, understood to have been built later, had been shaped in connection with the street.³ (Figure 4)

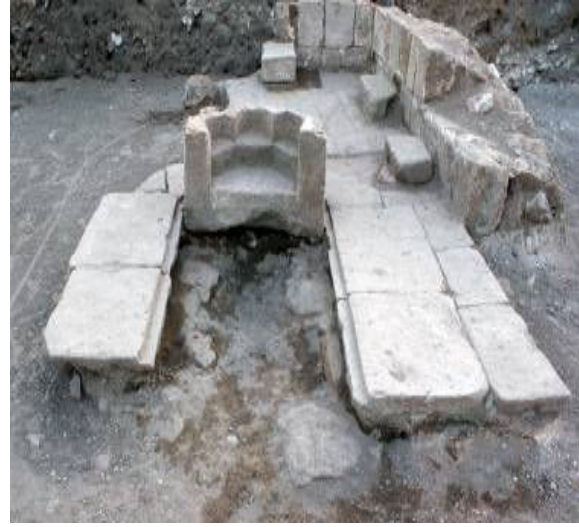
Figure 5. The wall remnant and the şadırvan (pool)

During the excavation works carried on at the northeast of the building, it was ascertained that, cut-stones were used as the construction material, and *Horasan* mortar as the binding material at the bottom level. At the west part of the bath, a *fountain basin* in trefoil form was unearthed as being situated on the stone cladding in the middle of the *soyunmalık* part of the women's section⁴. Besides, a wall remnant, put up by well-trimmed stone, was found at the north of the *şadırvan (pool)* ((Figure 5) Paving stones in varying dimensions were found at the *soyunmalık* part of the women's section. On the floor of the location, pipe drains, belonging to the water installation of the bath, were also found; and two separate pipe drain networks were found to get connected with a larger pipe drain at the east of the location.

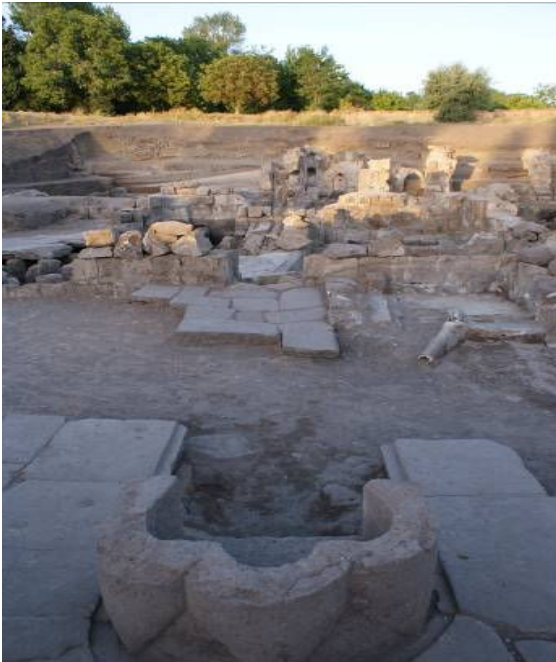
Figure 11. The Şadırvan (pool) pool and paving stones

Disregarding our lack of information regarding the fronts, despite there is no trace having survived up to the present day, the probability of the presence of windows at the *Soğukluk* section is quite high on the basis of the information incoming from the comparative study. According to the reviews, in the *soğukluk* locale, while there is no space at the fronts of the women's section, there is so at those of the men's section. Furthermore, just like the *şadırvan* (pool), having been unearthed at the *soğukluk* section of the women's bath, pipe drains were found running towards the middle of the *soğukluk* section of the men's bath, and it has become possible to mention of the presence of a *şadırvan* (pool) pool in this section, too. (Figure 11.)

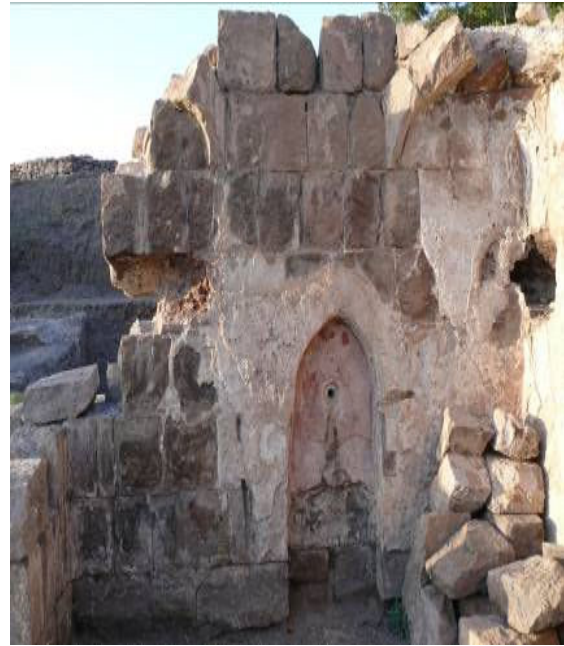
Figure 12. The concave stones and the pink plaster at the halvet.

Whole of the *sıcaklıks* of both women's and men's sections of the structure had been plastered by a pink colored plaster uninterruptedly, including the floors and walls. This plaster could have survived as preserved up to the present day¹⁰(Figure 12). Plaster remnants have been determined also at various layers over the wall parts at certain sections. As a result of the tests, having been conducted by Ankara University, the plaster has been found to be *Horasan* mortar. Besides, the wall, floor, and ceiling of the water depot had also been plastered by *Horasan* plaster, and the information regarding thereto is available in the excavation report, dated 09.08.1972.
