## Reevaluation of Geothermal Potential of Çubukludağ Graben (Western Anatolia, Turkey)

This study aims to determine the geometrical, structural features, and geothermal potential of the Çubukludağ Graben. Within the study's scope, fault-fracture and layer planes were measured at 110 stop points and plotted to the rose diagram and Wulff net. Thus, geological sequence, fault orientations, types and geometries, intersection areas, and lateral and vertical displacements of the faults, tensional-compressional areas, main compression directions, and rotation regions were determined. The geological and morphotectonic maps of the region were prepared. The formation mechanisms of the hanging rhyolite and dacite caps, along with the large-sized tears in the middle and west of the graben, were also explained using those maps. The main tectonic structures and the faulting characteristics of the Tuzla, Deliömer, Gümüldür and Değirmendere Fault Zones that boundary these structures, and the relations between the geological setting and the geothermal system are detailed. In the light of the new field data obtained, a new geological model of the graben has been constructed, and the geothermal pot

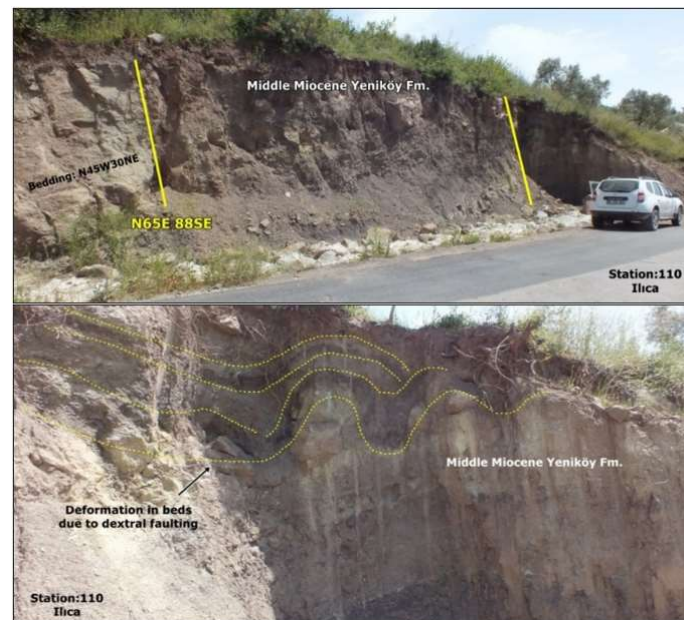
Fig. 5. Faulting and layer deformation due to right-lateral strike-slip of the Tuzla Fault Zone cutting the Yeniköy Formation (X: 492623, Y: 4218118)

strike-slip faults of the Tuzla Fault Zone that cut the Yeniköy Formation are observed. The N70E/85NW-trending fault is the main faulting trace of the Tuzla Fault Zone, and N25E 65/75SE faults represent antithetic faults. Along with the faulting, red conglomerates of the Yeniköy Formation juxtapose with gray conglomerate-sandstones. Faulting of the N48E/68SE right-lateral strike-slip of Tuzla Fault Zone, which cuts the Yeniköy Formation, is observed in Temşeahtı Village, Ortaca Hill. In the vicinity of the Ilıca Village, deformations in the form of folds are developed in the strata in the N45E/30NE direction due to the right-lateral strike-slip character of the Tuzla Fault Zone, which juxtaposes red sandstones with the claystones of the Yeniköy Formation (Fig. 5).

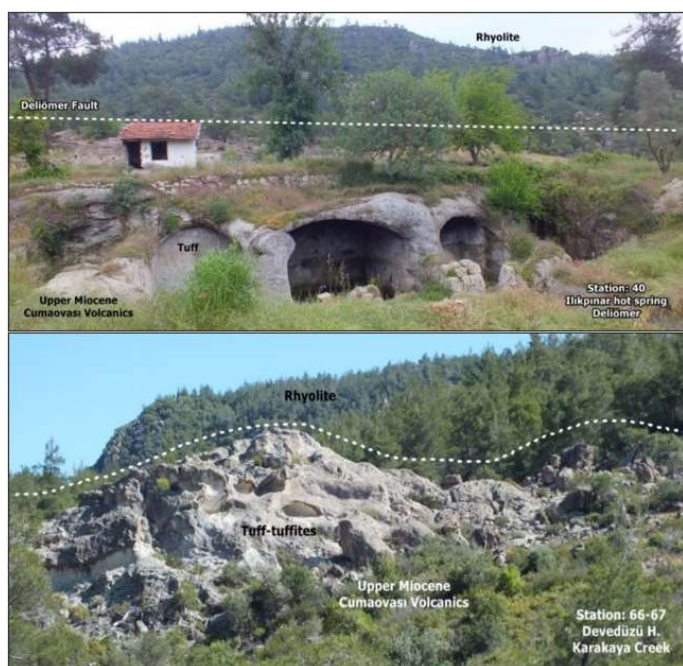
Fig. 7. Views from the right lateral strike-slip Deliömer Fault, which juxtaposes the tuffs and rhyolites of the Cumaovası Volcanics (Station 40, X: 505210, Y: 4225191; Station 67, X: 503766, Y: 4226296)

The Deliömer Fault is morphologically distinctive around 750 m in the north of Deliömer Village. Deliömer Fault with right-lateral strike-slip juxtaposes Cumaovası Volcanics with the units of Yeniköy Formation. Ilıkpınar Hot Spring is located along with faulted contact. Tuffs and rhyolites present a faulted contact relationship in this area (Fig. 7).

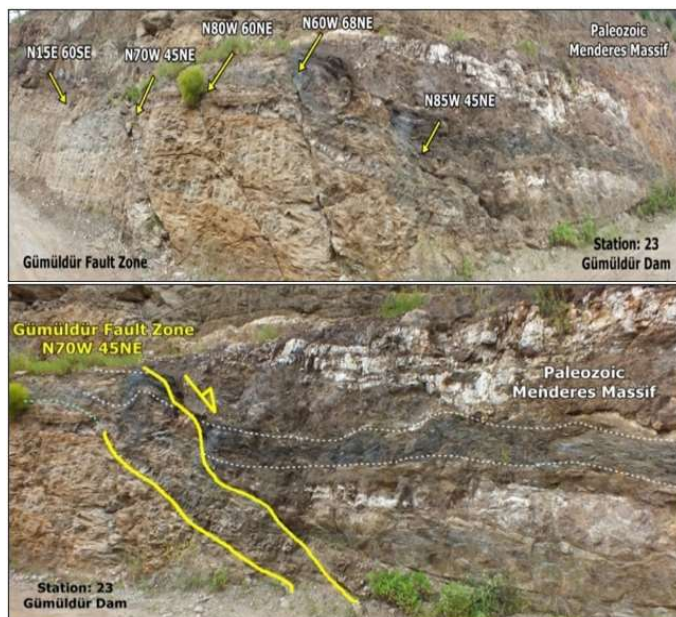
Fig. 8. A view from the faulting of the Gümüldür Fault Zone cutting the Menderes Metamorphics (X: 501098, Y: 4215980)

On the right bank of the Gümüldür Dam body, stepping faults orientated K15E/60NE, K70B/45ND, N80B/60NE, N60B/68NE, and N85B/45NE which are parallel to the Gümüldür Fault Zone trending, which cut schists and quartzites of Menderes Metamorphics, are observed. Along the Gümüldür Fault, the metamorphic units forming the region's basement outcrop (Fig. 8). In the deep well of 1215 m, these units have been drilled at a depth of 850 m. This finding indicates that the basement buried deeper by the Değirmendere Fault Zone in the Çubukludağ Graben has been brought up a little bit more by the Gümüldür Fault.

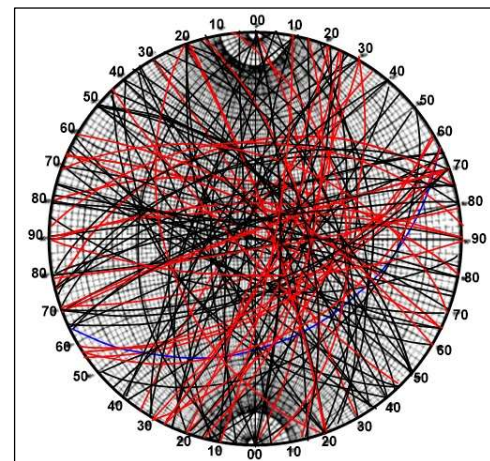
Fig. 12. The distribution of fracture and fault planes measured in the study area on the Wulff net

Faults and layers' planes have been measured at 110 different stopping points to reveal the structural features and the geothermal potential of the area (Table 1). The 114 fracture/crack/fault plane measurements at 52 stop points and 52-layer plane measurements at 43 stop points have been conducted. A rose diagram is prepared, and the orientations of the fracture planes are plotted on the Wulff net to determine the dominant fault/fracture/layer planes from the 12 different oriented fracture and layer planes along with the principal stress directions in the region (Figs. 11 and 12). As can be seen from the rose diagram of the fault-fracture planes, it is obvious that dominant the fault-fractures in 4 main directions are as follows: (1) N00-30E; (2) N00-30W; (3) N60-75E; (4) N75-90. (1) N00-30E-trending faults; (2) N00-30W-trending faults and NS/NE-SW-trending left-lateral strike-slip faults; (3) N60-75E; (4) N75-90W-trending cracks representing the cracks of E-W oriented right-lateral strike-slip Tuzla and Deliömer Fault Zones.

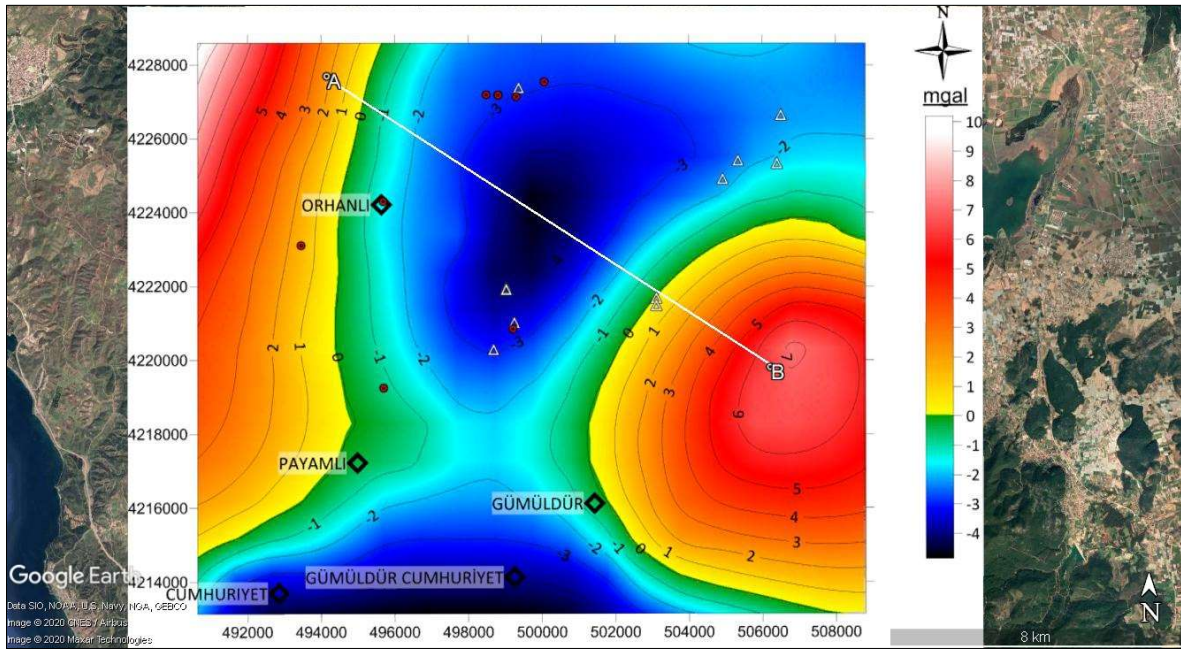
Fig. 20. Color contour map of regional gravity anomalies of the Çubukludağ Graben. Red circles: wells drilled in the graben, white triangles: hot springs

The contour maps specifically prepared from regional gravity and aeromagnetic data measured by the General Directorate of Mineral Research and Exploration of Turkey (MTA) for the study area have been used to interpret subsurface geology and geothermal potential of the area. The gravity map (Fig. 20) contains young sediments composed of lower-density sedimentary origin rocks (Neogene units and altered parts of the Paleozoic basement) and metamorphic (slate, phyllite, etc.) rocks represented by dark blue, light blue, and green colors. In the areas featured by orange, red, and yellow colors, an anomaly is characterized by the rocks having relatively higher densities (blocky flysches, marble, and metamorphics). Graben is mostly located in an area with low-density rocks. The NW section of the graben can be evaluated as suitable for reservoir development (areas in blue and dark blue on the map) considering the geological and tectonic data.
