An examination of different heat treatment effects to the fracture parameters of connecting rod made from C70S6 steel

The main microstructure of the crackable C70S6 steel is pearlite (%90 of the structure is about pearlite). Changing the microstructure by various heat treatment applications such as hardening&quenching, annealing, tempering can be economic and technologic alternatives to the use of crackable C70S6 steel. In this study, the microstructure and the metallography of the crackable C70S6 steel is examined by various heat treatment applications. Besides this, some fracture experiments has been carried out for each heat treatment application. Finally, it has been seen that tempered martensite structure can be an important alternative to the pearlitic crackable C70S6 connecting rods.

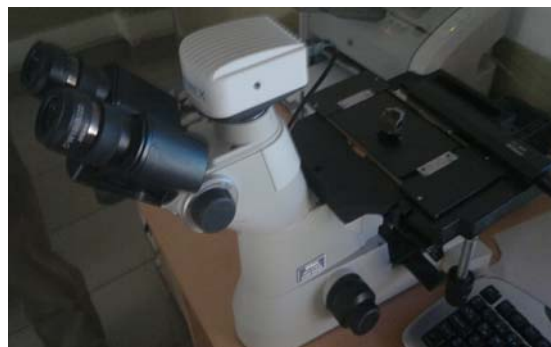
Fig. 2. Optical microscopy

The examination consists of heat treatment applications (hardening, annealing and tempering), fracture experiments, metallographic observation and the interpretation of these analysis. The hardness has been measured, the relation of the hardness and microstructure has been examined. Fractured specimens' optical photos were carefully examined at the Nikon MA 100 Metal Microscopy (Fig. 2).

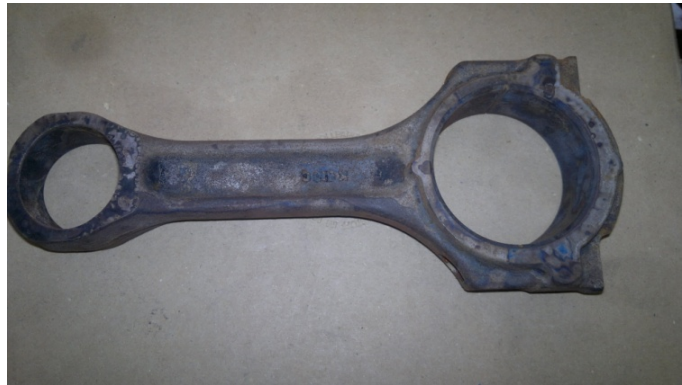
Fig. 3. Crackable con-rod C70S6 heated to the 800°C and held in furnace 45 min., then quenched in water

The C70S6 con-rod is subjected to a thermal treatment consisting of austenitisations at 800°C/45 min. followed by water quenching.

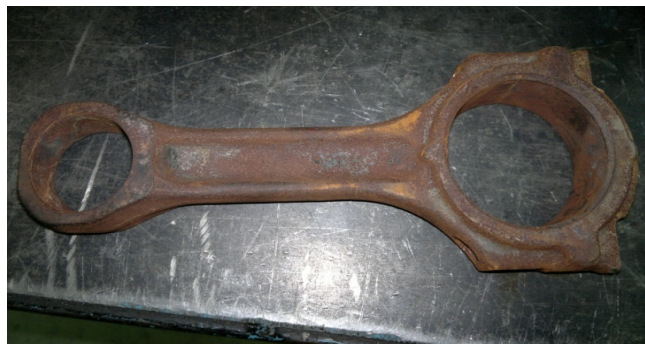
Fig. 7. Crackable con-rod C70S6 heated to the 800°C and held in furnace 45 min., then quenched in % 10 NaCl water

The C70S6 con-rod is heated to the 800°C, it is held in furnace for 45 min. Then it is quenched in %10 NaCl water.

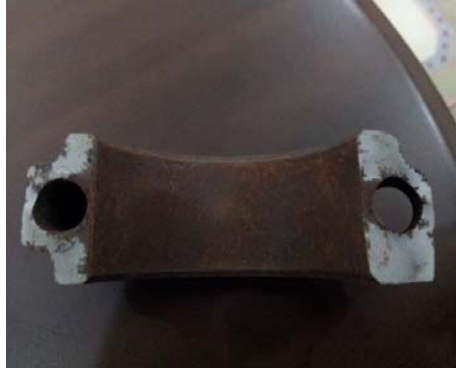
Fig. 8. The photo of C70S6 con-rod after fracture test applied

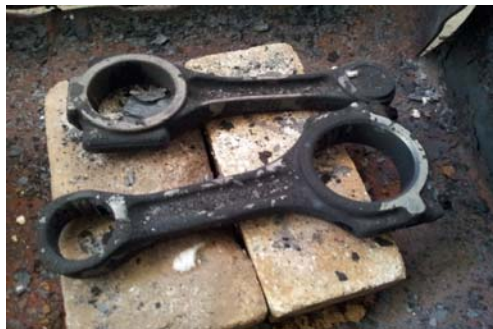
Fig. 10. Crackable con-rod C70S6 heated to the 800°C and quenched in still air

The C70S6 con-rod is heated to the 800°C, then it is quenched in still air.

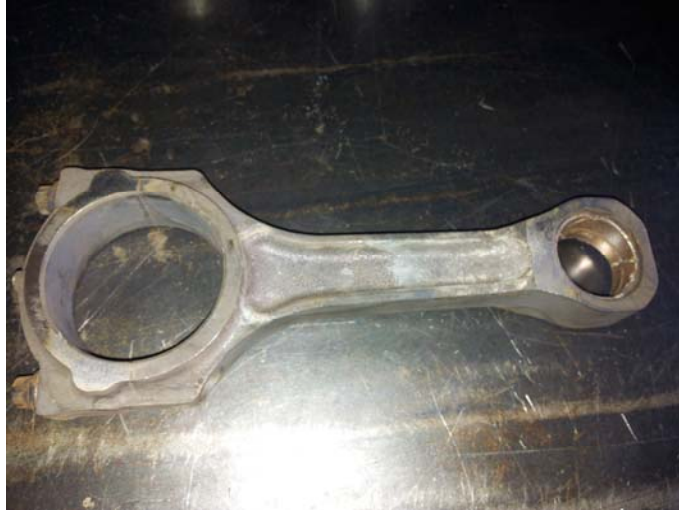
Fig. 13. Crackable con-rod C70S6 heated to the 780°C and held in furnace 45 min., then quenched in water, tempered at 450°C for 30 minutes

The C70S6 con-rod is heated was subjected to a thermal treatment consisting of austenitisation at 780°C/45 min. followed by water quenching, and tempered at 450°C/30 min. then taken to the still air.

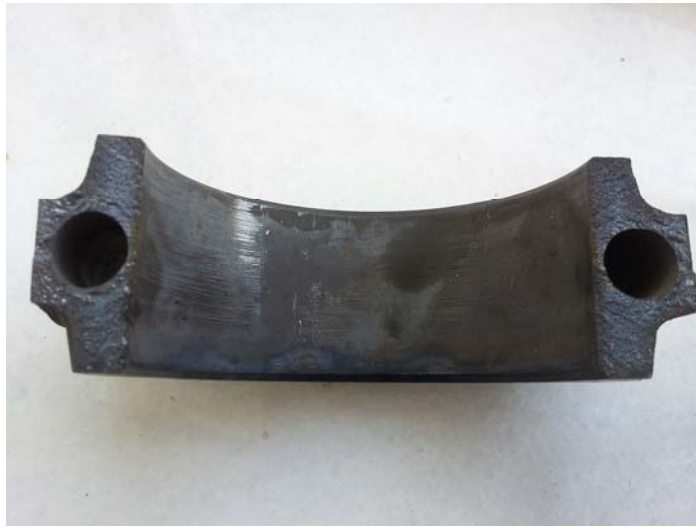
Fig. 19. Tempered martensite fractured surface after fracture test (a perfect brittle fracture)

1. The tempered martensite is separated into two pieces from the starting notches. An excellent fracture from starting notches has been obtained.
2. The martensite structure obtained by %10 NaCl water quenching is too brittle and hard (612 HB.) so as to get a perfect fracture from the starting notches. So no technological usage is predicted for this crackable con-rod.
3. The martensite structure obtained by water quenching is brittle and hard (352 HB.) Almost an excellent fracture from the starting notches has been obtained. But the use of crackable con-rods should be considered carefully. Because the microstructure is hard for fracture splitting.
