Evaluation of the modern architectural buildings in terms of sustainability: A case of Çorlu municipality building

FRP, Çorlu municipality building, modern architecture, structural systems, sustainability

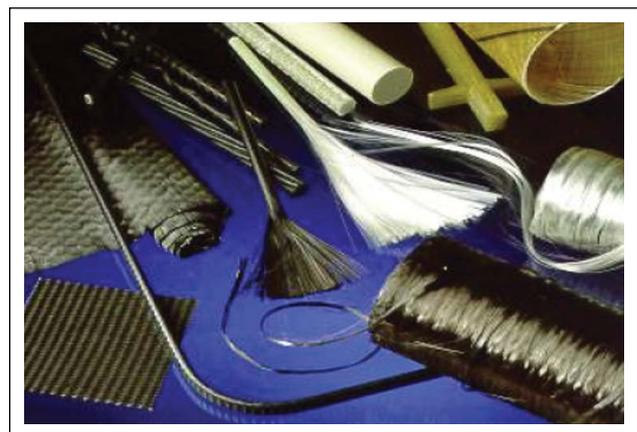
Figure 9. FRP composite.

Retrofitting technique with fibrous polymer, one of the new generation methods; is a system that increases the strength, ductility and rigidity capacities of the structure, obtained by bonding high-strength fibers such as carbon, glass, aramid with resins to the surfaces of building elements with different methods and shapes (Fig. 8, 9) [9].

The fibers are the load-bearing component with a high modulus of elasticity. It can be based on glass, aramid and carbon (Table 2). The fibers are attached to the reinforced concrete surface with epoxy etc. bonds with a matrix and
