Cultural Heritage and Science https://dergipark.org.tr/en/pub/cuhes

## Tracing the cultural heritage values of a traditional Antakya house

## Mert Nezih Rifaioğlu \*100

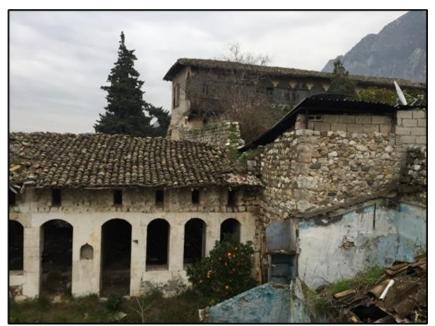
Figure 4. The main mass-courtyard relationship in the close vicinity. The high mass in the rear belongs to Gali Mansion

On the other hand, in Gali Mansion, the relationship between the main mass and the courtyard differs from that of the houses in the near vicinity. Two spaces in the main mass which occupy the largest area among the spaces on the ground floor level reach the courtyard via an *eyvan*. There are two directly related spaces between the courtyard and the main mass. These two spaces are the spaces with the smallest area on the ground floor. Regarding the annex building, it is directly related to the courtyard and has a more intense architectural program and spatial setup compared to other annex buildings located in the close vicinity. In terms of building scale, the annex building is equivalent to the main masses of the houses in the near surrounding (Figure 4 and Figure 5).

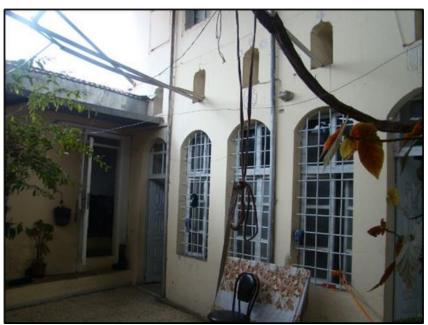
Figure 5. The courtyard-main mass-annex building relationship in the close vicinity

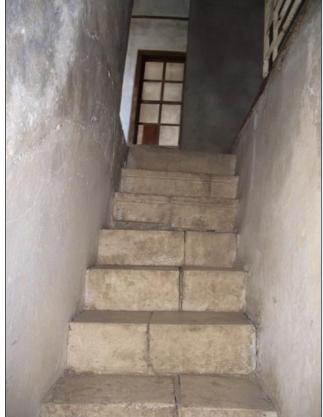
**Figure 8.** The 3 steps added to the arched stone staircase that provides access to the upper floor and the vault-stair level relationship

The upper floor spaces, which were reached in two different ways in the previous period and at different levels, were brought to the same level by adding three more steps to the arched stone staircase in this period. Thus, the entire upper floor is connected to each other by the corridor area that has survived to the present day. In addition to the previous period, a space with three guillotine windows and a decorated traditional timber ceiling which is supported by the vault that was built next to the stairs was added to the beginning of the corridor. With the addition of this mass, the space, which was a balcony in the previous period, turned into a hall connected to the corridor. Since the guillotine windows opening to this hall could not fulfil their function anymore, two windows were opened to the exterior in the room located in the eastern corner. The differences in the dimensions of these windows with cut stone jambs also show that these windows did not exist in the first period. In this case, the upper floor is divided into six rooms in total. Three of these rooms can only be reached from the corridor in front of them, and two of them from the hall in front of the stairs, while one room can be reached from both the corridor and the hall. At the end of this corridor, there is a window with two wings and wooden shutters, while the part of the corridor facing the courtvard is open. The top of the corridor, which was added to the building later, was covered in the manner of an eaves by extending the roof (Figure 16). At certain intervals, wooden posts support the eaves covering the

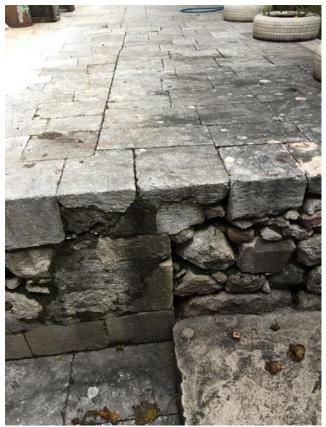
**Figure 10.** The photo shows that the ground level of the First Period was lower and there was an access to the stone floor of the courtyard by steps after the cut stone finish

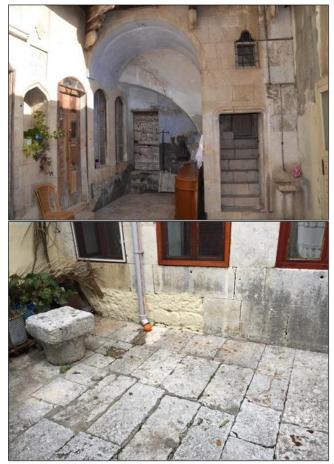
**Figure 13.** With respect to the comparative study on the trace on the wall and the one on the adjacent building lot no: 2060, and the statement of the inhabitant in the adjacent building in the current situation, the presence of a platform can be proposed.

added under the newly added stair arch. As a result of the comparison of the traces on the façade in this section with those on the adjacent building lot no: 2060, the presence of a platform in this area was determined (Figure 13). The staircase, which started with the opening on the wall in the part that was the entrance vault of the previous period, extends to the main wall of the main mass with the missing three steps that were found to be added later (Figure 14). Here, through the opening on the façade, the space consisting of an inner balcony/eyvan is reached. The decorated traditional timber ceiling in this section is bordered by curvilinear support elements on both sides at the ceiling façade. Apart from this space, in the space divided into two rooms, the two guillotine windows of the room with a decorated traditional timber ceiling, which have survived to the present day, open to this space.

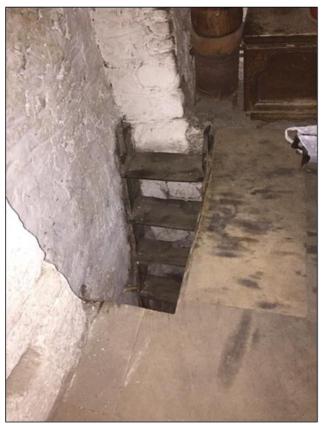
**Figure 15.** The ladder providing access to the upper floor in the building on the building lot no: 2060 in the 4th circumscription

In this period, with the transformation of the upper floor, which was used as a warehouse in the previous period and was reached by the *mabeyn*, into a living space, the upper floor consisting of the three rooms in the northern corner of the building was added in order to meet this need. It was determined that this floor can be reached via a timber ladder leaning against the wall from the niche, as in the neighbouring building lot no: 2060 (Figure 15).
