Experimental Study of Evolution of Breach Resulting from Piping at Upper Part of Earth-Fill Dam

ABSTRACT

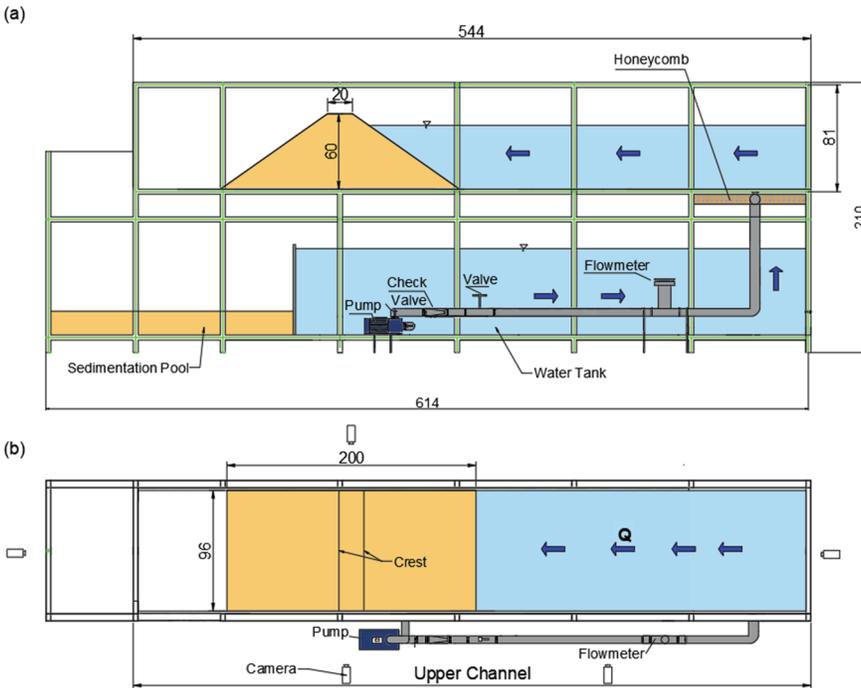
The experimental dam was built in a rectangular channel of 1 m wide, 0.81 m high and 5.44 m long, as shown in Fig. 1. The dam having a height of 0.6 m, a bottom width of 2 m and a

Figure 1 - Experimental system (a) side view, (b) plan view (All dimensions are in cm)

crest width of 0.20 m was built in the upper channel. The slopes of the upstream and downstream sides were set to 1:1.5. Water circulated between the lower reservoir and the upper channel by means of a pump. Soil mechanics tests were carried out in the laboratory before the construction of the dam.

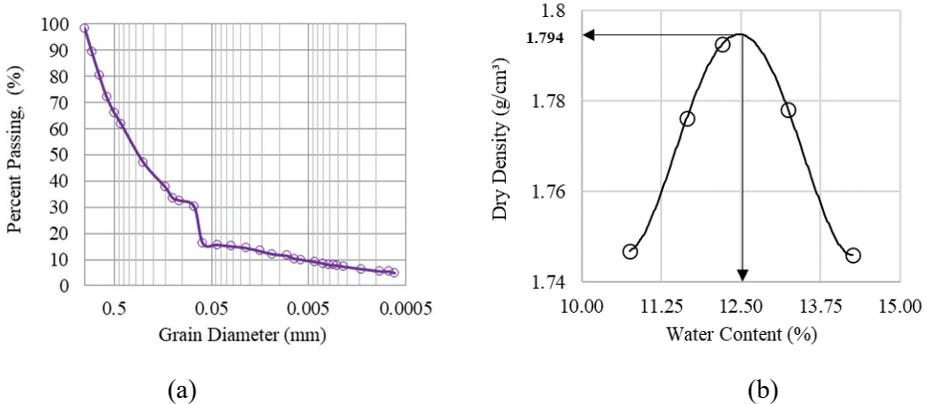
The grain-size distribution curve for soil mixture obtained from sieve analysis (ASTM D-6913) and hydrometer analysis (ASTM D-7928) is given in Fig. 2a. Some characteristic diameter values are as follow; $D_{10}=0.006$ mm, $D_{30}= 0.075$ mm, $D_{50}= 0.3$ mm, and $D_{60}= 0.4$ mm. The coefficients of uniformity and gradation were found as $C_u =66.7$ and $C_c =2.34$, respectively. The soil classified as Clayey Sand with a corresponding symbol SC according to Unified Soil Classification System. The specific gravity for the mixture was found as $SG= 2.63$ (ASTM D854 – 23).

Proctor test (ASTM D-698) was performed to obtain the maximum dry unit weight and the optimum water content (Fig. 2b). From Fig. 2b, $\gamma_{dry,max}= 1.794$ gr/cm³ and $w_{opt}= 12.5$ %. In the experiments, the energy was reduced by 50 % in order to facilitate the occurrence of piping. The applied compaction energy was 309 kJ/m³. Hence, the number of blows applied for each layer during the construction of the dam was 13 instead of 25. In the experiments, the bulk density of 1.997 g/cm³ was satisfied for each layer. Before the compaction, each layer was 14 cm thick and after the compaction it was reduced to 10 cm.

Figure 2 - a) Grain size distribution of soil mixture with sieve analysis and hydrometer analysis b) dry density versus water content graph

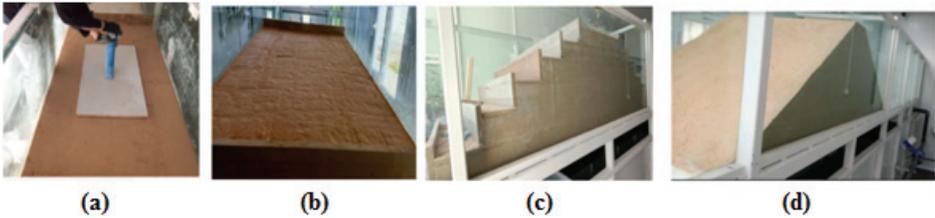
The dam was constructed layer by layer. Each layer of 14 cm was compacted so that its thickness becomes 10 cm by using Proctor Hammer and plate. Some construction stages and finished shape of the dam body are given in Fig. 3.

Figure 3 - Some construction stages: (a) Compacting by proctor hammer, (b) After compaction of the first layer, (c) After compaction of the last layer, (d) Final shape

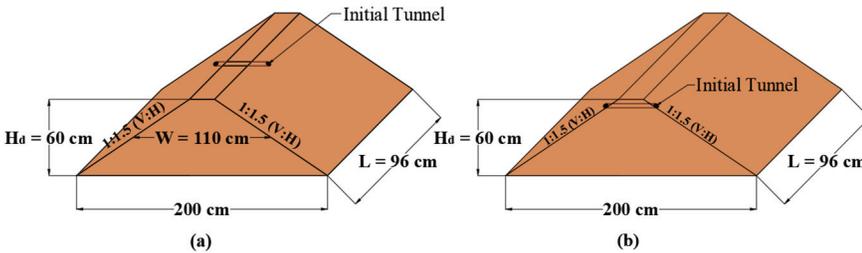
Figure 4 - Schematic views of the dam body corresponding to seepage a) along centerline b) at corner

In order to generate the formation of the breach, a circular hole of 2 cm diameter lying from upstream to downstream was created at 54 cm from the bottom of the dam body (Fig. 4).

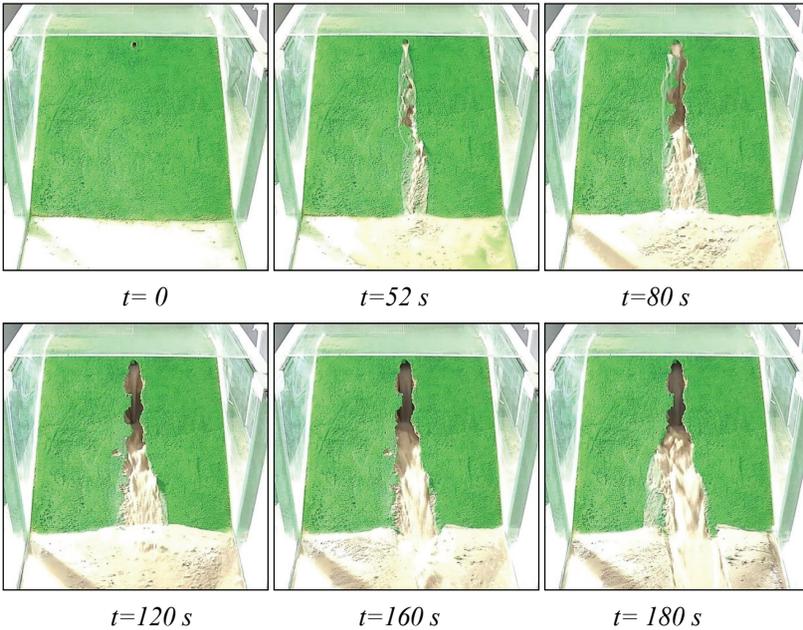
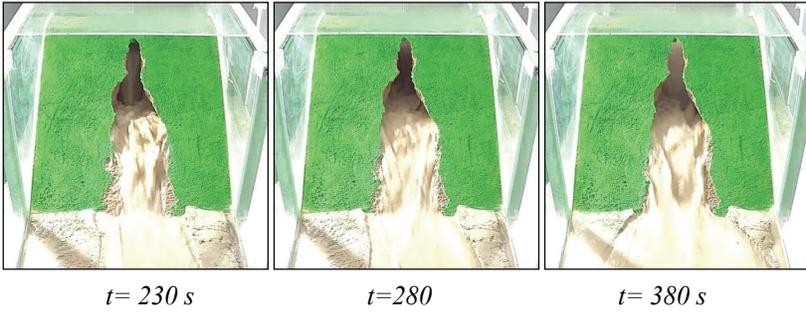
The temporal developments of the breach recorded by the cameras located at downstream and upstream of the dam are given in Fig. 5 and Fig. 6, respectively. The time $t=0$ corresponds to the starting of the seepage [15, 19]. As seen in Figures 5 and 6, there was head cut erosion proceeding from downstream to upstream. The breach formation started at downstream side first and progresses backward to upstream side.

Figure 5 - The temporal development of the central breach at downstream

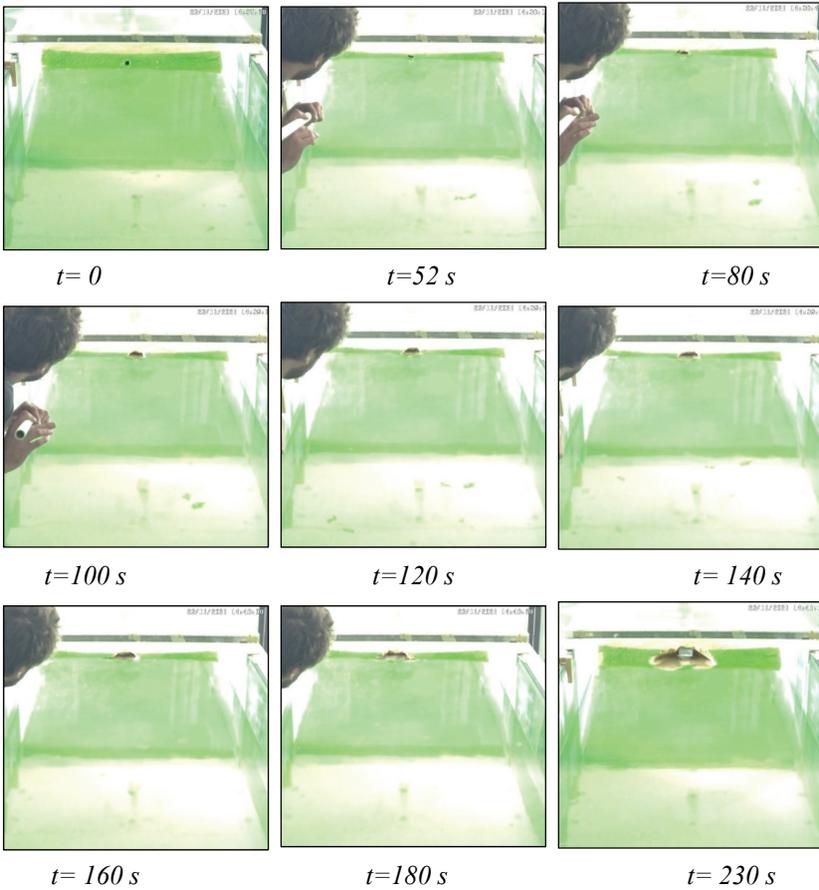
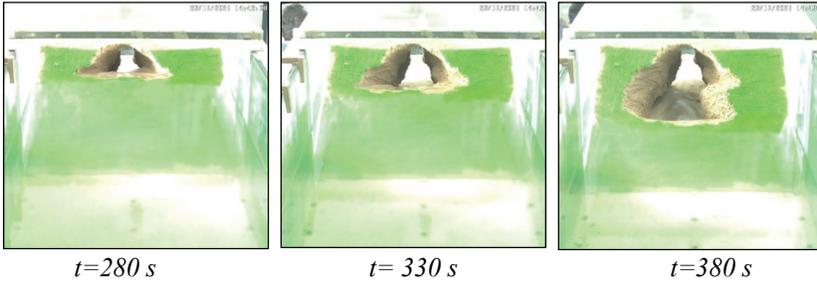
Figure 6 - The temporal development of the central breach at upstream

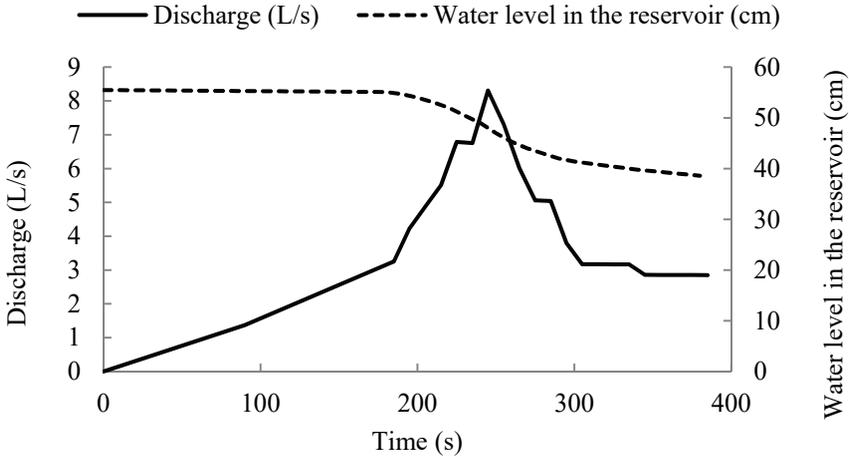
The time-varied water level in the upstream reservoir and average discharge from the central breach are given in Fig. 7.

Figure 7 - Time-varied water level in the upstream reservoir and average discharge from the central breach

The maximum discharge from the breach was calculated as $Q_{\text{max}}=8.31$ L/s at $t=245$ s.

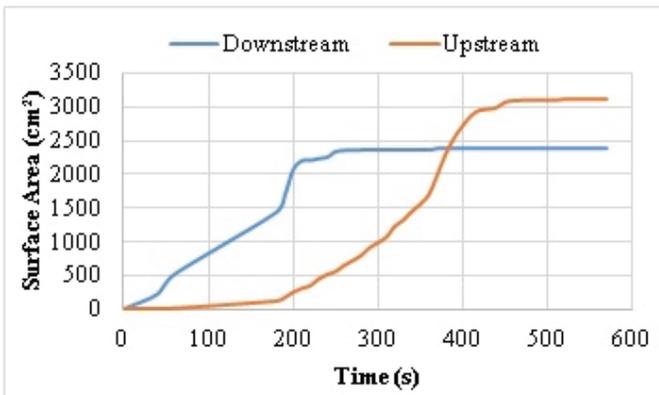
The temporal variations of the central breach area at downstream and upstream are presented in Fig. 8.

During the experiment, the breach initiated on the downstream side and then evolved towards to upstream side. As expected, there was a delay in the evolution of the breach at upstream side. At downstream the breach reached its maximum value at $t=370$ s and remained nearly constant while at upstream side the evolution of the breach continued, and its maximum value was greater than that at downstream.

Figure 8 - Temporal variations of the central breach area at downstream and upstream

The maximum breach surface area at the upstream was found to be $A_{\text{umax}} = 3128.7 \text{ cm}^2$ at $t=520$ s.

At downstream $A_{\text{dmax}} = 2379.3 \text{ cm}^2$ at $t=370$ s and remained unchanged afterwards.

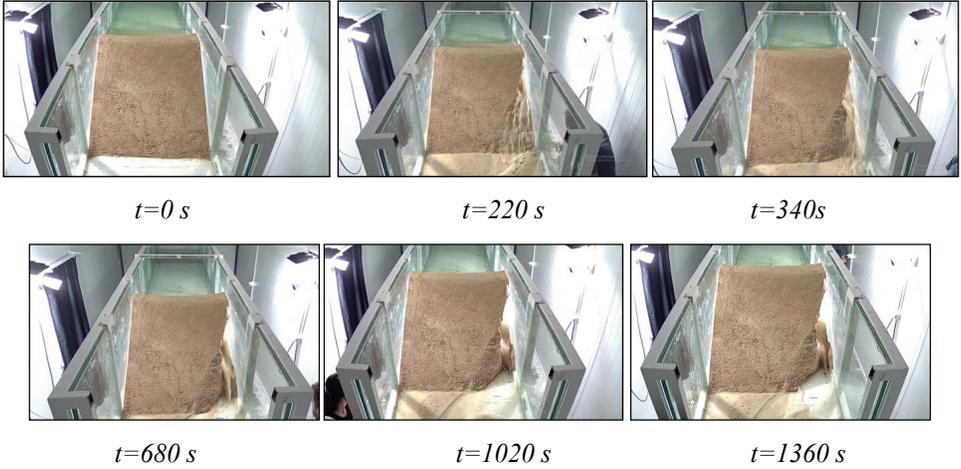
cameras located at downstream, upstream and lateral side of the dam are shown in Figs. 9, 10 and 11, respectively. The time $t=0$ indicates the beginning of the seepage [14, 19].

Figure 9- The temporal development of the corner breach at downstream

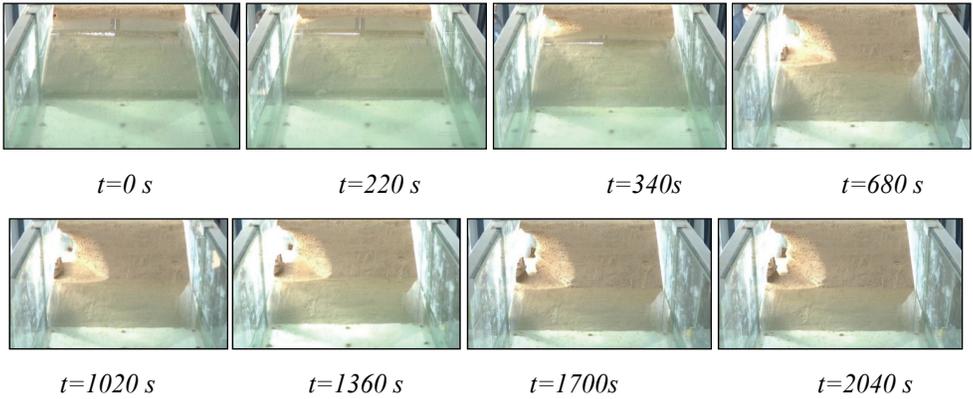
Figure 10 - The temporal development of the corner breach at upstream

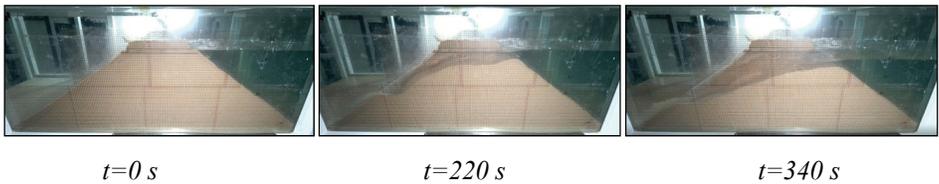
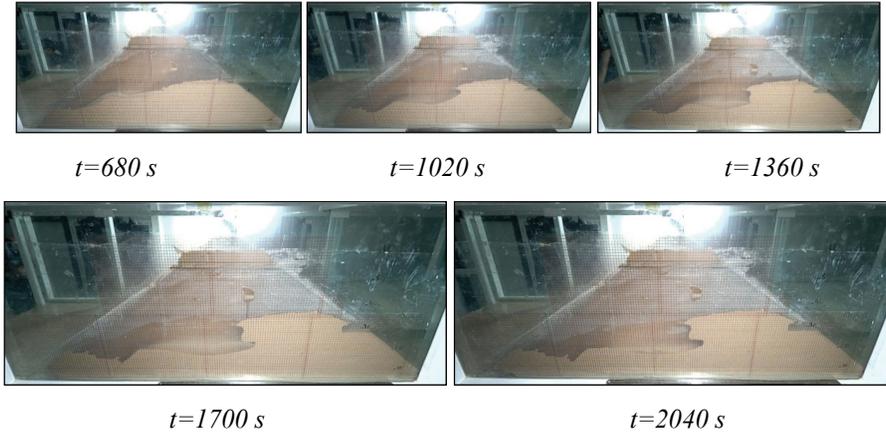
Figure 11 - The temporal development of the corner breach at lateral side

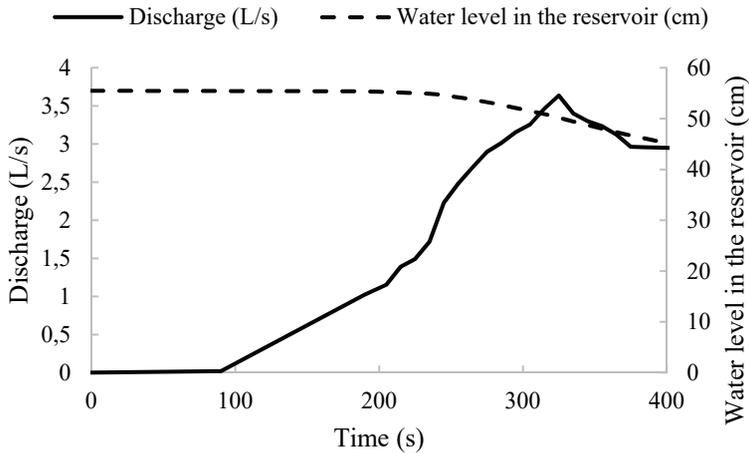
The time-varied water level in the upstream reservoir and average discharge from the corner breach are given in Fig. 12.

Figure 12 - Time-varied water level in the upstream reservoir and average discharge through the corner breach

The maximum discharge from the breach was calculated as $Q_{\max}=3.64$ L/s at $t=320$ s. The peak flow rate was found to be quite smaller compared to that found in the 1st scenario (8.31 L/s) and this value was reached later (320 s instead of 245 s.).

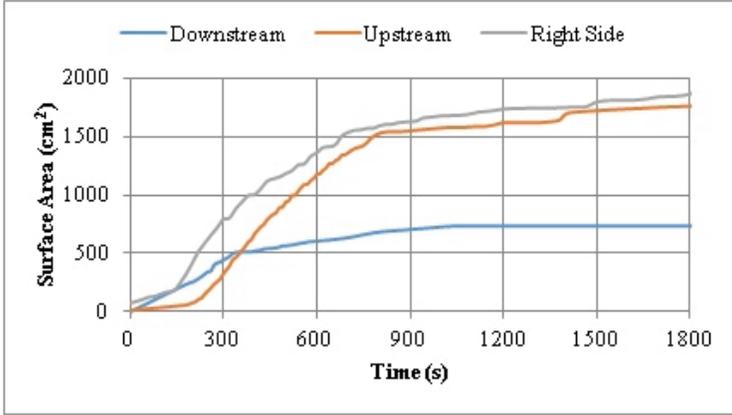
The temporal variations of the corner breach area at downstream, upstream and lateral side are presented in Fig. 13.

Figure 13 - Temporal variations of the corner breach area at downstream, upstream and lateral side

Likewise, it was observed that the breach started at the downstream side and then developed towards to upstream side. The delay in the development of the breach at upstream was found to be smaller compared to the 1st scenario. The breach surface area of the upstream was recorded at a maximum level of $A_{\text{umax}}=1760 \text{ cm}^2$ at $t=1800 \text{ s}$. At downstream $A_{\text{dmax}}=732 \text{ cm}^2$ at $t=1080 \text{ s}$ and remained unchanged, also $A_{\text{latmax}}=1875 \text{ cm}^2$ at $t=1800 \text{ s}$.

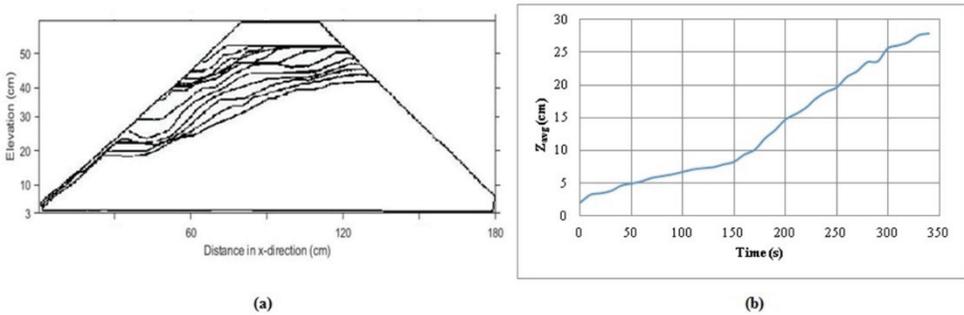
Fig.14 illustrates the bottom erosion lines and the average erosion depths corresponding to the 2nd case.

Figure 14 - a) Bottom erosion lines for every 30 seconds (starting from $t=10 \text{ sec}$) b) Temporal variation of the average erosion depths for case 2

As seen from this figure the average breach depth developed rather slowly in the first half of the experiment period while it developed nearly twice as fast in the second half. Besides, when the first half of the experiment period was completed, the edge of bottom erosion line reached the upstream surface of the dam, and then it was observed that there was an increase in the development of breach depth at the second half of the period.

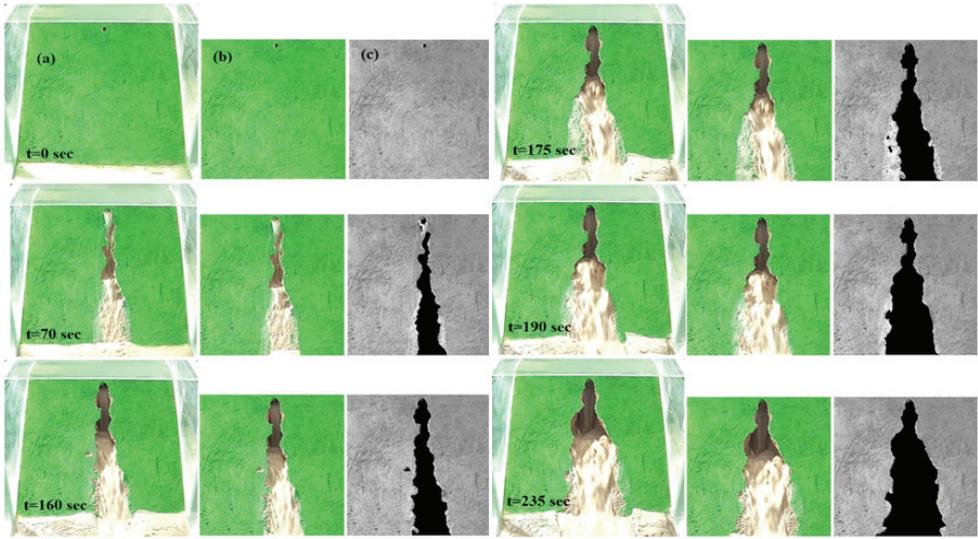
The time dependent image processing using Matlab Color Thresholder for downstream and upstream sides of the dam corresponding to the 1st case are given in Figs. 15 and 16, respectively.

Figure 15 - Time dependent image processing using Matlab Colour Thresholder for downstream – HSV. a) Original picture from experiments. b) Cropped Image c) After Colour Thresholding for case 1

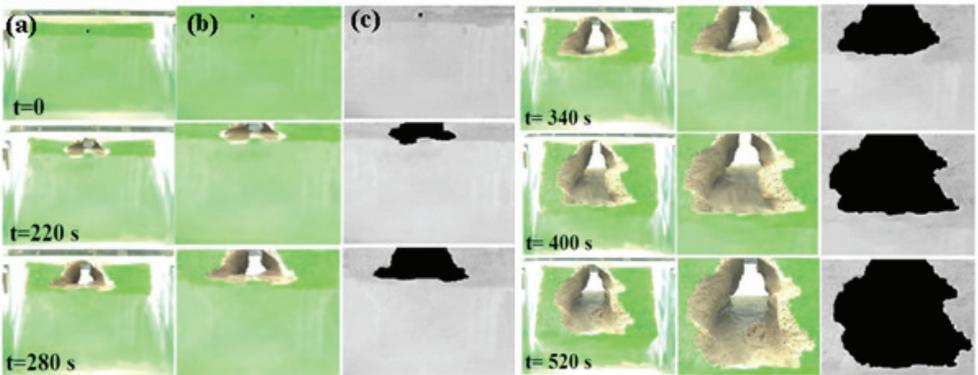
Figure 16. Time dependent image processing using Matlab Colour Thresholder for upstream - HSV. a) Original picture from experiments. b) Cropped Image c) After Colour Thresholding for case 1

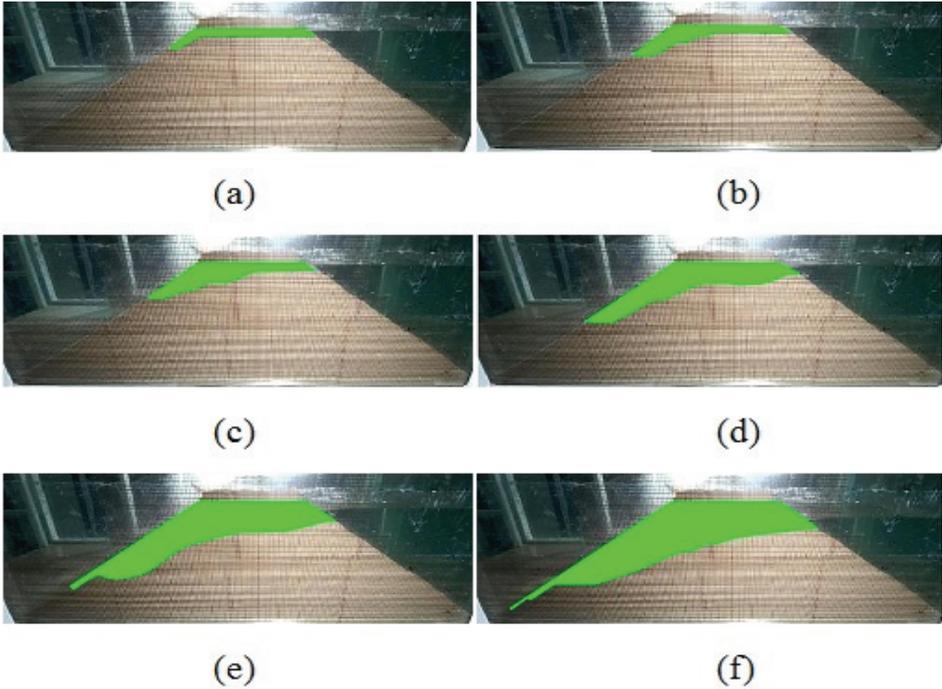
Figure 17 represents the evaluation of eroded lateral area at different time instants for the 2nd case.

Figure 17 - The evaluation of eroded side area at different time instants a) $t=10$ sec, b) $t=70$ s, c) $t=130$ sec, d) $t=190$ sec, e) $t=250$ sec, f) $t=310$ sec for case 2

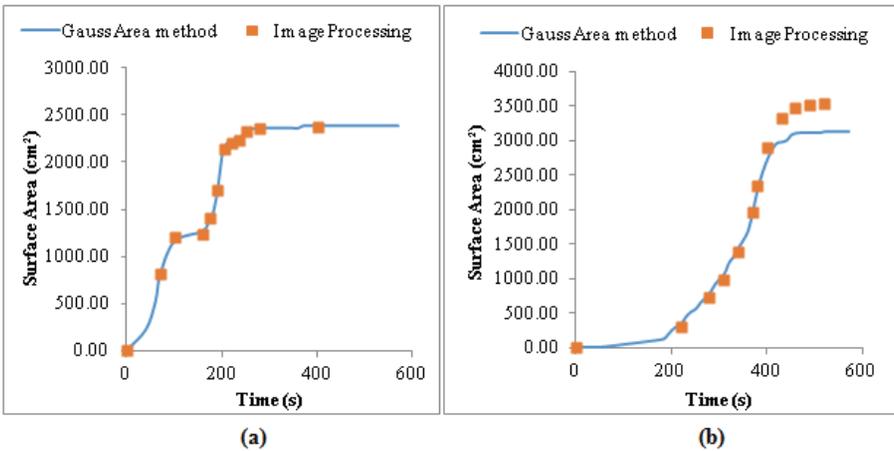
The calculated breach area values were compared with those obtained from the Gauss Area method (Figs. 18 and 19).

Figure 18 - Comparison of Gauss Area method and Image Processing results for case 1 a) at downstream b) at upstream

A very good agreement was found between the area values obtained from these two different approaches for both cases 1 and 2. Consequently, it was demonstrated that either of these approaches can be used to determine the time-dependent breach areas.

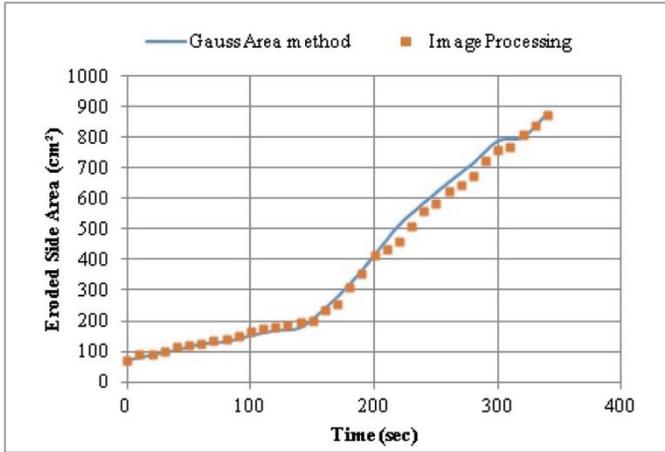
Figure 19 - Comparison of Gauss Area method and Image Processing results for the 2nd case

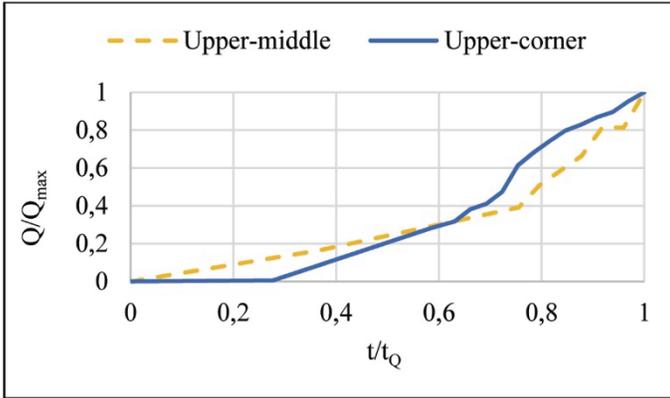
It was revealed that the dimensionless flow rates versus dimensionless time could be considered as two segment lines with two different slopes and two different stages, the first slope being smaller. The first stage lasted much longer in the 1st scenario.

Figure 20 - Dimensionless flow rates versus dimensionless times curves

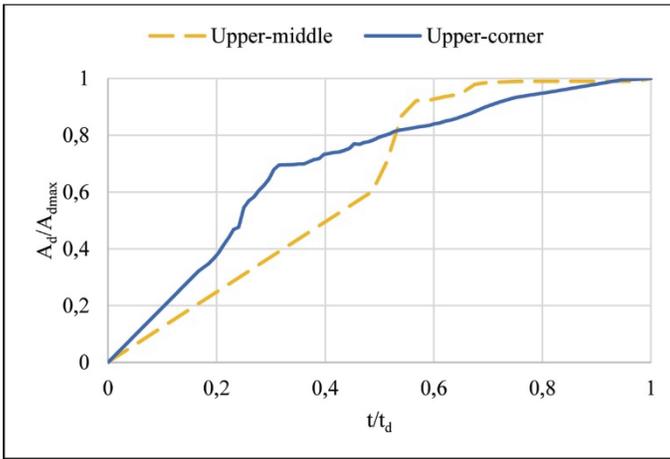
The dimensionless breach areas versus dimensionless time in the 2nd scenario could be approximated to two segment lines while in the 1st scenario the linear behavior appeared only in the first stage.

Figure 21 - Dimensionless breach areas at downstream versus dimensionless times curves

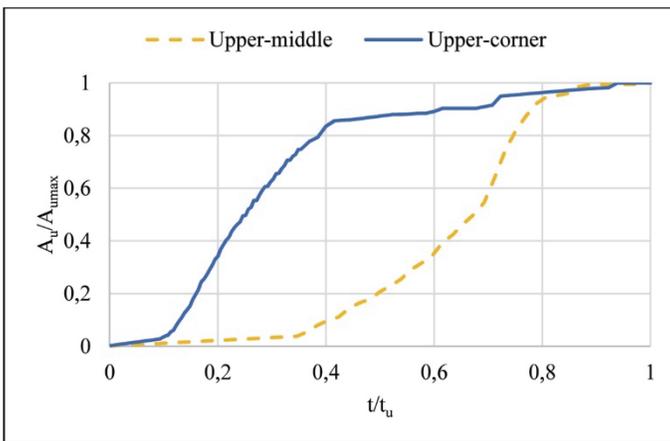
The tendency of the dimensionless curves at upstream were found to be very different in the 1st and 2nd scenarios. The evolution of the dimensionless breach areas was nearly exponential in the 1st scenario whereas the evolution can be considered as combination of the straight

Figure 22 - Dimensionless breach areas at upstream versus dimensionless times curves

lines when the seepage initiated at corner. Besides, the upstream breach area was significant when $t=0.4 t_u$ in the 2nd scenario while at this time the breach area was quite small and then increased significantly in the 1st scenario.

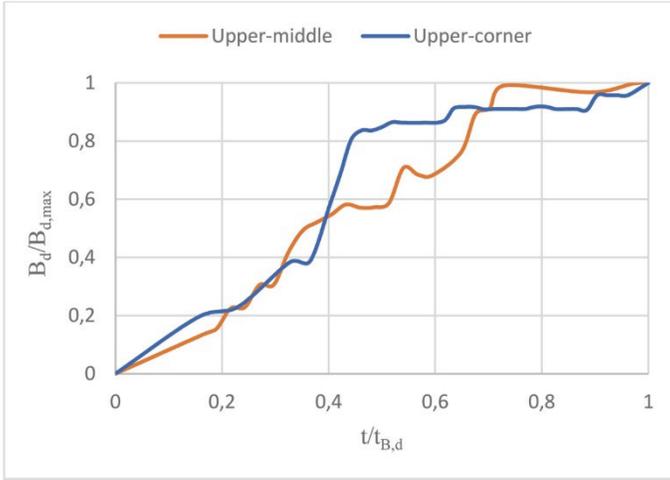
Figure 23 - Dimensionless breach widths at downstream versus dimensionless times curves

When $t= 0.50 t_{B,d}$ the breach width at downstream was almost $B_d= 0.85 B_{d,max}$ in the 2nd scenario, while $B_d= 0.58 B_{d,max}$ in the case of the 1st scenario.

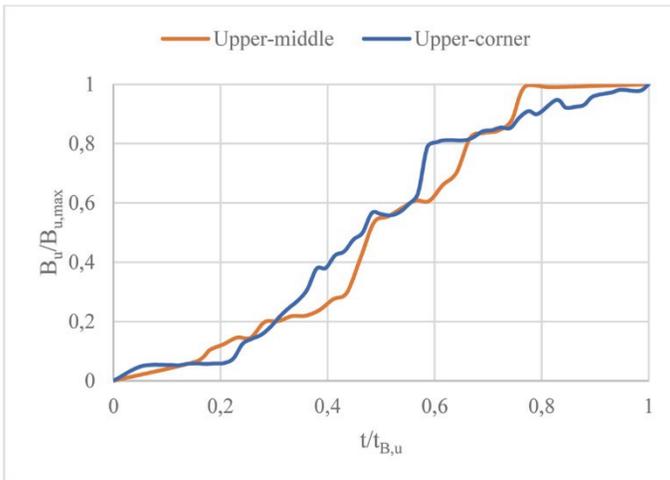
Figure 24 - Dimensionless breach widths at upstream versus dimensionless times curves

When $t= 0.50 t_{B,u}$ the breach width at upstream was approximately $B_u= 0.48 B_{u,max}$ in both cases. In the 2nd scenario, the dimensionless breach width developed continuously but in the 1st scenario there was no change in dimensionless breach width beyond $t= 0.76 t_{B,u}$.
