## Seismic Progressive Collapse Response of Older Reinforced Concrete Structures with Pre-Existing Column Cuts

Omar Abdulaziz Hassan\*<sup>1</sup>, Aydın DEMİR<sup>1</sup>

\*<sup>1</sup> Sakarya Üniversitesi Mühendislik Fakültesi İnşaat Mühendisliği, SAKARYA

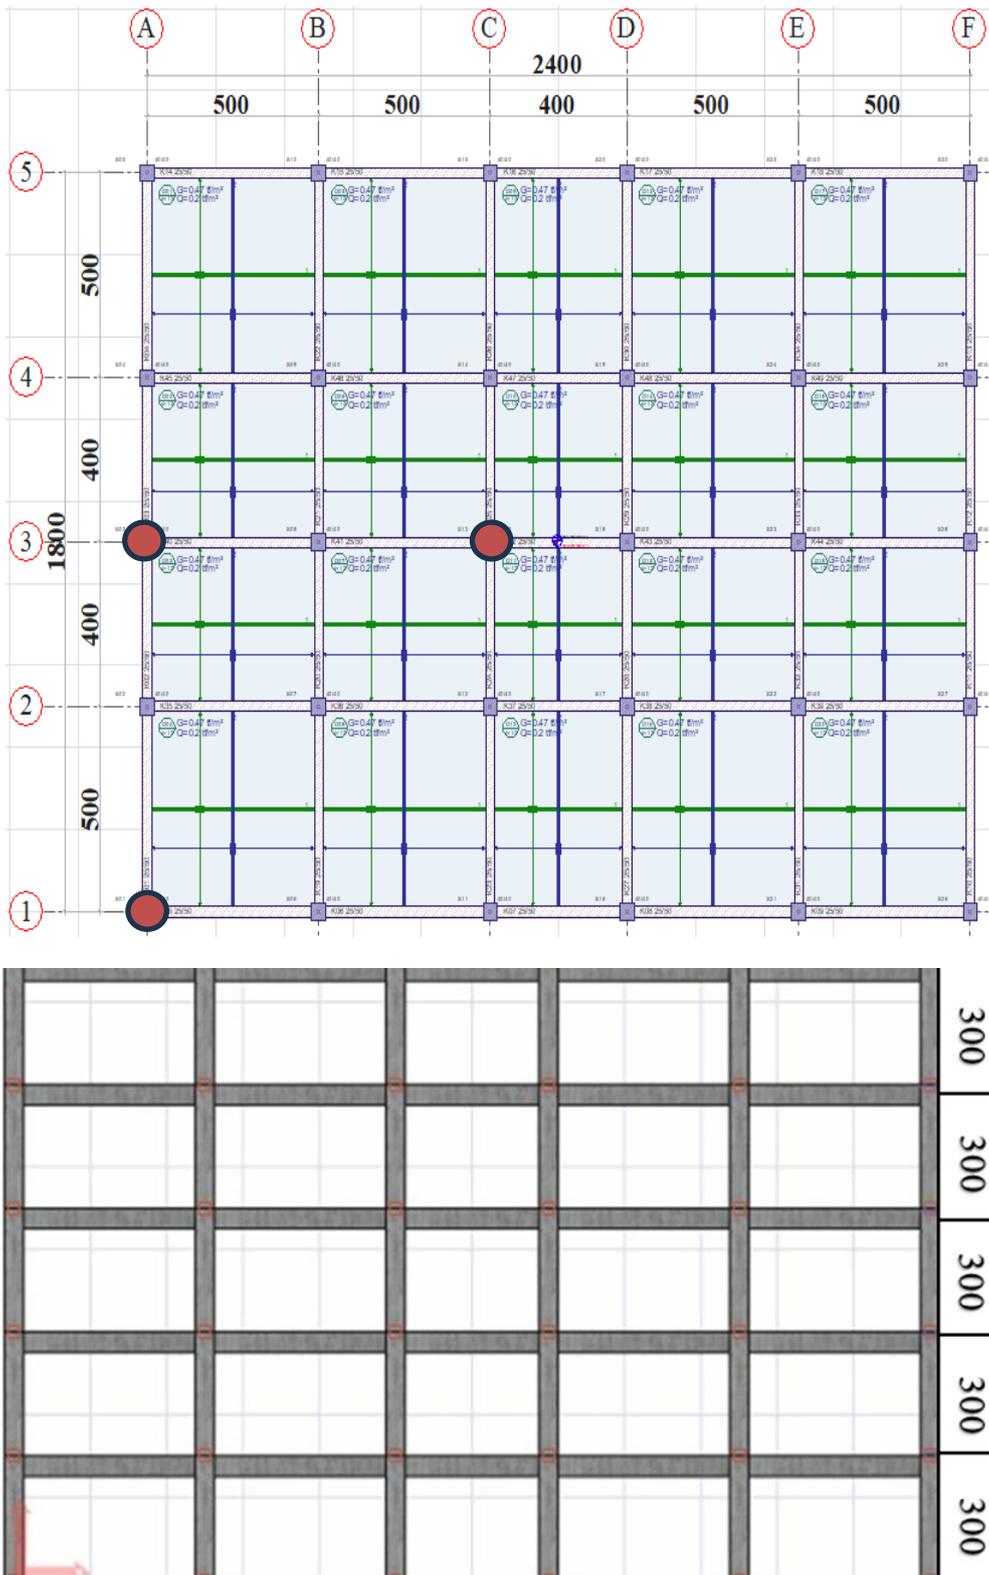
Figure 1. Building Plan (top) and elevation (bottom) views of the buildings (dimensions in cm)

Both structures will utilize C25 concrete with a characteristic compressive strength of 25 MPa, and S220-grade reinforcing steel, which has a yield strength of 220 MPa. The buildings will have overall dimensions of 18x24 meters. The shorter side will be divided into four bays measuring 5m, 4m, 4m, and 5m, while the longer side will consist of five spans of 5m, 5m, 4m, 5m, and 5m. Each story will have a constant floor height of 3 meters. Architectural plans and elevations, including the layout of beams and columns, are provided in Figure 1 highlighting critical columns considered for removal in PC analysis.

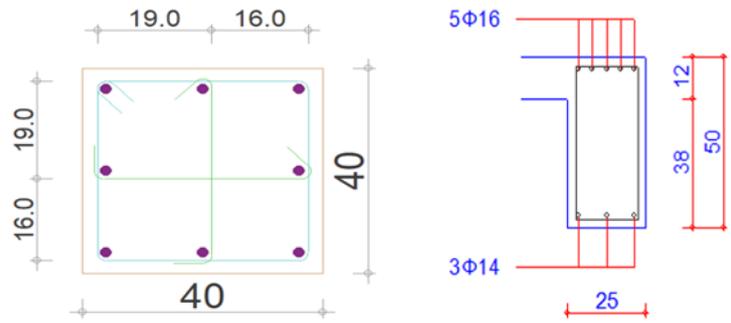
Figure 2. Sample Section Detail of Columns (left) and Beams (right)

For the 5-story building designed according to TEC-1975, columns will have a uniform cross-section of 40x40 cm, beams will measure 25x50 cm, and slabs will be 12 cm thick. According to TEC-1998, column dimensions will increase to 45x45 cm, while beams and slab thickness will remain unchanged. In the 10-story building, column sizes will vary. According to TEC-1975, the first four stories will have 50x50 cm columns, reducing to 45x45 cm for the 5th to 7th stories and 40x40 cm for the upper three stories. Beam sections will be 25x50 cm throughout, with a constant slab thickness of 12 cm. For TEC-1998, column dimensions will increase to 55x55 cm for the first four stories, 50x50 cm for the 5th to 7th stories, and 45x45 cm for the top floors. Beam sections will be enlarged to 30x50 cm, while slab thickness will remain at 12 cm. Figure 2 will provide sample cross-sectional details of columns and beams, and Table 1 will summarize geometrical and reinforcement details.

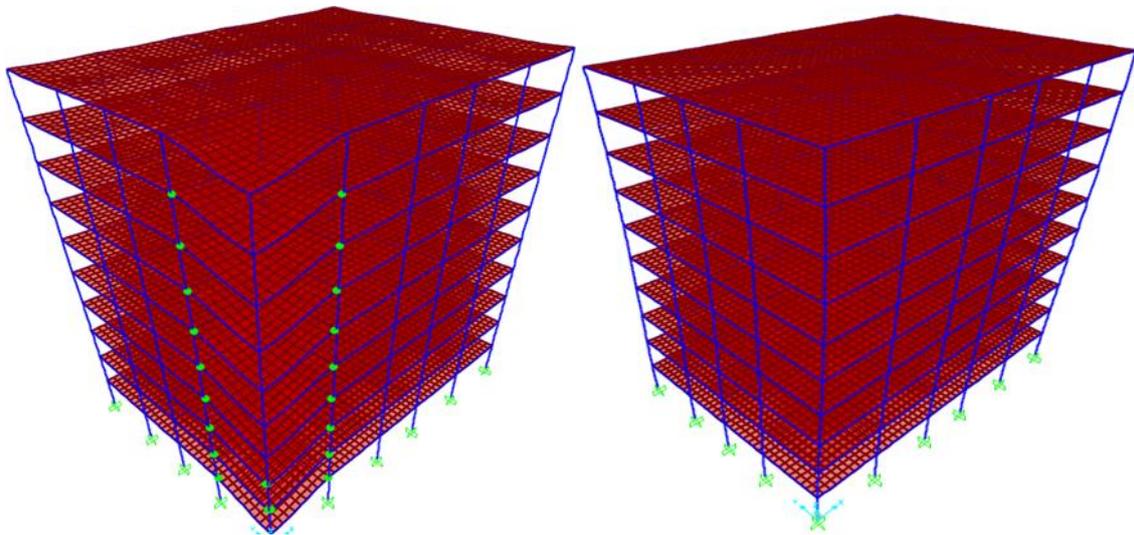
**Figure 3.** 3D illustration of column removal scenario before (left) and after (right) column removal

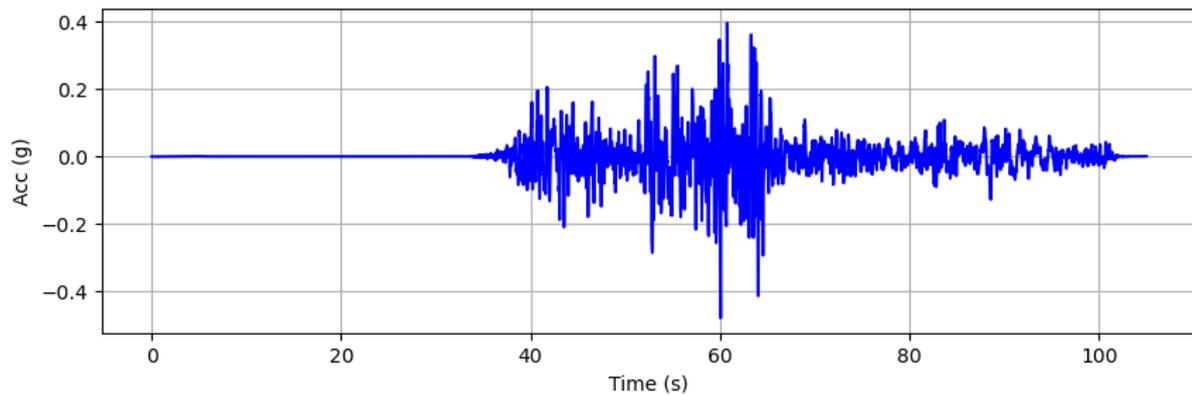
**Figure 4.** Acceleration time history (X-direction) from the 6 February 2023 Pazarlık earthquake

The ground motion data used in the analysis was obtained from the AFAD strong motion database [33]. Specifically, acceleration records from the Dulkadiroğlu district in Pazarlık (Kahramanmaraş) (Station Code: 4625) were utilized. This station recorded the mainshock of the 6 February 2023 Pazarlık earthquake (Mw 7.7). Located at 37.288°N, 37.043°E and approximately 8.6 km from the epicenter, it provided high quality near fault ground motion data. These acceleration time histories were downloaded from AFAD in processed form and used directly in the nonlinear time-history analysis. Figure 4 presents a sample acceleration time-history from the Pazarlık station in the X-direction.

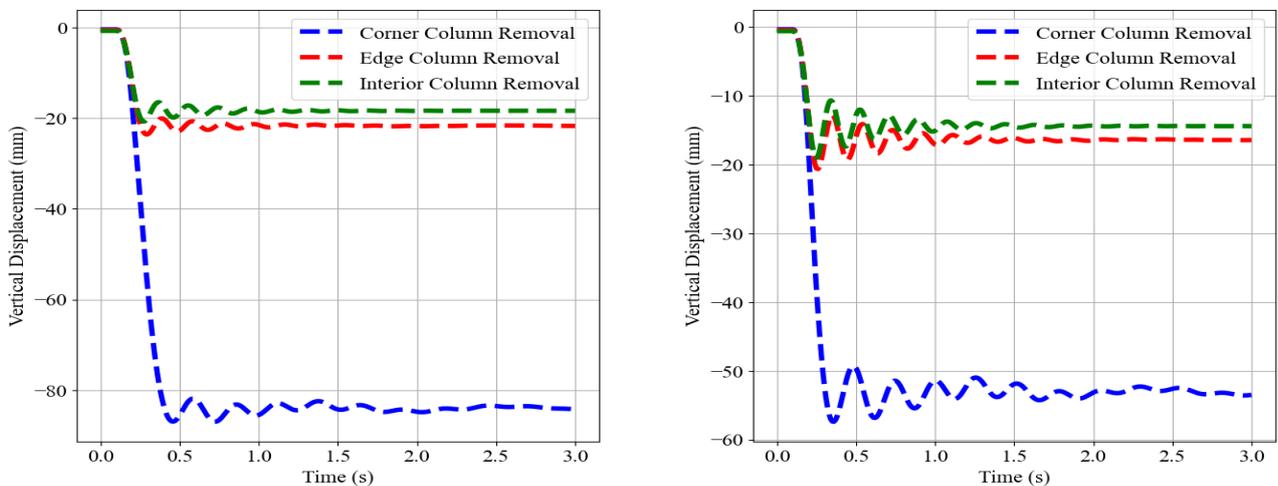
**Figure 5.** Vertical Displacement Time-history of the Node Above the Removed Columns for Different Column Removal Cases in the 5-story buildings —TEC-1975 (Left) and TEC-1998 (Right)

The time-history results for vertical displacement of the nodes above the removed column are illustrated in Figures 5-6, corresponding to various column removal cases. The PC analysis under gravity loads, as summarized in Table 3, highlights the structural vulnerabilities of older RC buildings in Kahramanmaraş, Türkiye, particularly in response to column removal. These findings support concerns raised after the Kahramanmaraş earthquakes that prior column cuts at the ground-floor significantly impact structural stability.

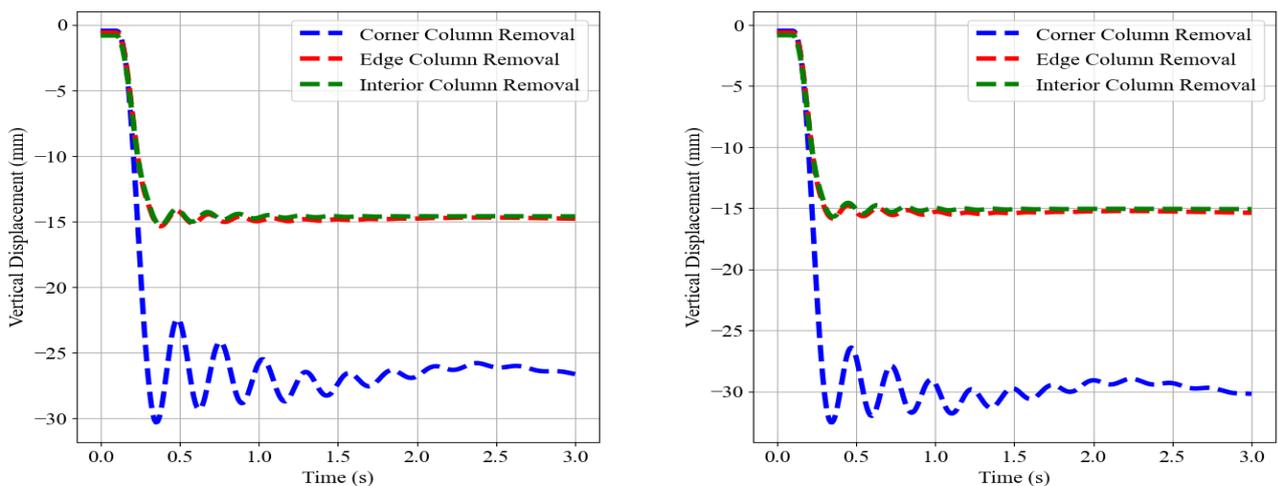
**Figure 6.** Vertical Displacement Time-history of the Node Above the Removed Columns for Different Column Removal Cases in the 10-story buildings —TEC-1975 (Left) and TEC-1998 (Right)

For the 10-story building, the performance patterns differed slightly. While TEC-1975 designs maintained structural integrity with no plastic damage observed in any column removal scenario, the TEC-1998 designs exhibited slightly higher maximum and residual displacements in all cases. In particular, under corner column removal, the TEC-1998 model experienced limited damage, in contrast to the TEC-1975 counterpart which remained within the no plastic damage range. This indicates that, despite the general trend of improved performance under newer code provisions, certain localized vulnerabilities, especially at exterior columns in taller buildings, may still lead to unfavorable outcomes under extreme damage conditions. The increased flexibility or redistribution patterns associated with later code provisions may contribute to this effect, underscoring the need for targeted design strategies in high-rise structures.

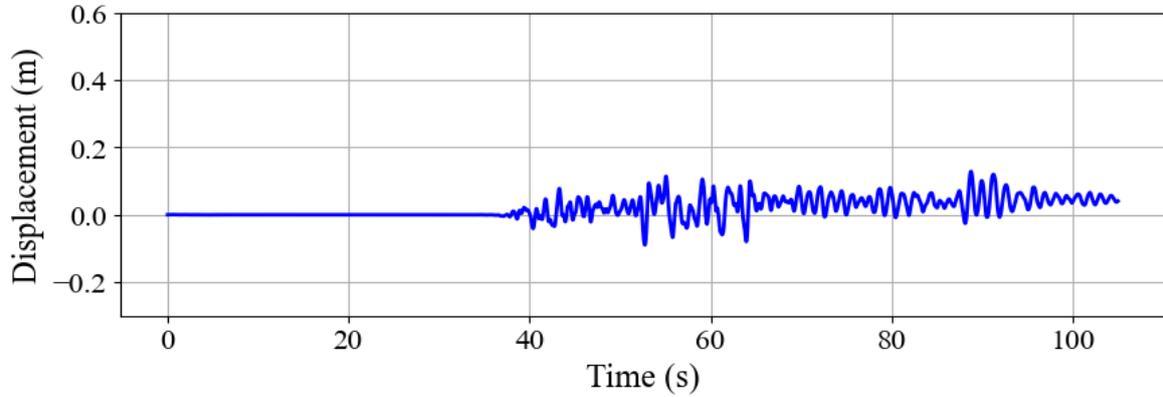
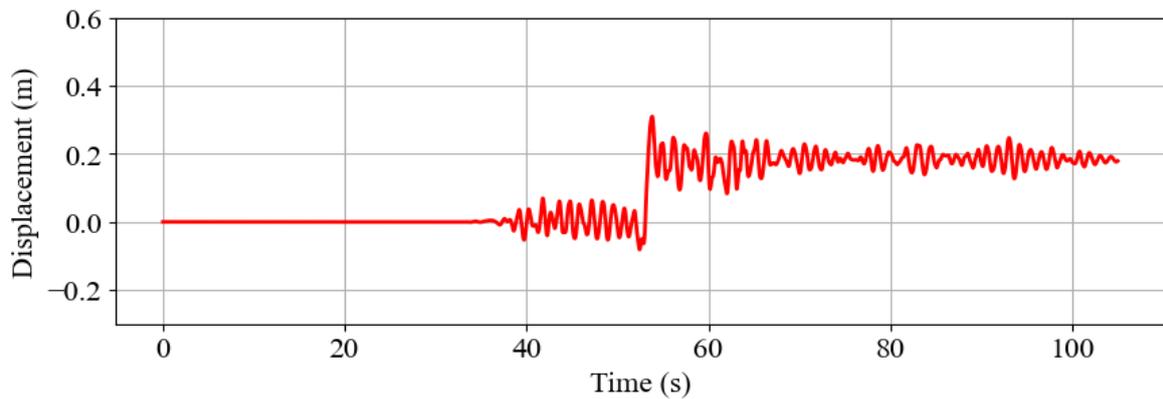
**Figure 7.** Top Displacement Time-history Curves of the 5-story buildings (TEC-1975): UX (a) and UY (b)

In Parallel with the gravity load analysis, a numerical assessment was conducted to evaluate the seismic vulnerability of the structures under a simulated earthquake, consistent with the seismicity of Kahramanmaraş. The top displacement time-history curves, presented in Figures 7-10, illustrate the structural response under a 7.7 magnitude seismic event. In this context, the "UX" and "UY" notations used in displacement plots refer to lateral displacements in the global X and Y directions, respectively, and represent how the structure responds to earthquake forces applied in orthogonal directions. These parameters are commonly used in finite element analysis to track roof-level drift during seismic loading.

Furthermore, as evidenced in figures 7, 8, 9, and 10, the top displacement time-history responses exhibit significant residual displacements, indicating permanent plastic deformations within the structural systems. These residual drifts align with hinge formation at critical joints and irreversible internal damage, confirming progressive structural deterioration during the seismic excitation. Such unrecoverable displacements are indicative of severe structural compromise and serve as clear evidence of irreversible damage. This dynamic response behavior not only confirms the critical performance deficiencies identified but also underscores the severity of the seismic-induced failure mechanisms observed in these buildings.

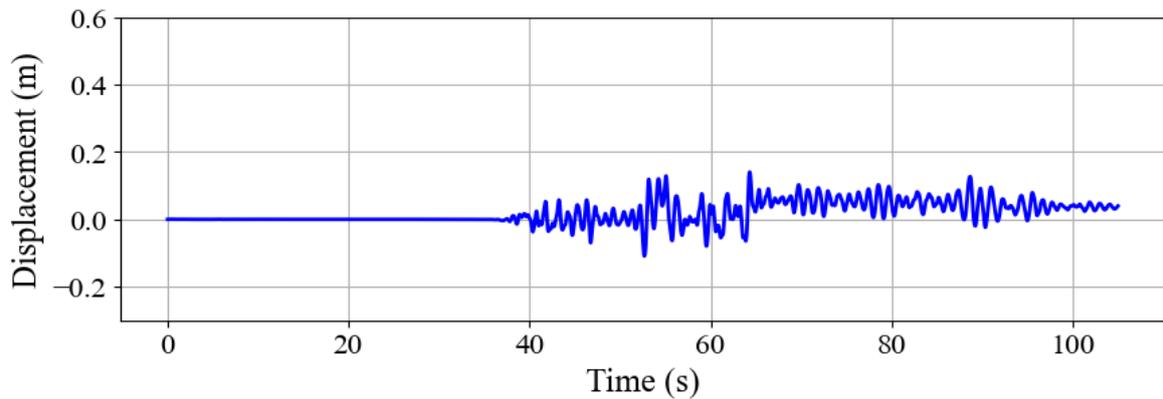
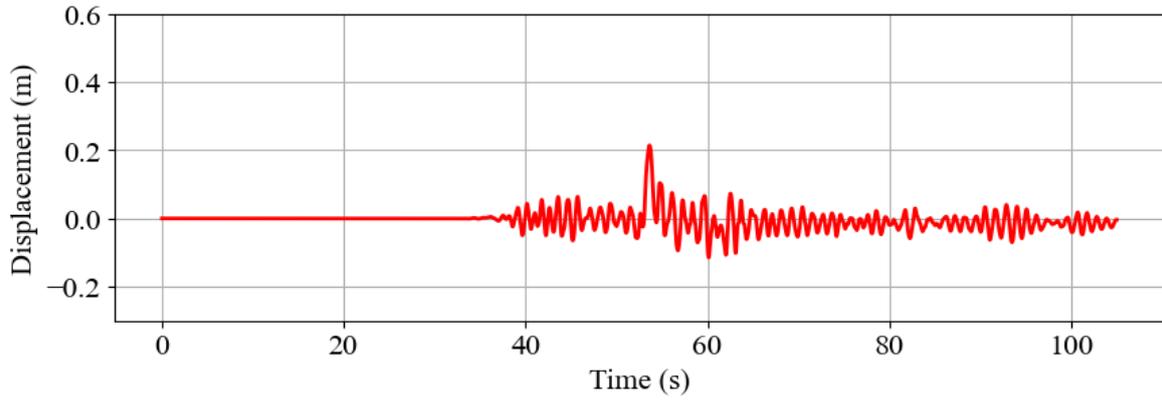
(b)  
**Figure 8.** Top Displacement Time-history Curves of the 5-story buildings (TEC-1998): UX (a) and UY (b)

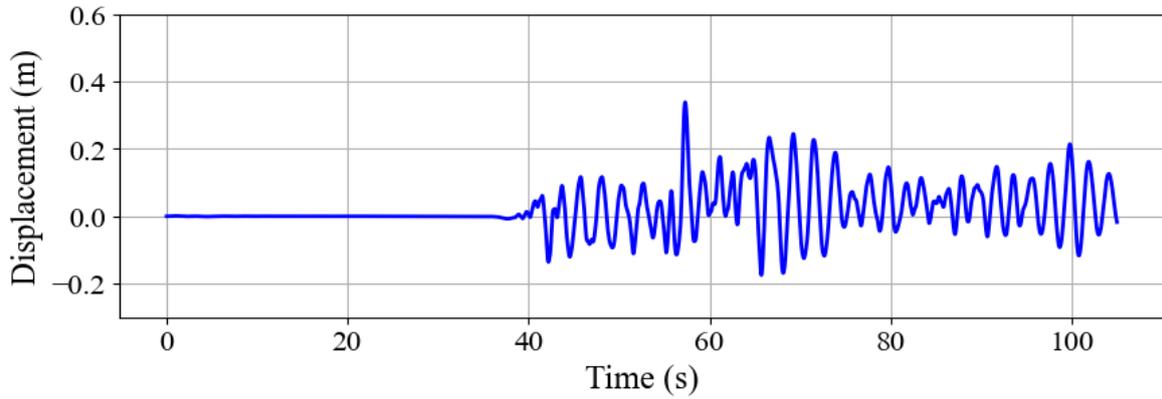
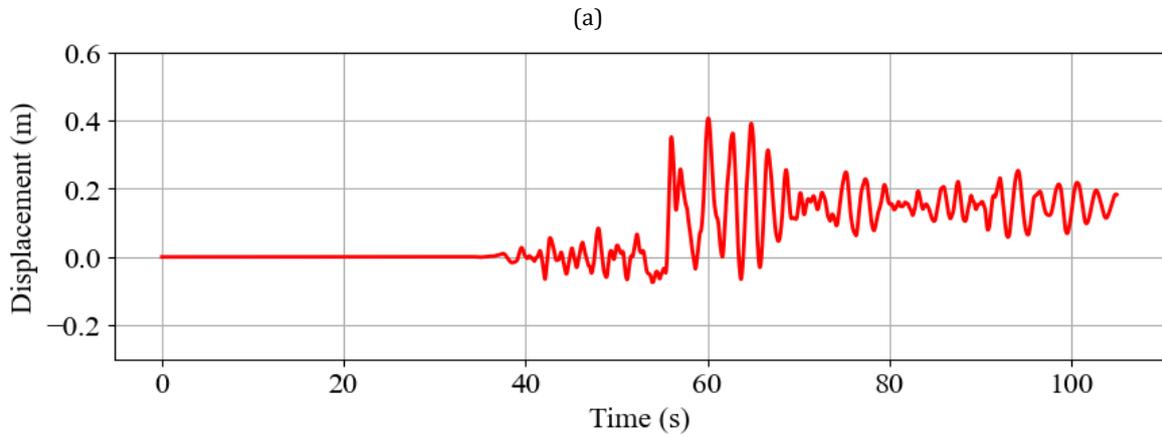
(b)  
**Figure 9.** Top Displacement Time-history Curves of the 10-story buildings (TEC-1975): UX (a) and UY (b)

The mid-rise building designed according to TEC-1975 exhibited substantial structural deficiencies when subjected to seismic forces. Specifically, 20 of the 30 ground-floor columns reached the Severe Damage Region, while the remaining 10 entered the Moderate Damage Region. According to TEC-2018 performance criteria, this level of damage was deemed excessive, leading to a classification of collapse.

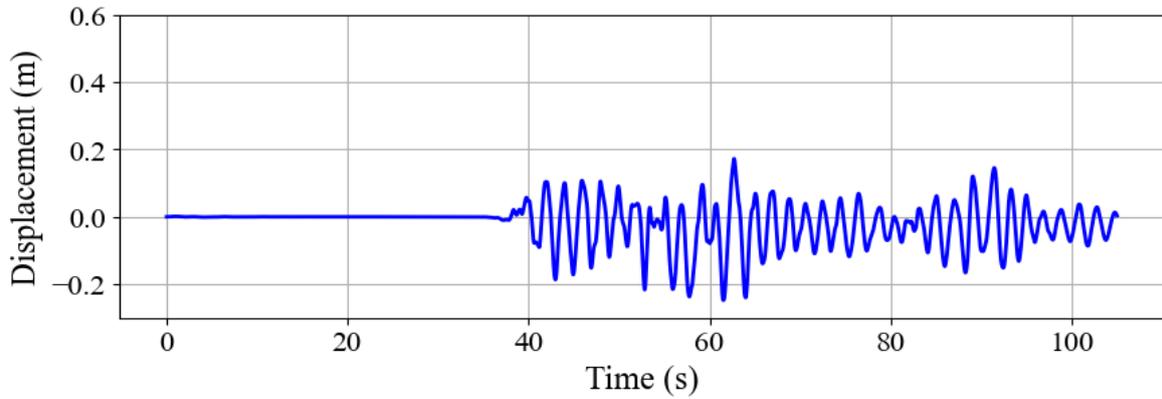
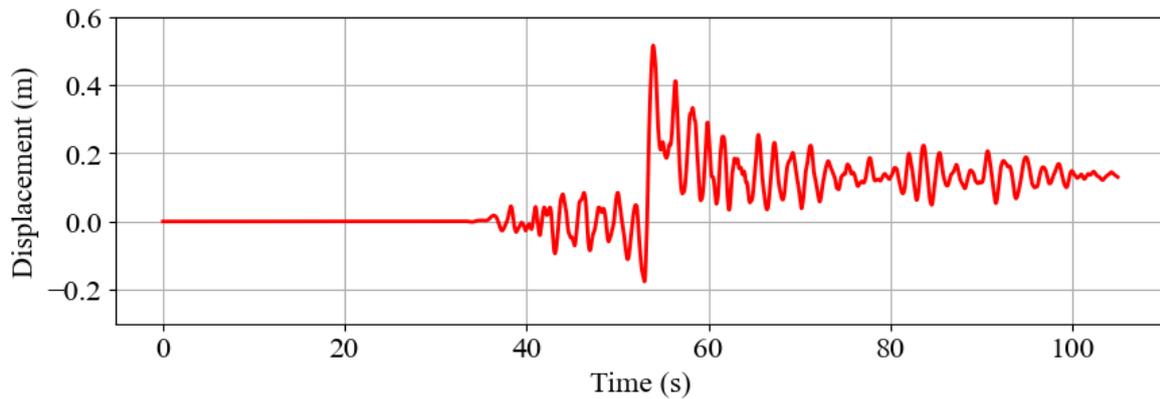
**Figure 10.** Top Displacement Time-history Curves of the 10-story buildings (TEC-1998): UX (a) and UY (b)
