On the Architectural Identity of a Lost Soap Factory on Cunda Island: An Analysis in the Light of Excavation Data and Visual Documents

Hasan UÇAR

Zeynep ÖZKAN TEKNECI

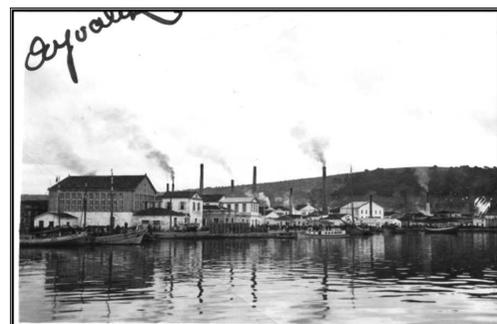
Image 1.

Layout of factories in the urban plan of Ayvalık (Akin B., 2015)

From the second half of the 19th century onward, in addition to the small-scale workshops producing soap, large factories combining soap and olive oil production were established in Ayvalık (Image 1). These factories were typically two to four stories high, rectangular in plan, and included various workshops and units, either attached to the main structure or located separately within the same courtyard. Powered by steam, the olive oil and soap factories were distinguished by their tall, cylindrical smokestacks constructed entirely of brick, which became a prominent feature of the city's skyline (Akin B., 2015, pp. 223–224).

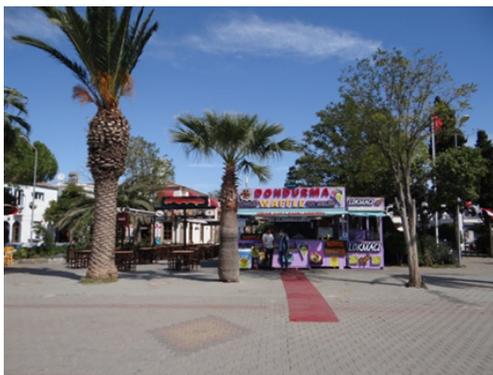
Image 2.

Parcel 1, Block 1079, prior to the excavation works

The building is located in Balıkesir Province, Ayvalık District, Mithat Paşa Neighborhood (Cunda), at map section 41, block 1079, parcel 1, within the area designated as green space in the Ayvalık Conservation Plan dated January 22, 1984. The structure, which was damaged in the 1944 earthquake and subsequently entered into a process of accelerated demolition, is understood to have completely disappeared by the early second half of the twentieth century. In relation to its reconstruction, an application was submitted to the relevant authorities by restoration architect Hasan Esen Suda. In this petition, it was noted that an old photograph showed a soap and olive oil factory on the parcel in question, and that the term 'sabunhane (soap factory)' also appeared in the title deed records. The request was made to conduct excavations on the parcel in order to uncover the existing walls and, following registration and restoration, to reintegrate into the city what is considered to be one of the known soap and olive oil factories on Cunda (Image 2).

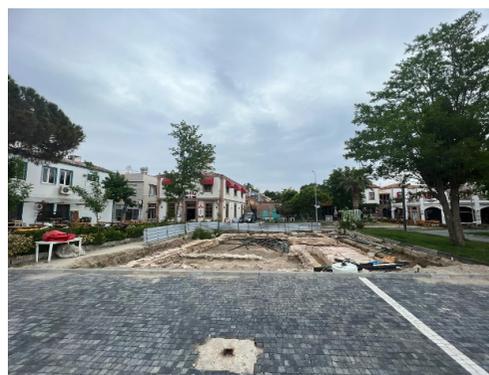
Image 3.

View of Parcel 1, Block 1079, after the excavation works (Etap3 İnşaat Proje Ltd. Şti)

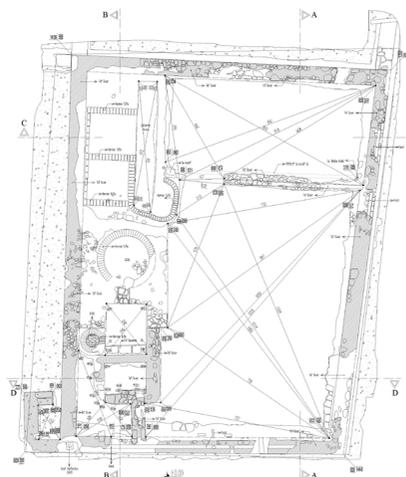
Figure 1.

Plan of the soap factory on Parcel 1, Block 1079 (Etap3 İnşaat Proje Ltd. Şti.)

Based on the excavation foundation trace and research excavation report prepared by S. Alaca and F. Gürboğa, dated March 8, 2023, excavation works were carried out on Parcel 1, Block 1079, Sheet 41, covering an area of 187.87 square meters. The excavations began on February 7, 2023, and were completed on February 16, 2023. As stated in the excavation report, foundation remains with a nearly square rectangular plan oriented north-south were uncovered (Image 3). The west wall measured 15.46 m, the east wall 14.91 m, the north wall 12.60 m, and the south wall 12.90 m in length, with all walls having a thickness of 60 cm. The wall remains were constructed using rubble masonry technique with stone material, and traces on the wall surfaces indicated the use of wooden beams. As a result of the excavations, the architectural elements within the space conclusively revealed that the structure functioned as a commercial building serving as a soap factory (Figure 1).

In the foundation trace investigations carried out in the area, the southern wall measuring 12.90 m, the eastern wall measuring 14.91 m, the western wall measuring 15.46 m, and the northern wall measuring 11.87 m, together with the foundation remains of the smokestack located on the eastern side of the structure and elements such as a pool, confirmed with certainty that this building functioned as a soap factory (Alaca & Gürboğa, 2023, p. 13).

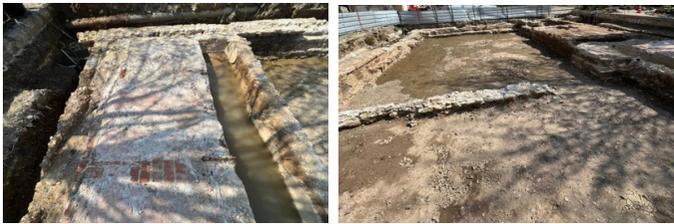
Image 4.

The structural elements that formed the essential components of the soap factory, such as the basin and hearth, were located adjacent to the eastern wall. For this reason, the eastern façade was left blind. Based on the surviving traces, these units appear to have formed three adjoining groups. To the south, a basin measuring 4.81 × 0.71 m, with a depth varying between 29 and 47 cm, was uncovered. The interior was plastered with lime, and the ends were rounded. On the opposite side of the basin, a surface paved with stone and lime mortar was identified, divided into three sections by two rows of solid bricks (Image 4). It is likely that workshops, which have not survived to the present day, once stood here. Immediately to the west of the basin, a stone trough was uncovered. The water connection to this trough was provided by a channel consisting of terracotta pipes placed on a rubble-stone platform bonded with lime mortar and aligned in an east–west direction. These pipes, however, are now deformed (Image 4).

View of the basin (left); water channel oriented east-west (right) (Etap3 İnşaat Proje Ltd. Şti.)

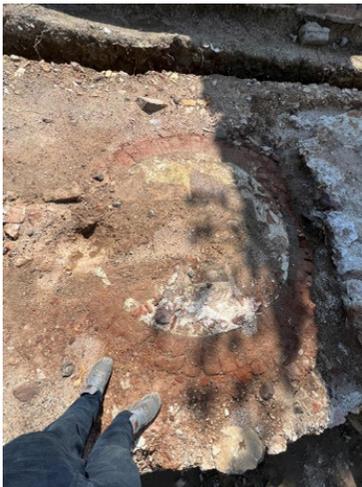
Image 5.

On the eastern side, the foundational trace of a hearth likely the base where the cauldron was placed was uncovered on a rubble masonry podium 70 cm high. It was enclosed by double rows of bricks and set on a stone-paved floor. Circular traces were identified within a square area, indicating that the hearth opening faced north (Image 5).

Traces of the hearth base (Etap3 İnşaat Proje Ltd. Şti.)

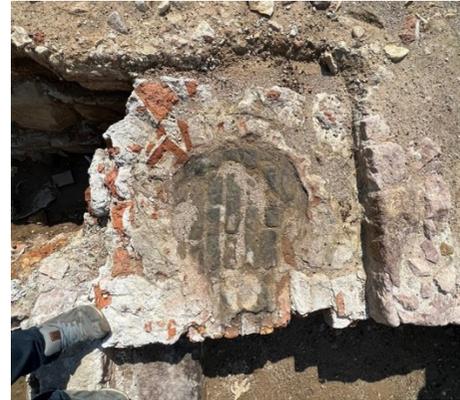
Image 6.

In the northern area, walls extending in different directions and the channels between them are particularly noteworthy. Another striking feature in this area is the trace of a second hearth or smokestack located at the same level as the other hearth and adjoining the eastern wall. Within an approximately square-plan area, a circular hearth with a diameter of 1 m, constructed with two rows of bricks, was identified, with a small portion of its opening facing west (Image 6). In their detailed excavation report, S. Alaca and F. Gürboğa noted that this hearth was likely a later ad-

Remains of the secondary hearth adjoining the eastern wall (Etap3 İnşaat Proje Ltd. Şti.)

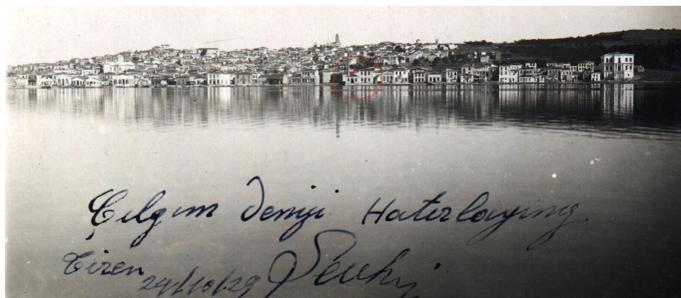
Image 7.

Photograph dated 1929 (Gülmez, p.8)

out at the corners of Parcel 1, Block 1079, a restitution proposal had previously been developed, taking into account the smokestack visible in a 1929 photograph included in the registration form, which appeared behind two buildings, one consisting of a ground floor and the other of a ground and first floor (Image 7). However, the data obtained from the comprehensive excavations conducted across the entire parcel in 2023 rendered this proposal invalid. It was understood that the building with a smokestack, identified as an oil mill and soap factory prior to the 1944 earthquake and which played a significant role in the registration of the site, was not related to the structure revealed in the excavations. The building with the smokestack in question was found to be located at a greater distance from the excavated structure. While the old photograph shows the smokestack on the western side of the building, the smokestack and furnace remains identified in the excavation area were located on the eastern side. Consequently, the archaeological data demonstrated that the building with the smokestack visible in the 1929 photograph actually belonged to a different oil mill. In this respect, it was concluded that the registration form should be updated and that this issue must be taken into account in restitution and reconstruction studies. (Alaca & Gürboğa, 2023, pp. 9- 12).

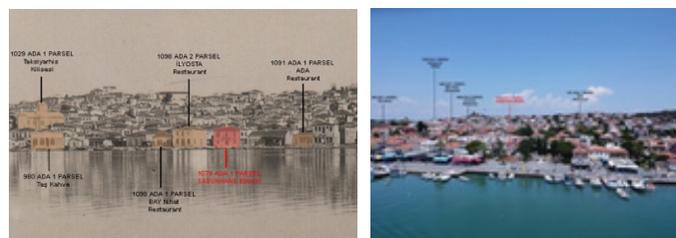
Image 8.

The location of the rectangular-plan building uncovered through the excavations was evaluated by comparing it with a photograph taken from approximately the same angle as the 1929 photograph (Image 8). In both photographs, the surviving buildings that have remained intact to the present day were cross-referenced, and as a result of this comparison, the position of the soap factory could be clearly identified in the 1929 photograph as well as in an earlier postcard (Image 9).

Soap factory and its surroundings in a 1929 photograph (left, detail from Image 7); pre-excavation view (right, Etap3 İnşaat Proje Ltd. Şti)

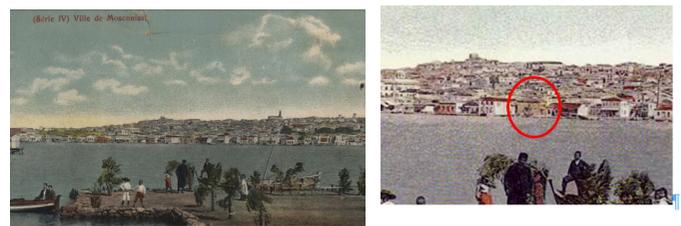
Image 9.

Postcard depicting Cunda from Tavuk Island (left); detail of the postcard (right) (Wikimedia Commons, retrieved September 19, 2025)

The exact construction date of the factory, which is understood to have been standing before 1929, is not definitively known. A postcard image taken from approximately the same angle as the 1929 photograph contributes to the documentation of the building. A detailed comparison of the two images reveals no significant differences between them. It is generally accepted that the use of postcards in the Ottoman Empire became widespread after 1895 (Öztunç, 2020, p. 545). The postcard depicting Cunda from Tavuk Island dates to 1906 (Image 9). The black-and-white photograph, on the other hand, bears a note from 1929, suggesting that it was likely taken shortly before this date. The bricks uncovered during the excavations, believed to belong to the smokestack, exhibit similarities with those used in the surviving factory smokestacks and hearth structures of soap factories in Ayvalık and its surroundings, and they qualify as industrial bricks. This type of brick began to be produced intensively in Europe, particularly after the 1840s, with the widespread use of mechanical brick machines. Comparable examples were also manufactured in Ottoman territories during the nineteenth century, with production peaking in the last quarter of the century (Mutlu & Başaran Mutlu, 2020, p. 71).

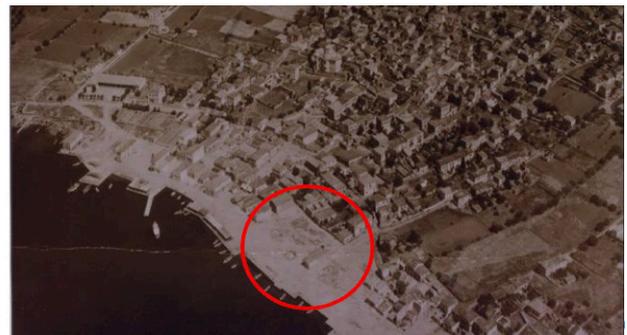
Image 10.

Aerial photograph taken after the earthquake (Gülmez, p. 8)

Based on this information, it can be suggested that the soap factory was constructed between the second half of the nineteenth century and the early twentieth century. The available evidence indicates that the building was largely damaged during the 1944 earthquake. Furthermore, an aerial photograph from the 1960s shows that the soap factory, along with the surrounding buildings, had completely disappeared (Image 10).

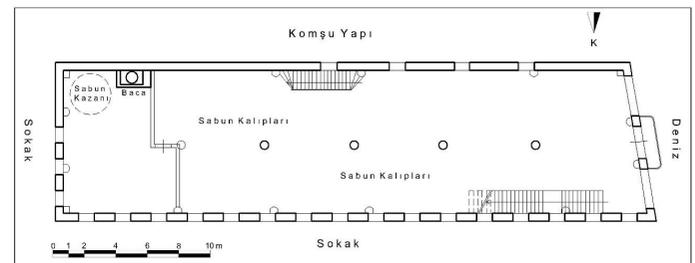
Figure 2.

Soap factories were most commonly built as two-story structures. For instance, the Erman Soap Factory in Ayvalık has a rectangular plan (Figure 2). However, its seafront façade is irregular due to the position of the parcel. The building contains entrance openings on both the street and seafront façades. On the ground floor, the soap cauldron and furnace are located in the corner of the building, while the upper floor served as the soap casting hall, where a greater number of openings were provided (Çiftyürek, 2021, p. 75; Çiftyürek & İnce 2023, pp. 156-161).

The plan of the Erman Soap Factory in Ayvalık (Çiftyürek 2021)

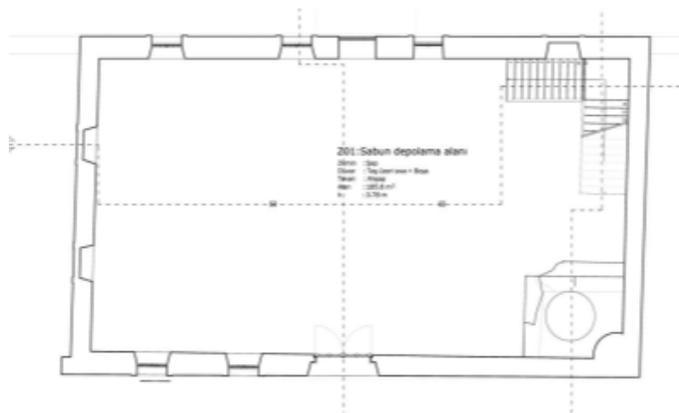
Figure 3.

The Hüsnü Tolun Soap Factory in Burhaniye also has a rectangular plan (Figure 3). Due to its location within a larger courtyard, the entrances are placed along the longer sides of the building. The soap cauldron is located in the corner. The upper floor served as the casting hall, where the number of window openings was greater compared to the ground floor (Akın D., 2014, pp. 30–31).

Ground floor plan of the Hüsnü Tolun Soap Factory in Burhaniye (Akin, D., 2014)

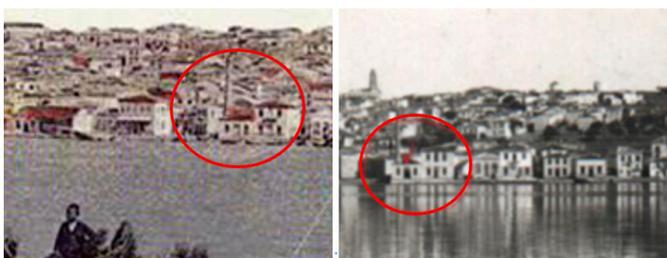
Image 11.

Although it has not survived to the present day, another olive oil mill–soap factory complex located in Cunda clearly reflected the regional plan typology, as seen in an old photograph. This building, oriented along the north–south axis, was designed with a rectangular plan and consisted of two stories (Image 11).

View of the olive oil mill–soap factory located further east in Cunda (detail from Image 7 and 9)

tent with the examples discussed above. The same roof form can also be observed in many houses on Cunda Island. Furthermore, the same photograph reveals that another olive oil–soap factory complex, situated to the east and likewise no longer extant, had its olive oil mill section also covered with a hipped roof.

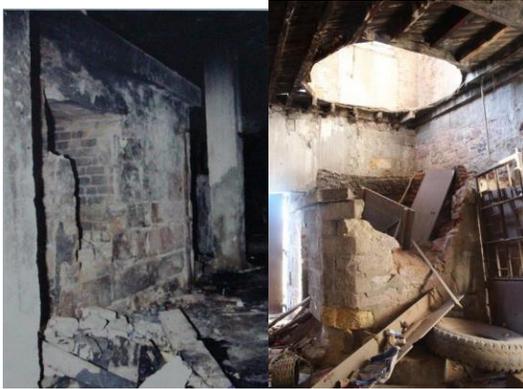
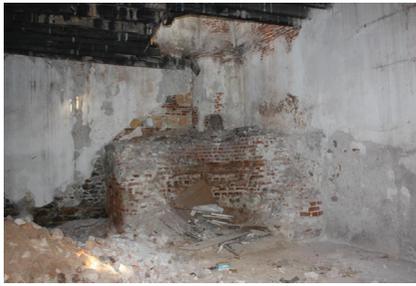
Image 12.

Analysis of soap factory plans demonstrates that no standardized location existed for the furnaces supporting the cauldrons. Constructed of either brick or stone, the furnaces were most frequently placed along the side walls or at the corners (Image 12). For instance, in the Fazıl Doğan Soap Factory in Ayvalık, the Eminzade Soap Factory in Havran, and the Küçükkuşu Burnaz Soap Factory in Ayvacık, double furnaces were positioned along the narrow side; in the Ali Rıza Karagözoğlu Soap Factory in Edremit, the Hüsnü Tolun Soap Factory in Burhaniye, the Ali Aday Soap Factory in Ayvalık, and the Yağcı Soap Factory in Burhaniye, they were located at the corners of the narrow side. In the Urla Soap Factory, however, the furnace was situated along the long side (Çiftyürek, 2021). As these examples illustrate, the brick furnace remains uncovered during the excavations in Parcel 1, Block 1079 exhibit similarities with the furnace placements observed in surrounding soap factories. In the reconstruction of the building, it is therefore of great importance to preserve the original architectural elements of the ground floor, particularly the pools, furnace, and channel located in the eastern section.

Examples of soap factory furnaces in the region (Akın, D., 2014; Çiftiyürek, 2021).

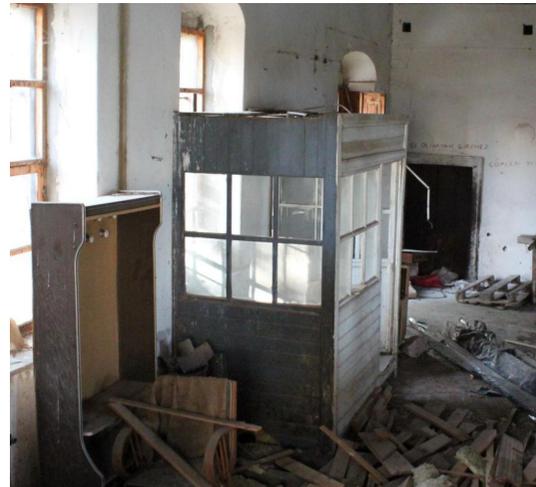
Image 14.

When examining examples of soap factories in the region, one of the significant elements encountered on the ground floor is the administrative office unit. The continuous functional transformations of soap factories over time have prevented the preservation of their interior layouts in their original form. Since only the foundation level of the building on Block 1079, Parcel 1 has survived, it is difficult to determine the precise location of the office section. However, based on nearby examples, it can be observed that offices were generally positioned to the right or left of the entrance on the street-facing façade (Image 14).

Office section of the Bademli Araser Olive Oil Factory (Akın, D., 2014)

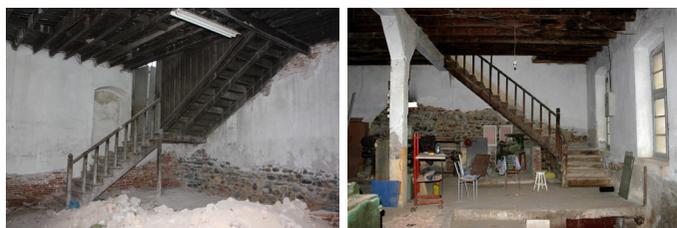
Image 15.

Examples of wooden staircases from soap factories in the region (Akin D., 2014; Acar Bilgin 2015)

In most soap factories, which were predominantly organized as ground floor plus one story, access to the upper floor, used as the soap casting and cutting area, was provided by a wooden stair-

case located on the ground floor (Image 15). The position of the wooden staircase typically varied depending on the placement of the cauldrons on the ground floor. Additionally, the location of the entrance openings also influenced the positioning of the staircase. When the entrances were located on the narrow façade, staircases were usually placed along the side walls, whereas when the entrance was on the long façade, the staircase was placed on the narrow side. Another consideration in staircase placement was to avoid creating excessive partitioning on the upper floor, which often led to positioning the staircase along the edges.

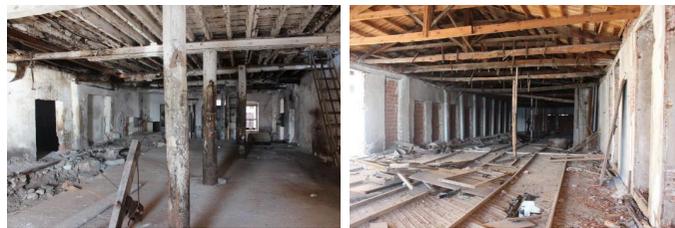
Image 16.

Ground floor of the Ertemler Olive Oil Factory and view from the first floor of its soap factory in Ayvalık (Çiftiyürek, 2021)

When examining soap factory buildings from the Ottoman and Early Republican periods, it is observed that the load-bearing walls were constructed using masonry techniques with stone or brick materials. The floors and ceilings of the upper stories were typically made of timber (Image 16). In almost all soap and olive oil factories, which were predominantly designed with rectangular plans, whenever the width exceeded approximately five meters, the wooden flooring of the upper story was frequently reinforced by a single row of support elements on the ground floor. By contrast, in the upper floors where the processes of soap casting, cutting, and drying were carried out, such vertical supports were rarely employed, so as not to obstruct the working space (Çiftiyürek, 2021, p. 253).

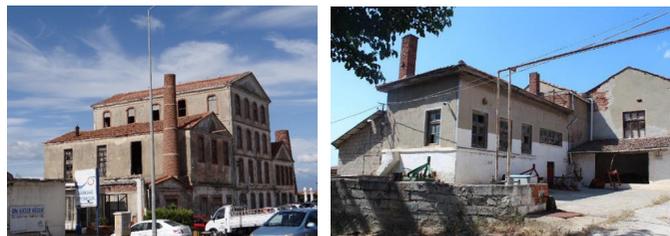
Image 17.

An examination of soap and olive oil factories reveals that these rectangular-plan structures were generally constructed with two distinct roof types (Image 17). The width of the building played a significant role in determining the roof form. The most common type was the gable roof, frequently employed in Ayvalık and its surroundings for commercial buildings. The gable form allowed for the creation of triangular pediments on the narrow façades of the building, thus imparting a neoclassical appearance to the exterior. The other type was the hipped roof, which is observed in certain examples. Notable cases of this latter type include the Hüsnü Pazarbaşı and Yağcı Soap Factories in Burhaniye, as well as the Ertemler, Fevzipaşa Neighborhood, Hulisi Zarplı, and Nusret Dervent factories in Ayvalık, along with the Gümüslü Eminzade complex (Çiftiyürek, 2021).

Madra Olive Oil and Soap Factory in Ayvalık (left); Halil İbrahim Selçuk Soap Factory in Pelitköy, Burhaniye (right, Çiftiyürek, 2021)

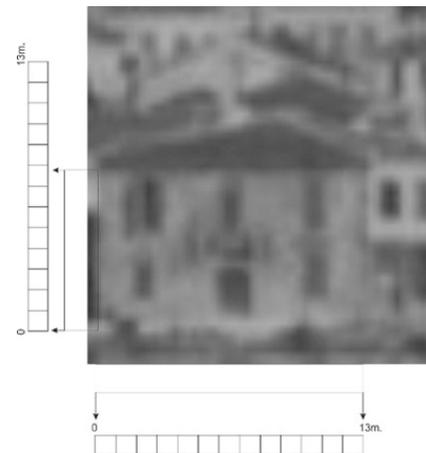
Image 18.

Scaled version of the photograph (Detail from Image 7)

The scaling indicates that the doorway of the building measured approximately 1.40–1.60 m in width and around 3.00 m in height, including the overdoor window. The calculations reveal that a proportional relationship of approximately 1:2 was maintained in the window openings. An examination of the façades of the surrounding buildings within the parcel, as well as comparable structures in Ayvalık, demonstrates that these proportions were consistently repeated and that the dimensions were strikingly similar (Image 19). In these examples, it is notable that the upper boundaries of door and window jambs terminate on the same horizontal line, and that overdoor windows were frequently placed above the doorways.

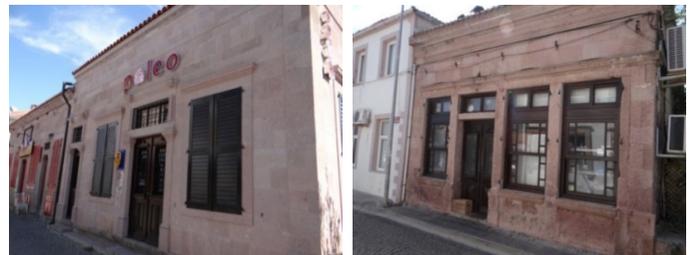
Image 19.

Examples of window designs with a 1:2 proportion from Cunda

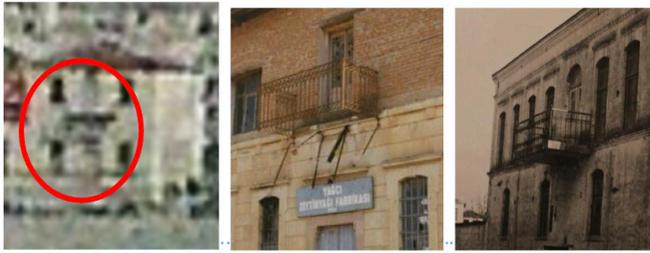
Image 20.

A soap factory located further east in the same postcard depicting Cunda, and examples of balconies from surrounding soap factories (Detail from Image 9; Akın, D., 2014; Çiftiyürek 2021)

The entrance opening located on the upper floor of the southern façade of the building indicates the presence of a balcony, which is clearly visible in the postcard. An examination of the surrounding buildings within the parcel shows that balconies were equipped with wrought-iron railings and supported by decorative iron consoles (Image 20). Comparable examples of wrought-iron balconies can also be observed in other soap factory buildings.

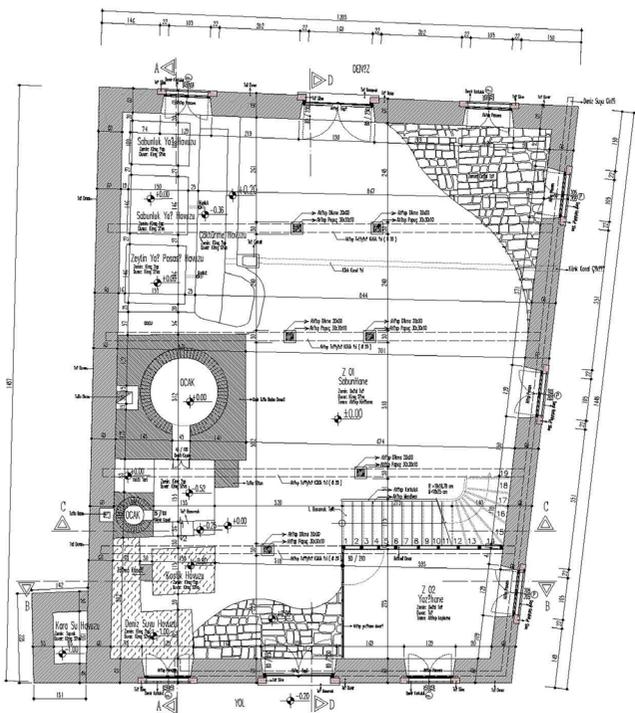
Figure 4.

The ground floor restitution plan of the soap factory (Etap3 İnşaat Proje Ltd. Şti)

Based on the available data, and considering together the excavation findings, historical photographs, and the surrounding soap factory structures, it may be inferred that the soap factory building under examination which has not survived to the present day was designed with a rectangular plan oriented along the north–south axis and consisted of a single story above the ground floor (Figures 4,5). On the east side of the ground floor, vat rooms containing smokestacks and boilers, as well as a wooden staircase providing access to the upper floor, were located. The north and south walls of the ground floor featured door openings and windows, while the west wall included only windows. The wooden flooring of the upper story was specifically designed for soap casting. While the eastern façade lacked openings, the other elevations followed a design similar to that of the ground floor. On the seaside façade, a balcony was also present. The building was reconstructed between 2024 and 2025 (Image 21).

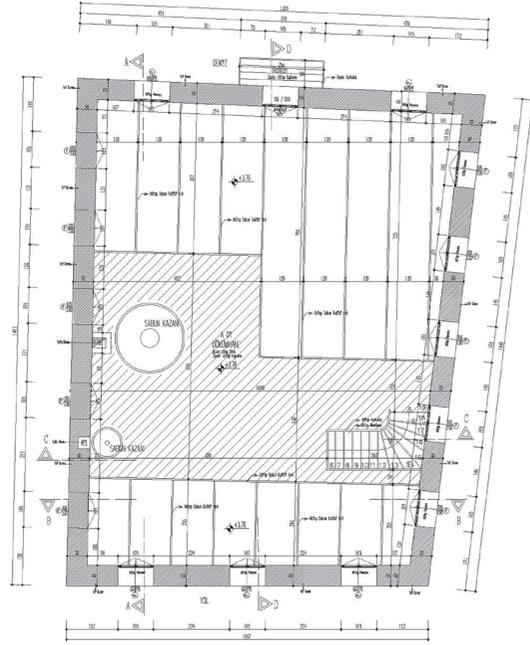
Figure 5.

The first-floor restitution plan of the soap factory (Etap3 İnşaat Proje Ltd. Şti)

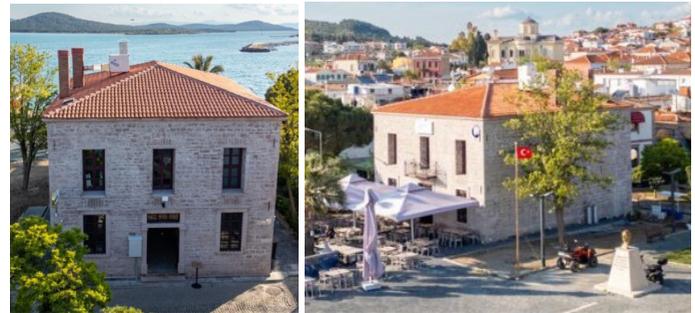
Image 21.

Present-day general view of the reconstructed soap factory, repurposed as restaurant. (Hanya Cunda Restaurant Official Website, Retrieved: September 19, 2025)
