## STRUCTURAL EVALUATION OF AN AIRCRAFT WING WITH A REPAIRED FRONT SPAR

**Abstract:** This article hypothesizes that the leading spar of an experimental aircraft wing is damaged, and that this damage will be repaired using different variations. The effect of these repairs on the wing's strength is investigated. Aircraft accidents and incidents caused by damage or cracks in the leading spar served as the basis for this study. 3D models of all repair variations were created, and mathematical mesh models were developed to examine the strength parameters generated using the finite element method. The von-Mises stress, shear stress, safety factor, and wingtip deformation in the repaired area of the leading spar were compared according to the repair variations to evaluate the wing's strength. Furthermore, the strength condition was also evaluated based on the damaged spar sector. During the evaluations, the strength parameters were examined using an undamaged wing as a reference.

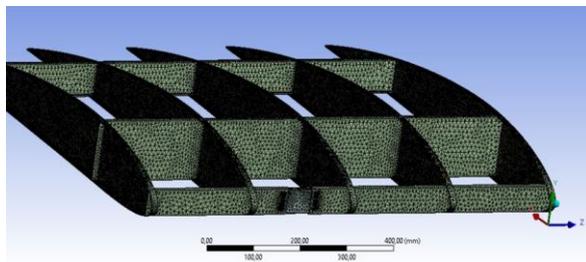
**Figure 2.** Mathematical mesh model of 5\*2+4 damaged and repaired wing.

Mathematical mesh models were created for all 3D repair models to calculate the wing's strength properties using the finite element method. A higher mesh density was used in the repair area to increase computational accuracy in that region. The 5\*2+4 model shown in Table

1 uses 461374 nodes and 224373 elements. The mathematical mesh model of the 5\*2+4 3D model is shown in Figure 2. Similar mathematical mesh models with similar mesh structures and numbers were also created for the other 3D models.
