# Performance Evaluation of A High Geomembrane Faced Rockfill Dam In Case of Liner Rupture and Earthquake Risks

Uğur Şafak Çavuş<sup>1</sup>, Murat Kilit<sup>2\*</sup>

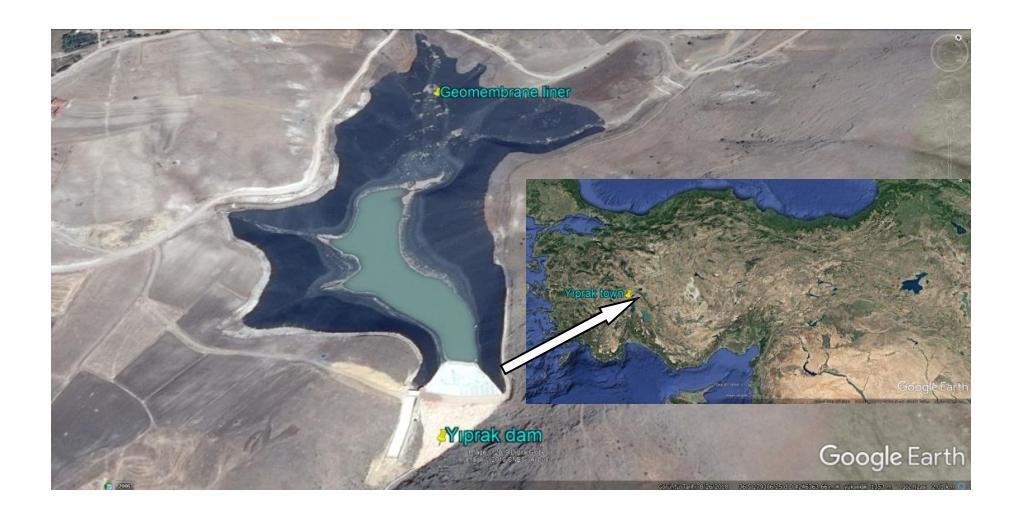
Fig.1. Google earth view showing Yiprak dam (Google Earth view).[9]

Yiprak dam located on 48 km far away Dinar province of Afyonkarahisar city in Turkey is an irrigation purposed high rockfill dam with large reservoir capacity see Fig.1[9]. Storage capacity is 875000 m<sup>3</sup> and maximum height of the dam is 31.5 m. Maximum cross section in the riverbed is also given in Fig.2. Since the bedrock is pervious in the reservoir site and also impervious clay core material is not available in the site, a geomembrane seepage barrier HDPE geomembrane liner overlain with a thin sand bedding layer on the rockfill was used to cover the upstream slope of the rockfill and pervious bedrocks see Fig.1[9].

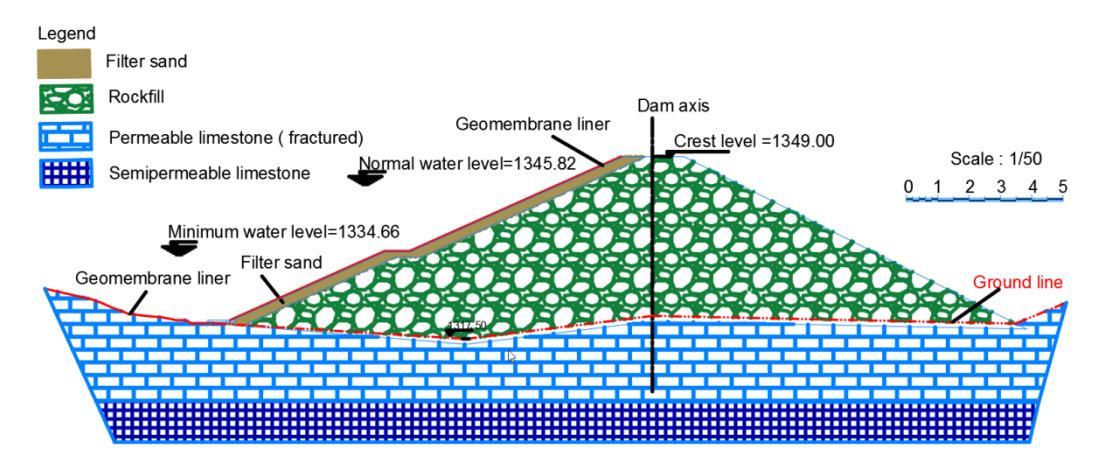
Fig. 2. Maximum dam cross section and bedrock foundation

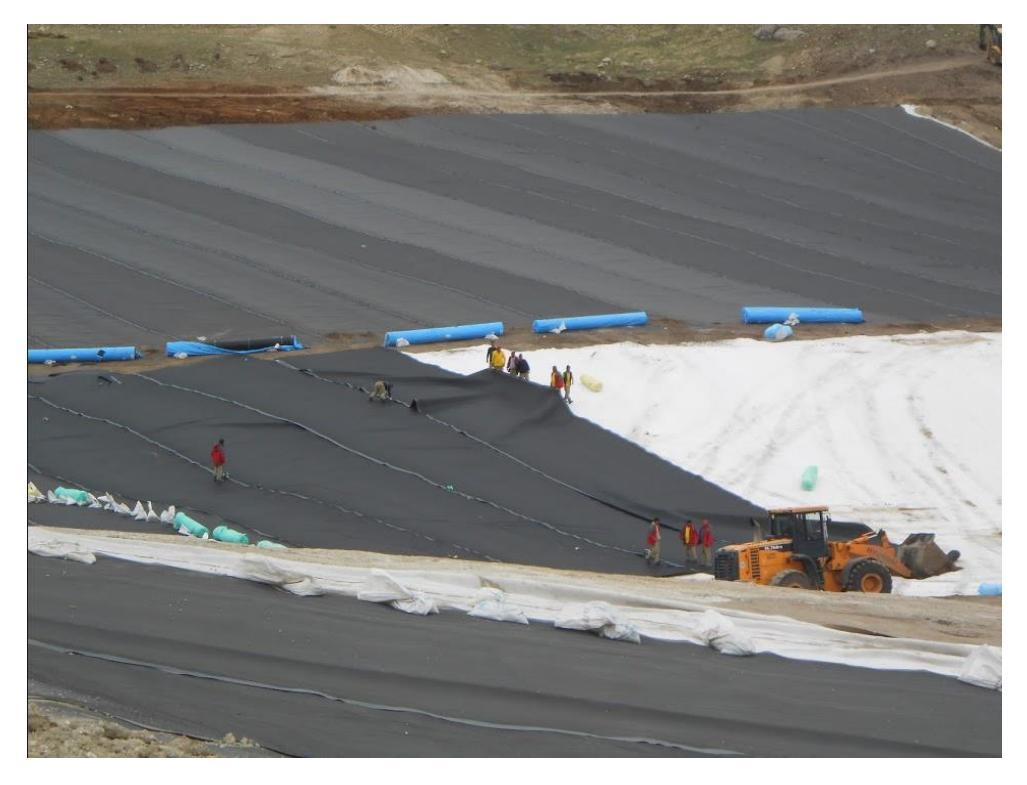
Fig. 3. A view showing reservoir lining for pervious bedrock

Structural geology of the dam site is composed of permeable limestone, conglomerate, tuff, consolidated clay and weathered marl with cracks due to tectonic movements. Strata of the rocks are almost horizontal. Mean RQD (rock quality designation) is evaluated as 58. Foundation alluvium beneath the dam is completely excavated. Cohesion and internal friction angle of the bedrock were estimated for the slope stability analyses from the literature by experience and evaluating site conditions such as RQD values, beddings and discontinuity situations etc [10,11]. Permeability of the bedrock was estimated according to the lugeon test results (wherein site lugeon value is mostly larger than 25 indicating the bedrock is highly permeable). Because the bedrock of reservoir and rockfill dam is pervious, both reservoir area and the embankment upstream face were decided to be covered by a geomembrane liner to prevent seepage flow (Fig. 3).

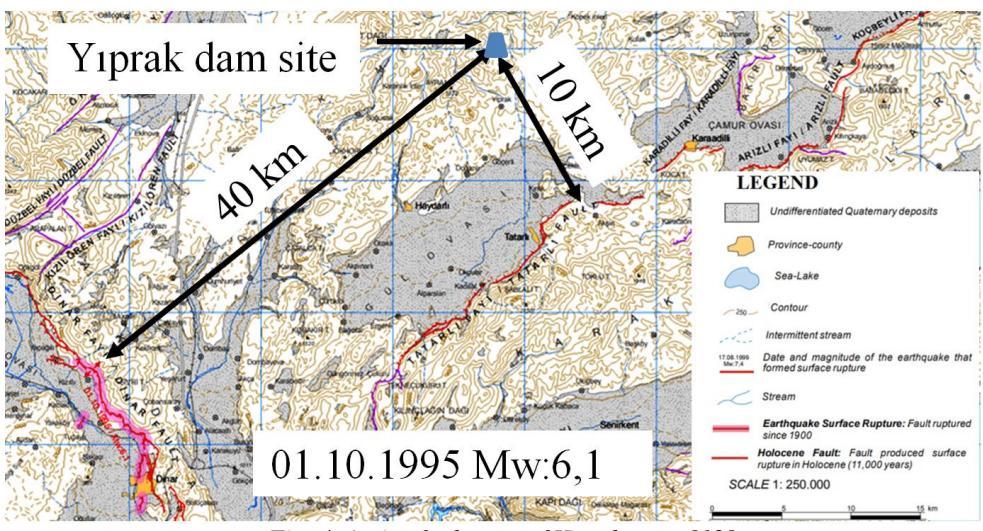
Fig. 4. Active fault map of Yiprak town [12]

Two active faults close to the Yiprak dam site are available in the region. One is called Tatarlı fault almost 10 km far away the location of the dam. The other is called Dinar fault almost 35 km far away the dam axis (Fig. 4)[12]. The maximum design earthquake (MDE) was selected equal to the Maximum credible earthquake (MCE) which is defined as an upper bound of an expected magnitude (Mw=6,1) for the site. An earthquake of such magnitude could produce 0.21g peak ground acceleration at the dam site calculated by using the attenuation curves produced by Gülkan and Kalkan [13] for Tatarlı fault which is just 10 km far away the dam site.

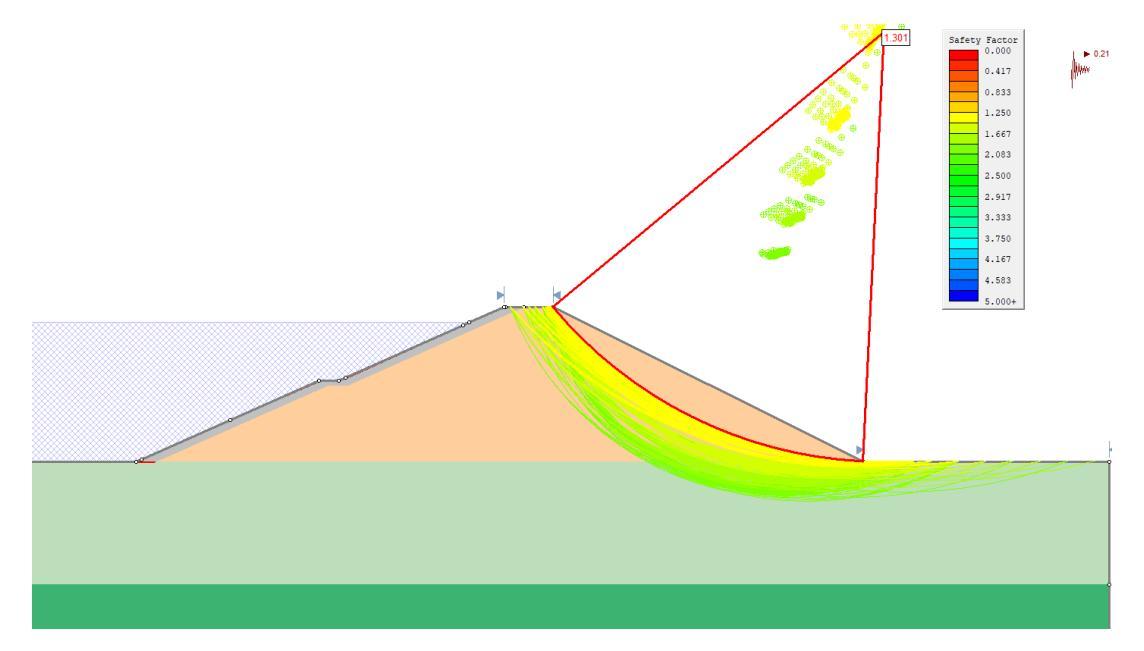
Fig. 5. Downstream slope safety factors of sliding surfaces for full and partial storage cases with 0.21g acceleration coefficient.

Slope stability analyses were performed using software SLIDE [23]. The factor of safety of the slopes were calculated by widely used Bishop limit equilibrium method described in Eurocode 7 [27] by using Equation 3. Calculated safety factors of upstream and downstream slopes along with transient seepage analyses for all three different scenarios are briefly given in Table 3. Case 1 in Table 3 represents full storage condition along with earthquake effect. Case 2 represents partial (minimum water level) storage with earthquake acceleration. Case 3 is a seepage case due to a tear occurrence of geomembrane liner when reservoir is its maximum level. Figures 5, 6 and 7 corresponds to the Cases 1 and 2. [28]

- Upstream and downstream slopes with 2.25H to 1V are sufficiently stable for full storage and partial storage conditions even in case of a large earthquake causing 0.21g average horizontal acceleration on the sliding surfaces.

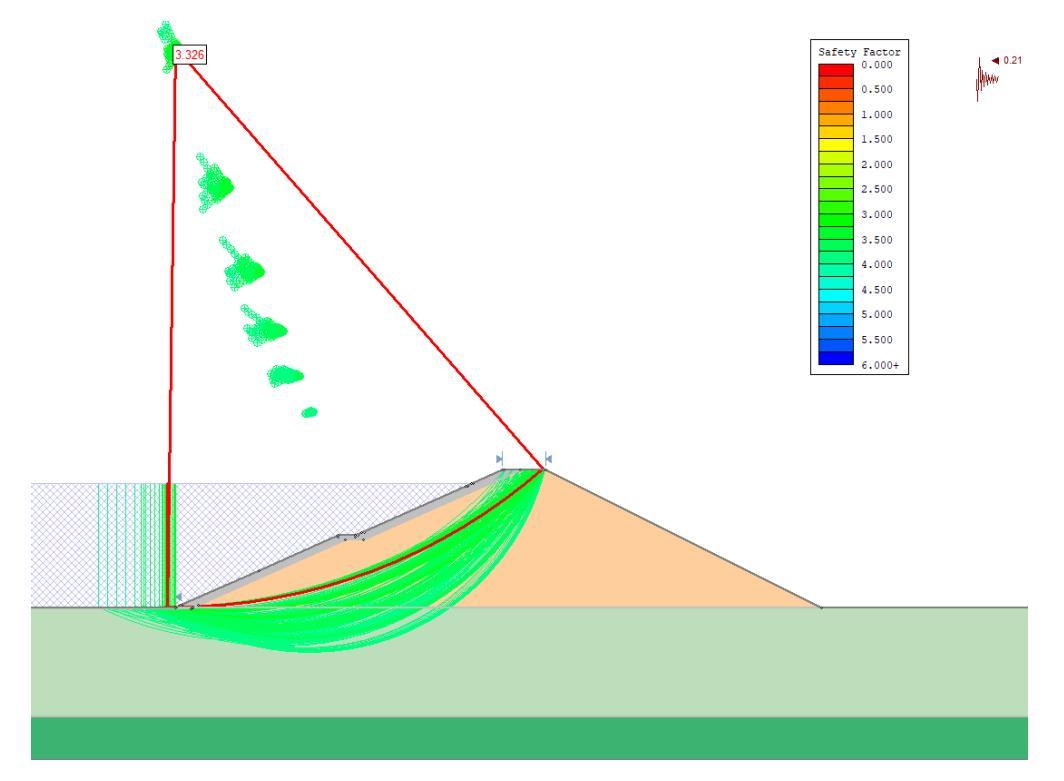
Fig. 6. Upstream slope safety factors of sliding surfaces for full storage case with 0.21g acceleration coefficient.

- For the upstream slope, the lower sliding safety factors were obtained when the reservoir is at its minimum storage level in case of earthquake with a seismic coefficient of 0.21g. However, sliding safety factors become the highest if the reservoir is its highest level since the highest water pressures acting on the upstream slope face occur. Since then, rockfill strength on the failure surfaces is increased due to the effect of reservoir water pressure.

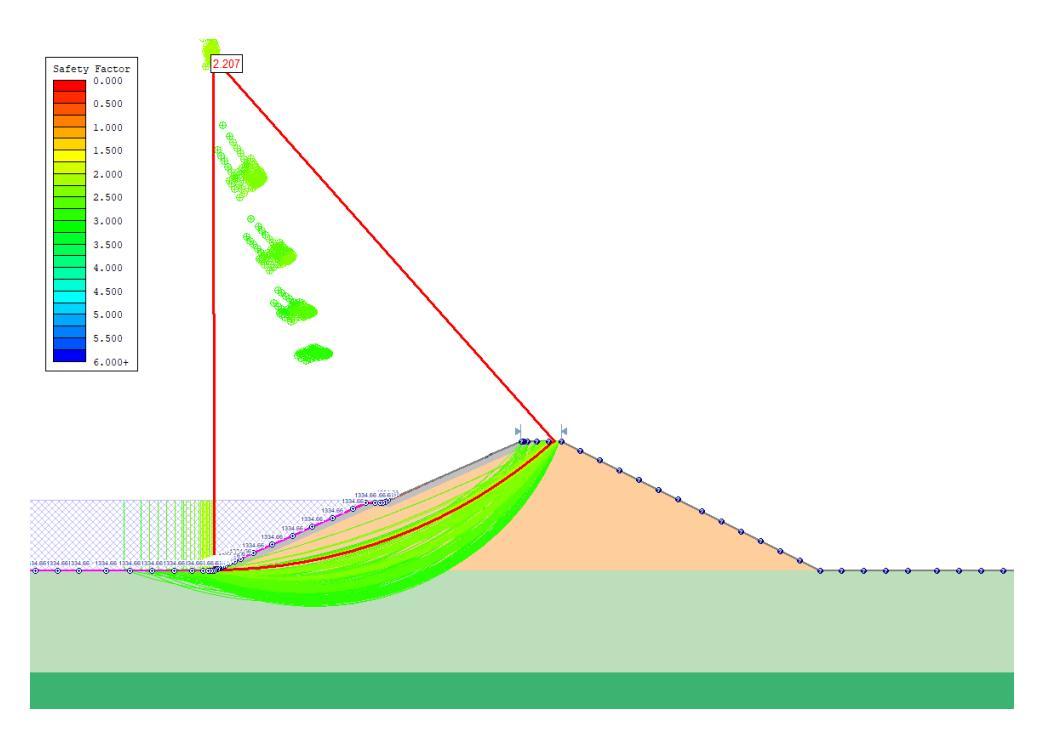
Fig. 7. Upstream slope safety factors of sliding surfaces for partial storage case with 0.21g acceleration coefficient.

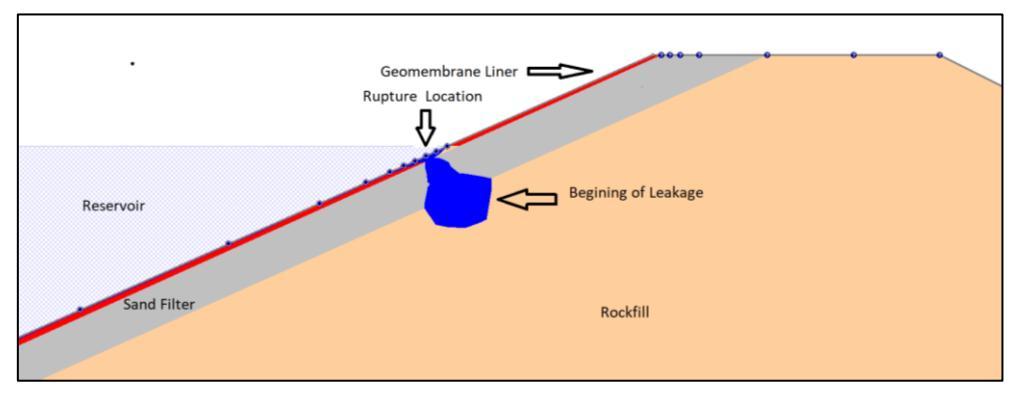
Fig. 8. Rupture location of the geomembrane liner

In case of leakage in the geoemembrane (Figure 8), numerical transient seepage analyses along with calculated stability safety factors of the downstream slope of the dam are also presented in the following Figures, 9,10, 11 and 12.

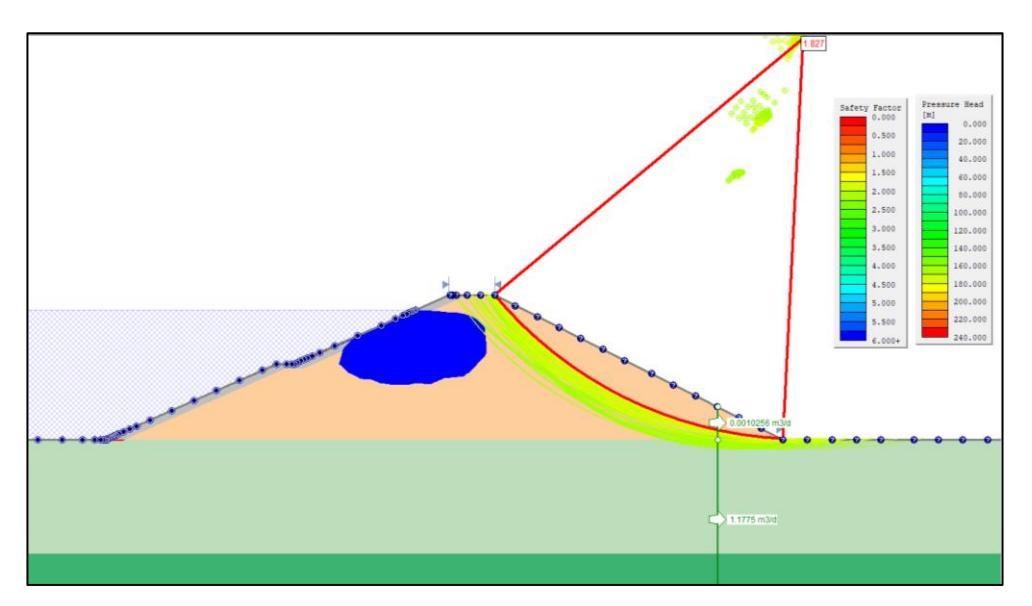
Fig. 9. Flow lines, pressure heads, seepage amount and safety factor of downstream slope in case of a geomembrane rupture when the reservoir is in its maximum level (Starting leakage (time =200 days))

As a result of transient numerical seepage analyses, it was observed that factor of safety value of the downstream slope diminishes for each time period (time step) depending on the developed pressures in the pervious rockfill and bedrock. For instance, in general, in the first step as the beginning of the leakage, safety factor of the downstream slope becomes higher. However, due to development of seepage in the rockfill and pervious rock foundation, factor of safety value of the slope decreases and reaches its minimum value at the end of the time step (steady state seepage condition). Numerical seepage analyses were performed using 2-D Laplace seepage equation solved by finite element method (Eqn 4). In the modeling, 3 noded triangle elements were used. The number of the elements was 1500. The number of time stages was 5 with the times, 50, 200, 500, 1000 and 2500 days. The maximum number of the iteration was 100 and tolerance was 0.0001. The general governing equation is for transient seepage flow in a heterogeneous and an isotropic soil [29].

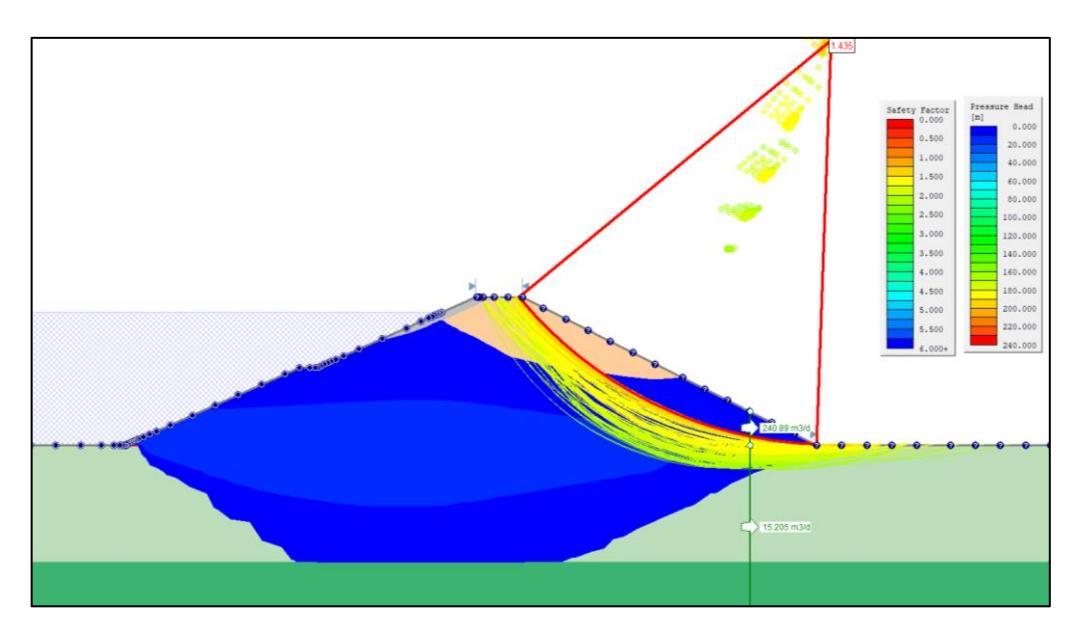
Fig. 10. Flow lines, pressure heads, seepage amount and safety factor of downstream slope in case of a geomembrane rupture when the reservoir is in its maximum level (Starting leakage (time =500 days))

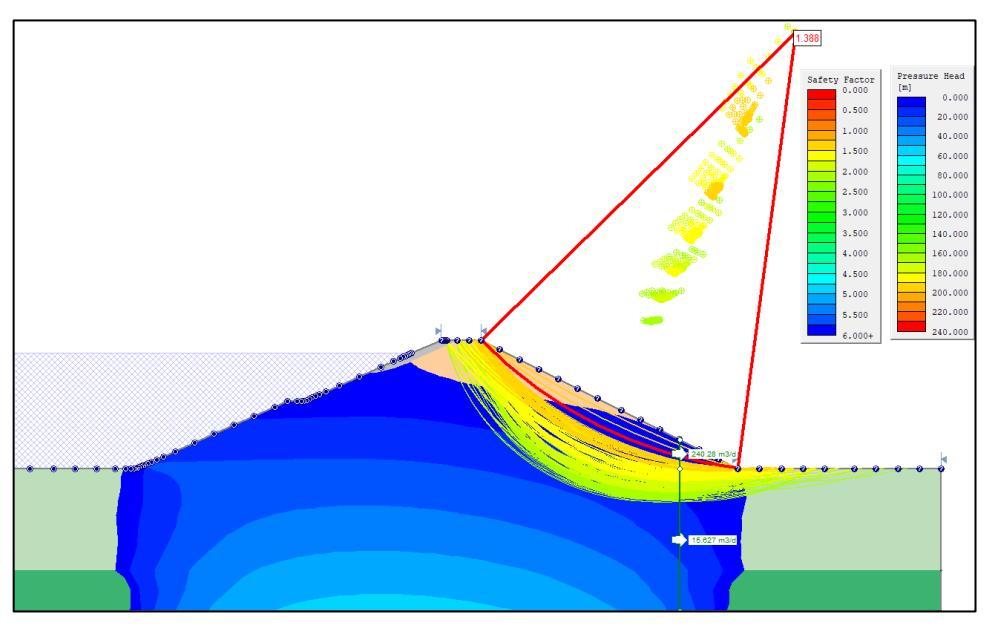
Fig. 11. Flow lines, pressure heads, seepage amount and safety factor of downstream slope in case of a geomembrane rupture when the reservoir is in its maximum level (Starting leakage (time =1000 days))

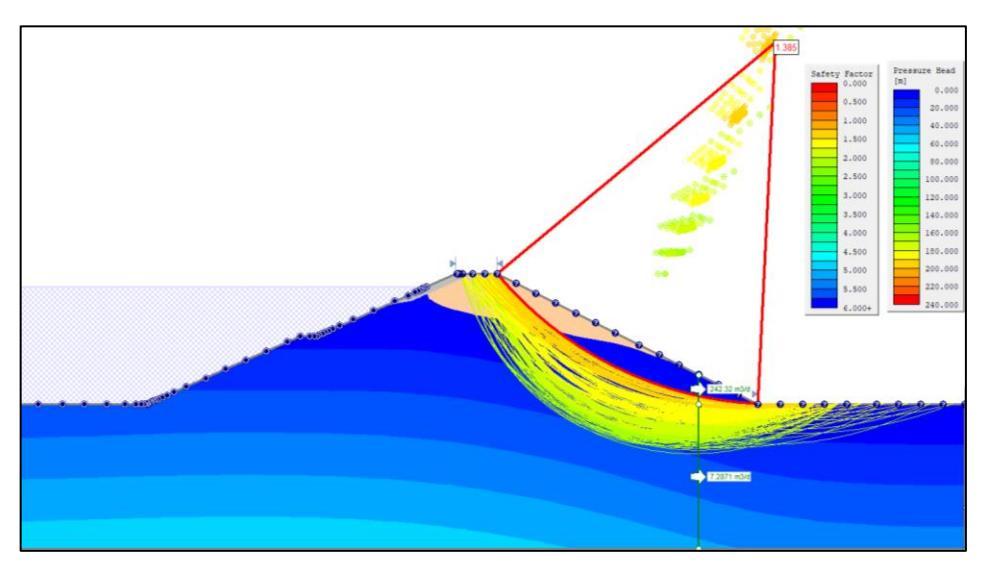
Fig. 12. Flow lines, pressure heads, seepage amount and safety factor of downstream slope in case of a geomembrane rupture when the reservoir is in its maximum level (Starting leakage (time =2500 days - steady state condition))

- Performing transient numerical seepage analyses is quite important to estimate the water pressures for different bedrock or foundation soil conditions as well as to determine the effects on the water pressure and slope safety factor variations. At the beginning of the seepage, it was observed that slope safety factors are usually higher since developed pore water pressures in the rockfill are less. However, at the final stage which is the steady state condition, slope safety factors become the lowest since then seepage pressures are the heighest.
