Problem Investigation of Konya Flood Protection Structures

Necmettin Erbakan University, Civil Engineering Department, Hydraulic Division, Konya, Turkey

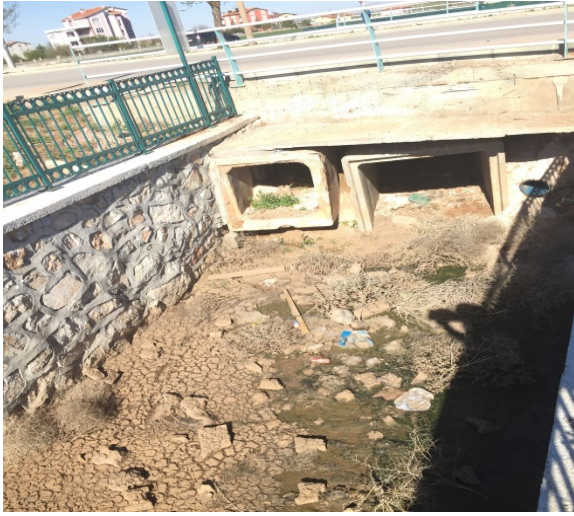
Figure 1. Konya Güneysinir district

As seen in Figure 1 and 2, rectangular open channel form for flood protection was built under the control of DSI and culverts by Konya municipality. The cross sections of channels and culverts are looking insufficient. As shown In Figure 3 the flood facility constructed by DSI in accordance with its project, intersects with the historical arch bridge at a certain point of its route, it has not rightly allowed to build up to 7-8 m to the historical bridge under the law of not touching the cultural assets by the Provincial Directorate of Culture and Tourism. In figure 4 in order to cross the water pipe KOSKI (Konya Water and Sewerage Administration) did demolish flood protection facility's wall which affects the function of the structure during flood flow.

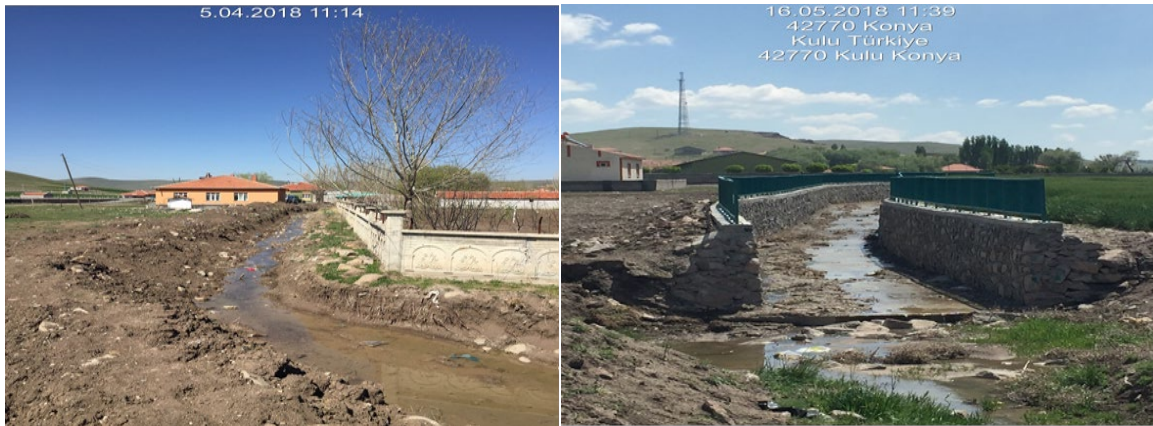
Figure 5. Flood protection plain of Kulu

Figure 5 shows the flood control structures which effected by flood water because of the lack of cadastral width on the route for building the flood protection channel.

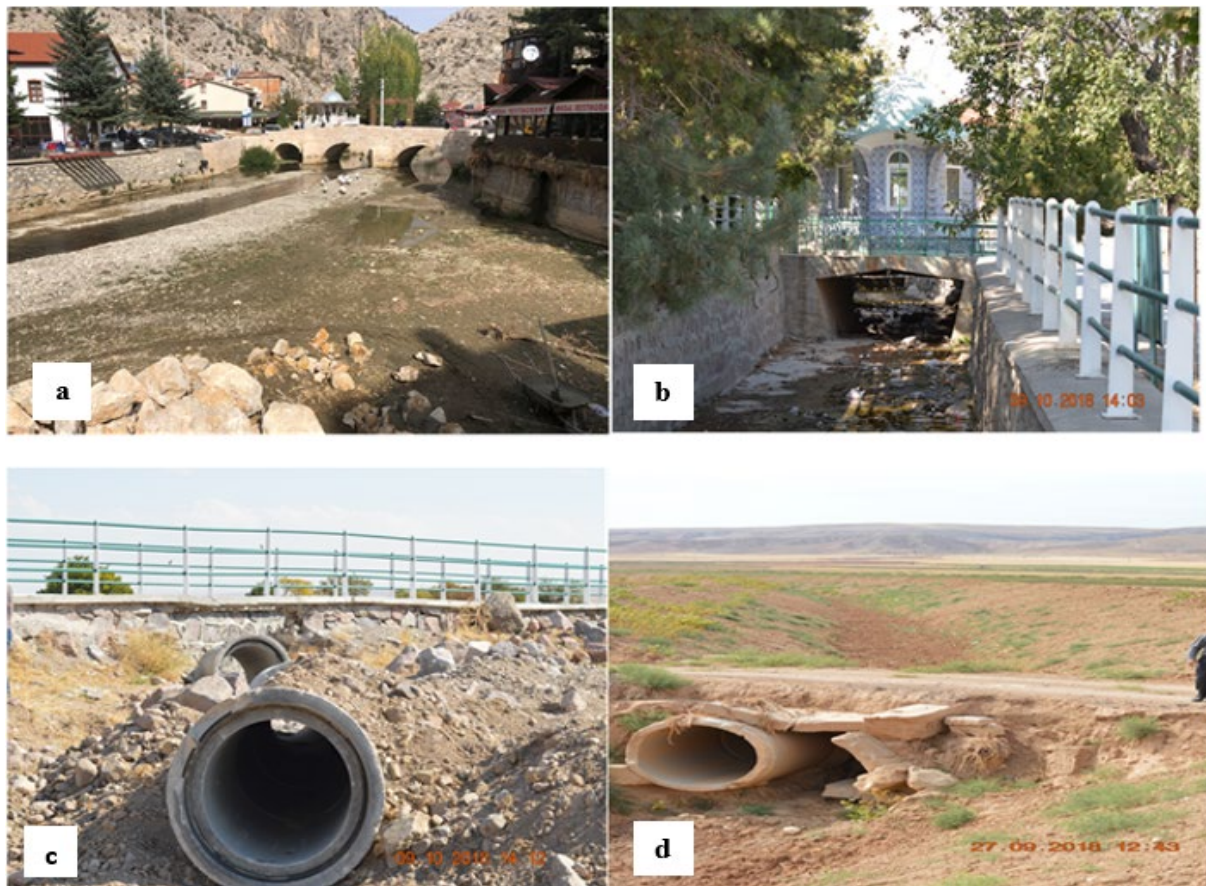
Figure 6. Narrowing the flood protection structures by construction of infrastructures (a) Konya Bozkir district, b) Konya Yarasli region, c) Konya Yarasli Region, d) Konya Kutukkusagi Region)

By the building roads by citizen over the flood channels as shown in Figure 6, a narrow section created and due to the change in section of channel they would not function proper to project and plan during the flood flow. In some of the flood facilities in Konya province as shown in the Figure7 narrowing of the section in the flood route prevents the efficient operation of the plant and also creates serious problems in terms of life and property security.

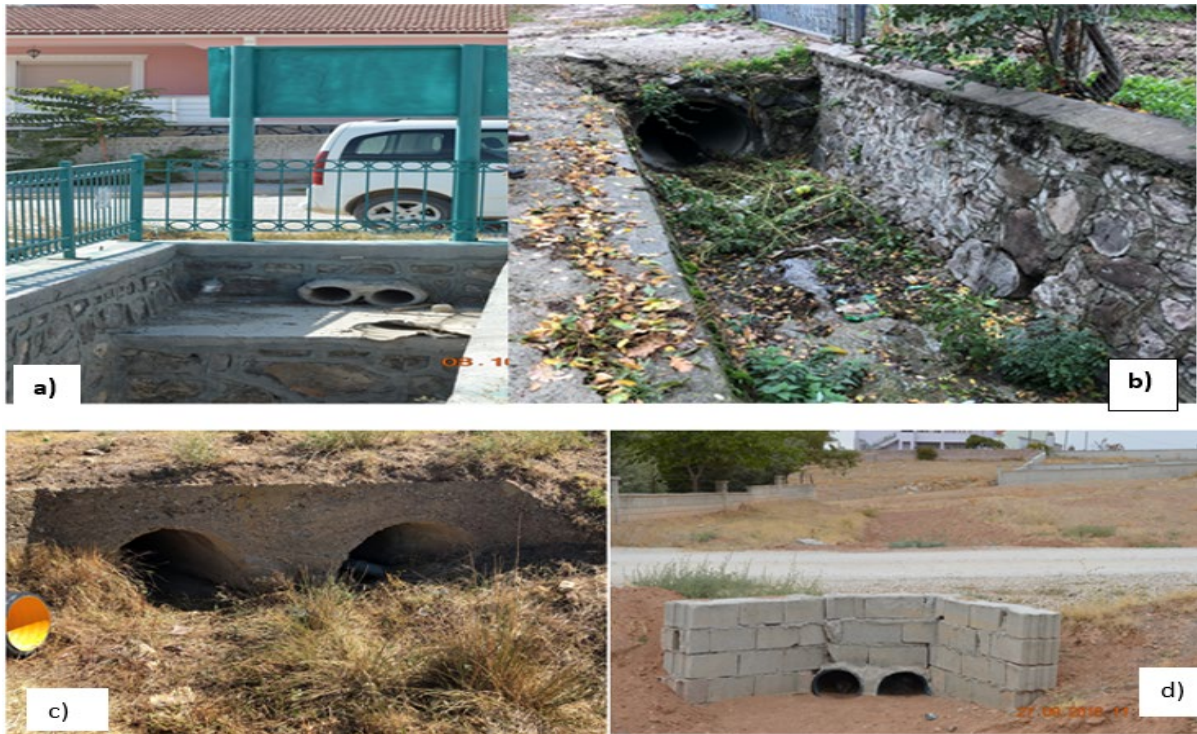
Figure 7. Narrowing the flood protection structures of a) Kirkpinar region, b) Gevrekli region, c) Yesilyurt region), Yeniceoba region

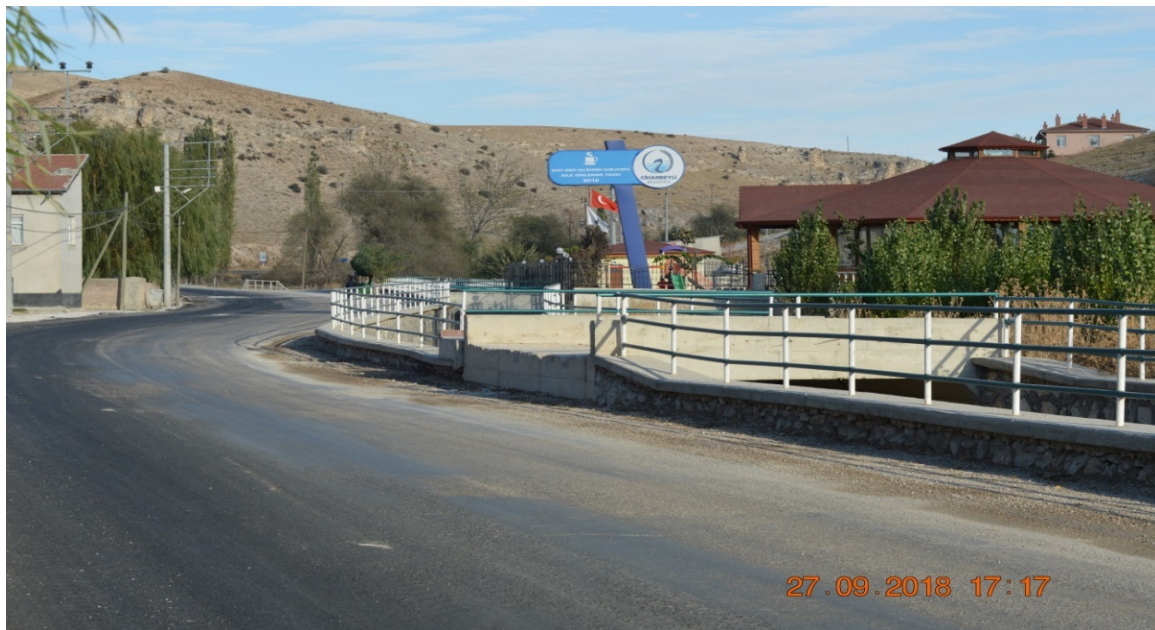
Figure 8. Konya Cihanbeyli District İnsuyu Region

In some of the flood facilities in the province of Konya, in order to reach the project criteria during the project phase, sometimes the structures do not comply with the environment and negatively affect the citizen's life as seen in Figure 8.

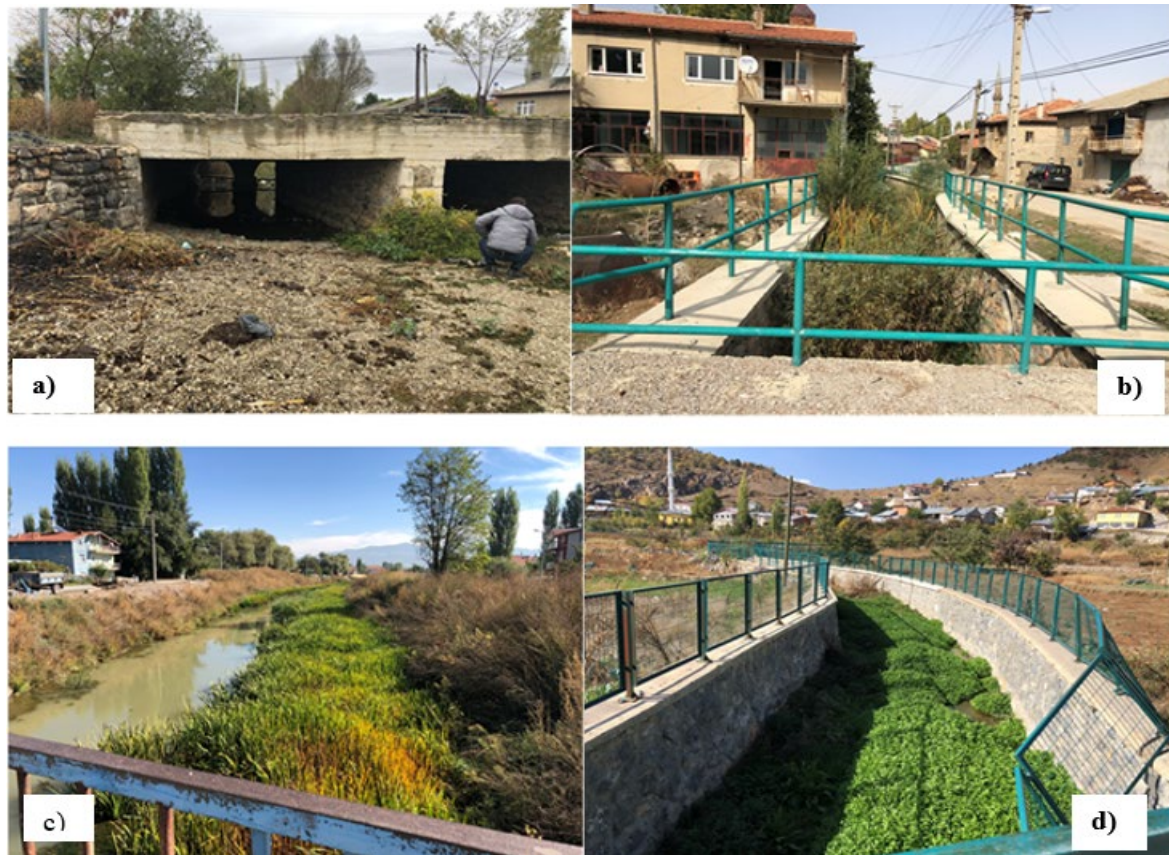
Figure 9. Narrowing of the cross-section by planting in a) Akcalar region, b) Harmanpinari region, c) Esence region, d) Bagbasi region

In some of the flood structures in the province of Konya, it is observed that the channels are filled with sediments or natural grasses grows in the bed both of which decrease the flow velocity, causes overflow and prevents the efficient operation of the flood facilities.
