Diagnosis and esthetic functional rehabilitation of two patients with dental fluorosis: Case report

Selcuk Dental Journal, 2015; 2: 81-85

This 2-case-report presents the esthetic rehabilitation of 2 dental fluorosis patients using direct and indirect laminate veneer techniques.

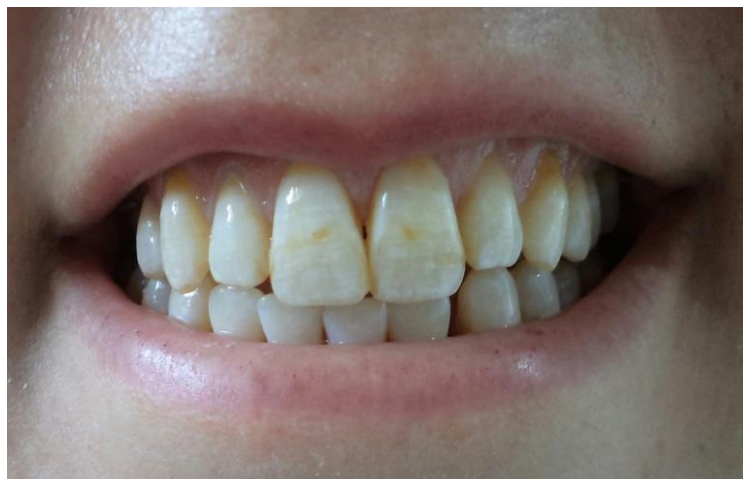
Figure 1.

The girl aged 23 had mild grade of fluorosis in her upper teeth. Thin white lines and brown markings are seen across the central incisors surface (Figure 1). She preferred two porcelain laminate veneer restorations.

Frontal view of the anterior teeth before treatment

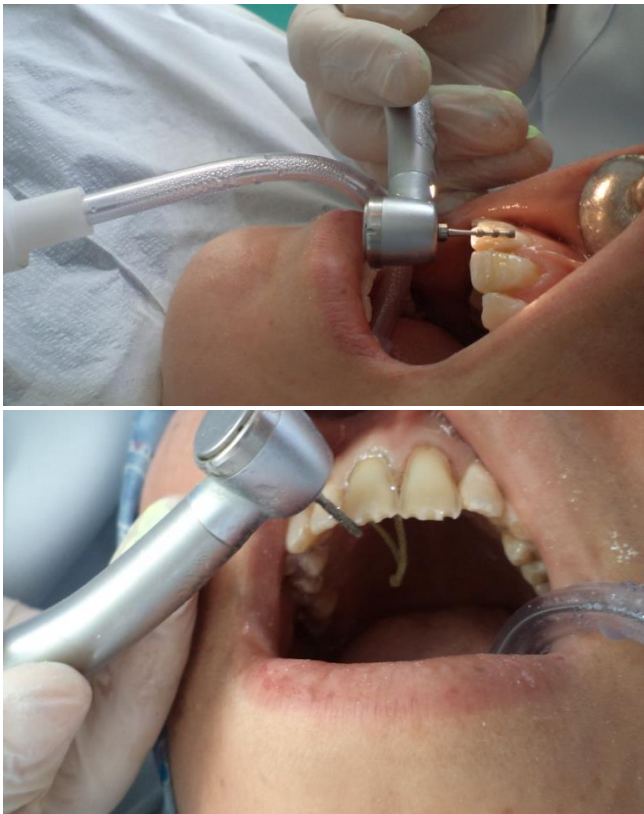
Figure 2 (a, b).
The central incisors preparations

In this case, an incisal overlap preparation was selected to give the dental technician maximum control over esthetics characteristics and translucency (Meijering et al. 1998). The facial, mesial, distal and incisal surfaces of the central incisors were reduced with a high-speed diamond rotary instrument (ISO 199/014 and 199/016, Shofu Inc., Kyoto, Japan) under water coolant (Figure 2a, b and Figure 3a, b). The impression was taken with polyvinylsiloxane impression materials (addition silicone regular body normal setting, Zhermack, Badia Polesine, Italy). Using a shade guide (vitapan 3D-Master), shades 1M2, 2M2 were selected for the patient. Porcelain laminate veneers were fabricated with IPS e.max Press system (Ivoclar-vivadent, Schaan, Liechtenstein). Then the veneers were checked on the master cast for esthetics and adaptation. instrument filled with fine diamond particles (CompoMaster, Shofu Inc.). The patient was satisfied with the esthetics and function of the restoration after treatment (Figure 4a, b).

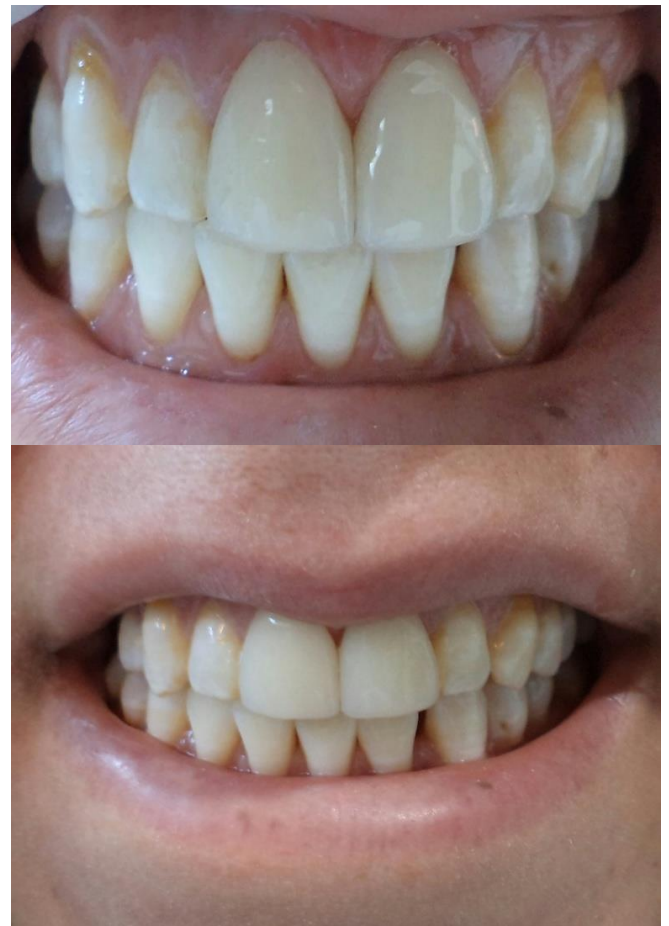
Figure 4 (a,b).
Facial view of the final restoration

excess resin cement with probe. Photopolymerization from multiple directions (40 s each direction) was implement. The marginal areas of the enamel-resin-porcelain interface were ground with a diamond rotary instrument and polished with a rotary silicone instrument filled with fine diamond particles (CompoMaster, Shofu Inc.). The patient was satisfied with the esthetics and function of the restoration after treatment (Figure 4a, b).

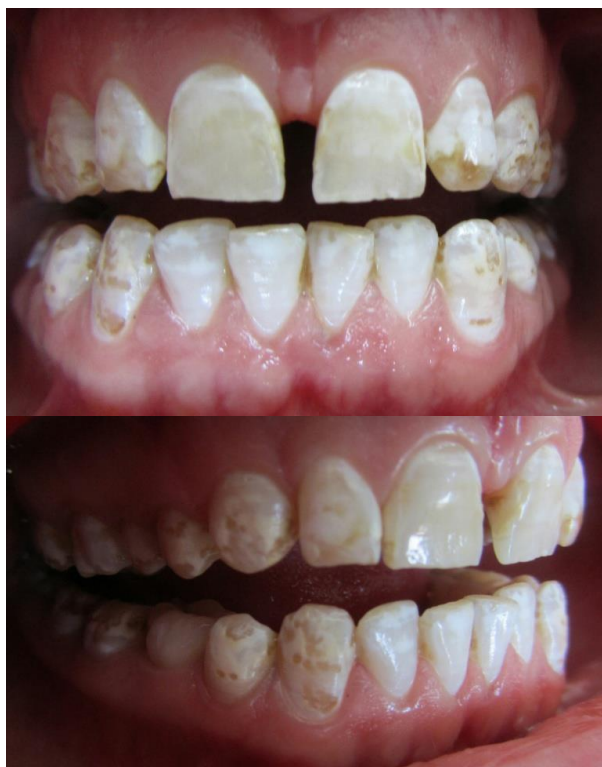
Figure 5 (a,b).

The girl aged 20 years old, all the teeth surfaces affected, white spots, pitting and brown stains were observed on the enamel and had diestema between central incisors (Figure 5a, b). Six upper front teeth due to the case II because of expensive porcelain laminate chose to make composite veneers. In the case, treatment plan involved direct composite restorations from superior canine to canine and inferior canines and first premolars. Direct composite laminate veneer restoration preferred due to these are more chap than porcelain restorations.

Intraoral view of teeth before treatment

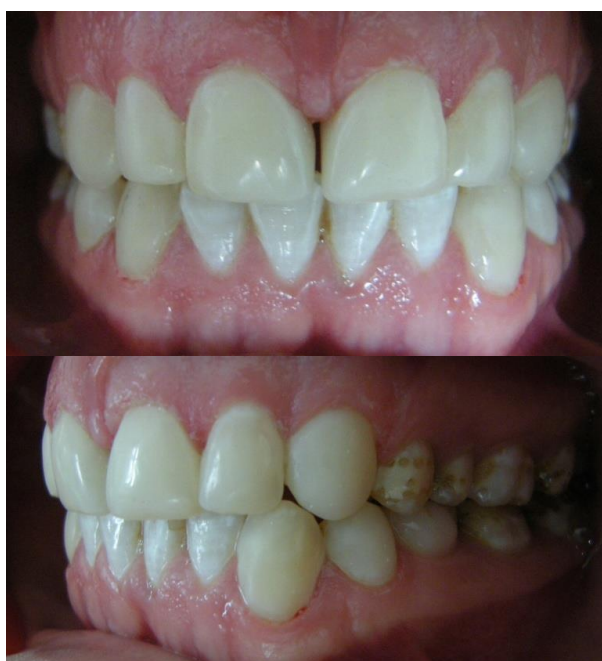
Figure 6 (a,b).

Finished and polished restorations

surfaces of the teeth were conditioned with 37% phosphoric acid gel (3M Scotchbond: 3M ESPE, St.Paul, Minn) for 30 seconds. The teeth were rinsed with water spray for 30 seconds and the teeth were air dried. Teeth were conditioned and primed with a self-etching adhesive (Clearfil SE bond, primer; Kuraray Co. Ltd) and polymerized for 10 seconds with a polymerizing unit (3M ESPE Elipar Freelight2, Germany). Hybrid resin composite (Universal Restoratif 200, 3M ESPE, St.Paul, ABD) was placed and tried to close the diastema between central incisors and then light-polymerized for 40 seconds. The diastema did not close fully because of large distance between incisors. So the composite was piled from the rear forward. The restorations was contoured and polished with polishing discs (Sof-Lex; 3M ESPE). The patient was satisfied with treatment outcome (Figure 6a, b).
