Real Estate Development at Landslides

Abstract

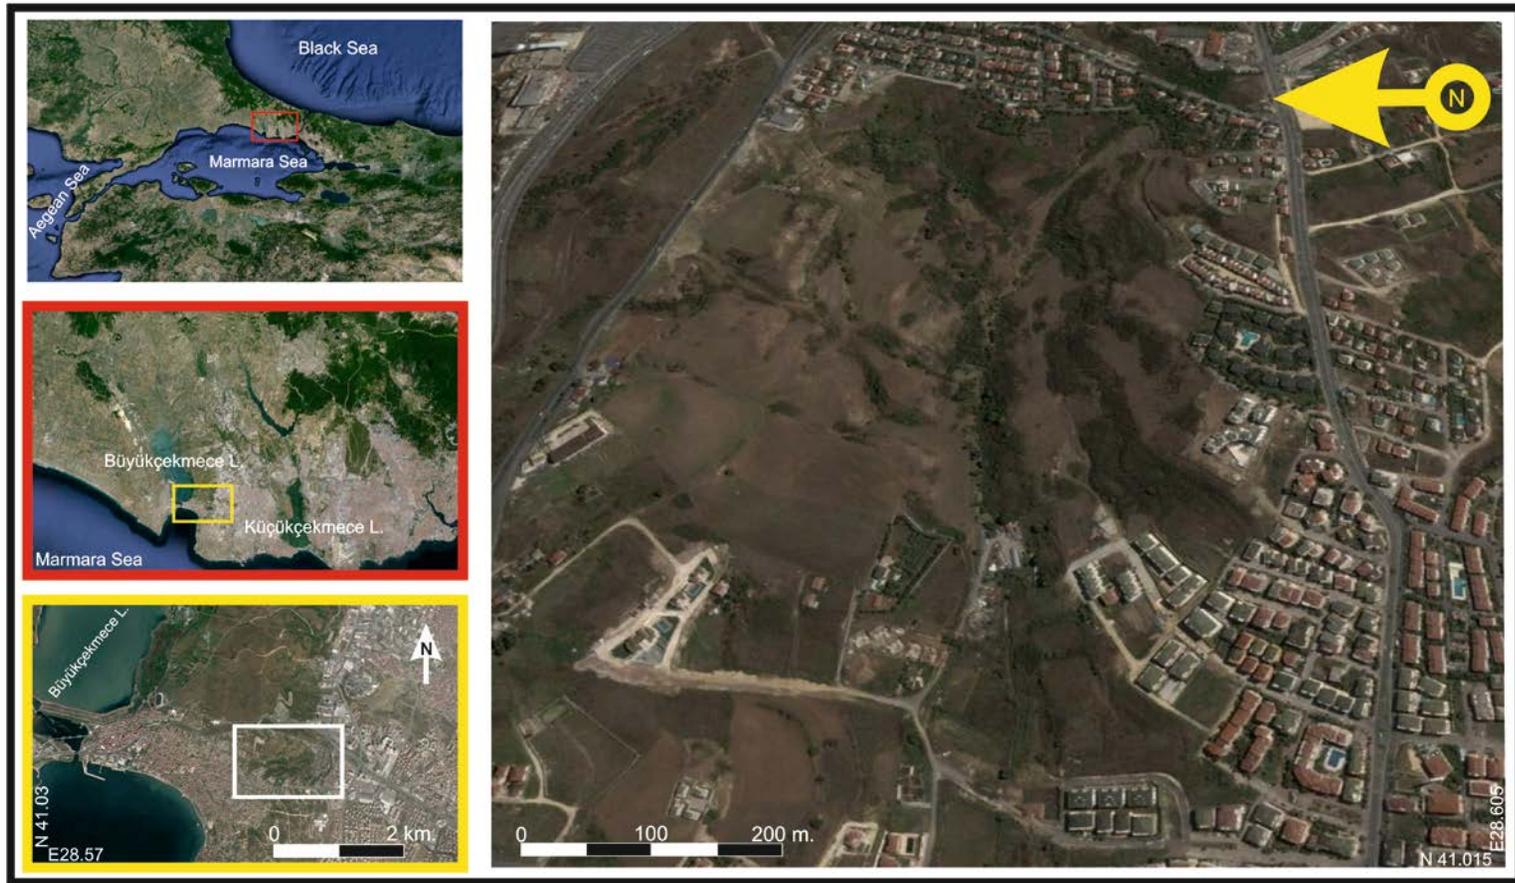
Fig 1. Study Area and Landslides of study area and Devebağirtan Valley

Study area the area remaining between Büyükçekmece lake (BL) and Küçükçekmece lake (KL) and it is a district in the European side of İstanbul in Marmara region, is surrounded by Çatalca in the N and W, KL in the E, the Marmara Sea in the S (Fig.1). In this

area the eastern hillsides of BL, the hillsides of Devebagırtan Valley, the hillsides on the coasts of Beylikdüzü district, the eastern and western hillsides of Kavaklı Creek that splits Beylikdüzü District in the middle as it springs out from the north and spills into the Marmara Sea to the south, the eastern and western hillsides of Haramidere, the valley hillsides making up the branches of this creek, the hillsides of Avcılar district facing the sea, Esenyurt district located to the north of the area under study, and the hillsides of the valleys located in the Çakmaklı and Kıraç areas are where the landslides are observed quite frequently (Ertek et al., 2001). In the light of latest investigation of faults exist as preparative parameter for the landslides between BL and KL. Also, the vertical erosion process during the last glacial age should have been effective in the occurrence of the landslides. Additionally, the existence of resistant fissured clay with watertight sand interlayers and the erosion processes on the heel of the slopes are determined as extra effective preparative factors (Dalgıç et al., 2010).

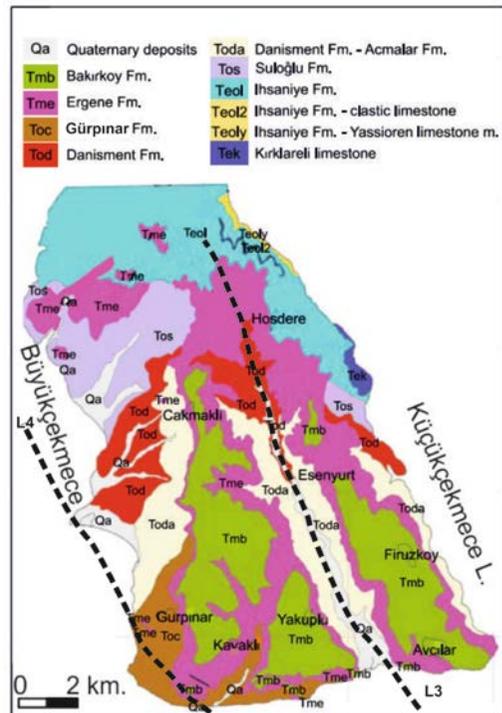
Fig.2. Geology of study area (modified from Doğan et al., 2013; Duman et al., 2006 and Gökaşan et al., 2002)

Oligocene aged Gürpınar formation composed of clay-claystone and sand levels is located at the bottom. Ergene formation composed of

mainly sandy levels overly Gürpınar formation. Moderate stiff-very stiff clay levels become dominant for the upper levels of Ergene formation. Bakırköy formation, which includes limestone as dominant lithology, overly this sedimentary levels (Fig.2).

This formation is suited between 150 to 400 m thick clays. It develops landslides and flows in places with steep topography. This formation extends from BL and has high water content. The Gürpınar formation is the dominant outcropping in Büyükçekmece region. This formation is fairly young age which is older than 30 million years old. (IMM, 2014).

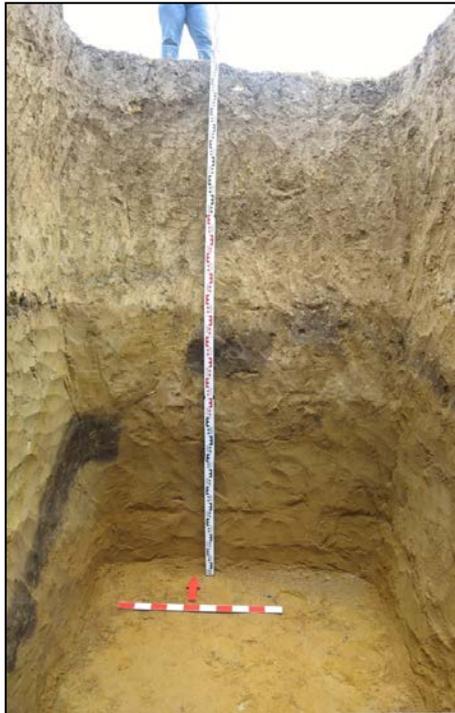
Fig 3. The Fault Line discovered in Bathonea Antique city to the west of KL.

During the studies conducted on Bathonea Antique city to the west of KL, the team conducting the diggings observed landslides in the archeological trench excavated for research purposes (Fig.3.). This shows that continental fault lines would be discovered if the area where the landslides have been observed is seriously scanned. When all the foregoing information is taken into consideration it can be seen that a high intensity earthquake would trigger the landslides in the site of the study that has the liquefaction of the ground, and a landslide together with an earthquake would

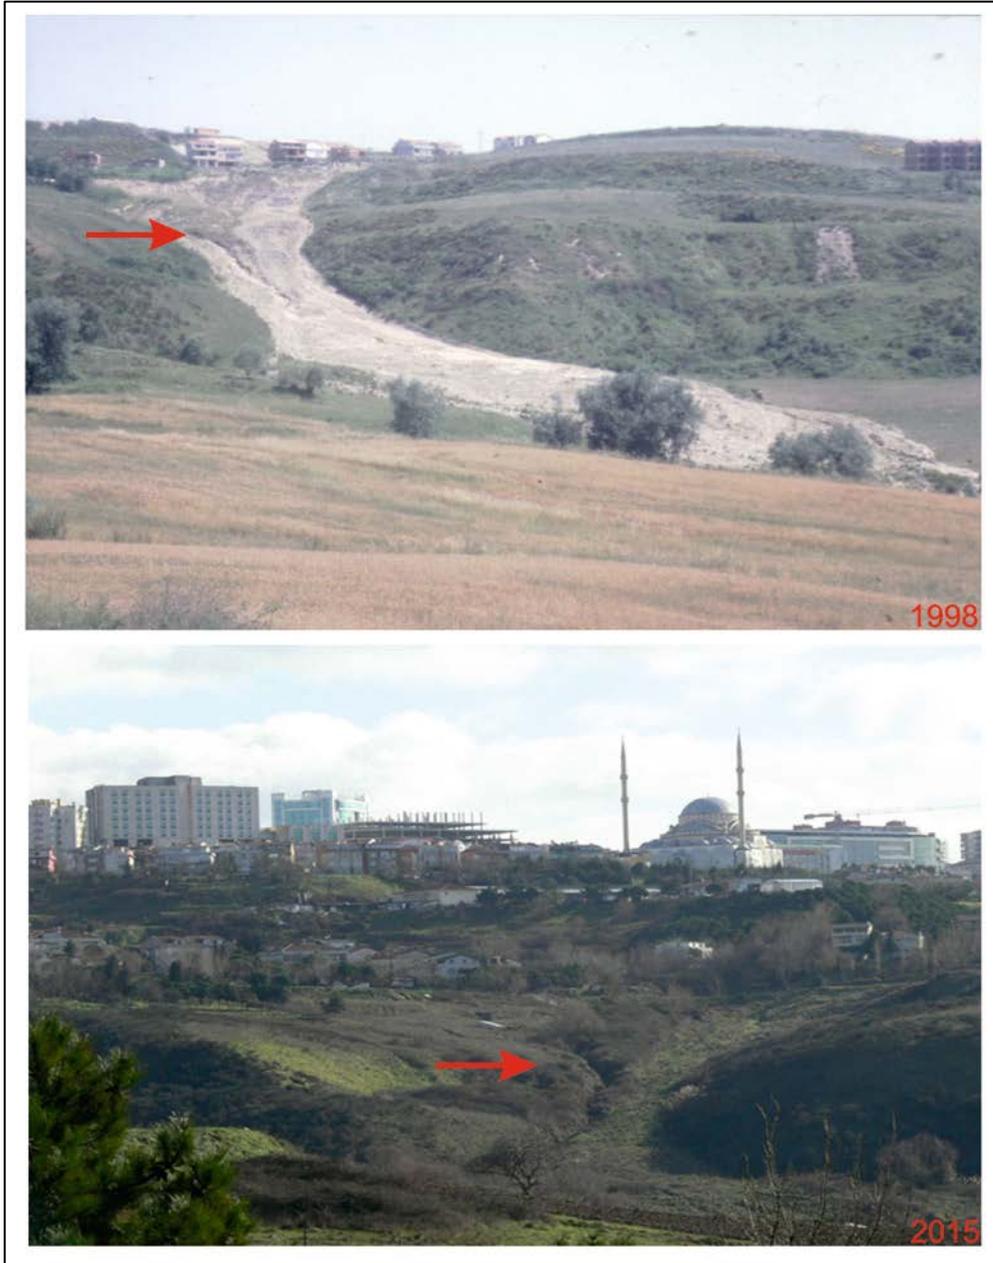
Fig 4. Landslides is suited in Devebağirtan valley SE (Büyükçekmece 1998-2015)

Between 1990 and 2005, many settlements and buildings erected on the hillsides of the Devebağirtan valley (Fig.4-5), Yakuplu and Haramidere valley (Fig 6), Avcılar (Sitelere - Ambarlı area), Kavaklı (Fig 7) and the Gürpınar-Çakmaklı line that are prone to landslides have been damaged as a result of this phenomenon, and while some of them collapsed others were reinforced to help them survive (Yücel et al., 1998).

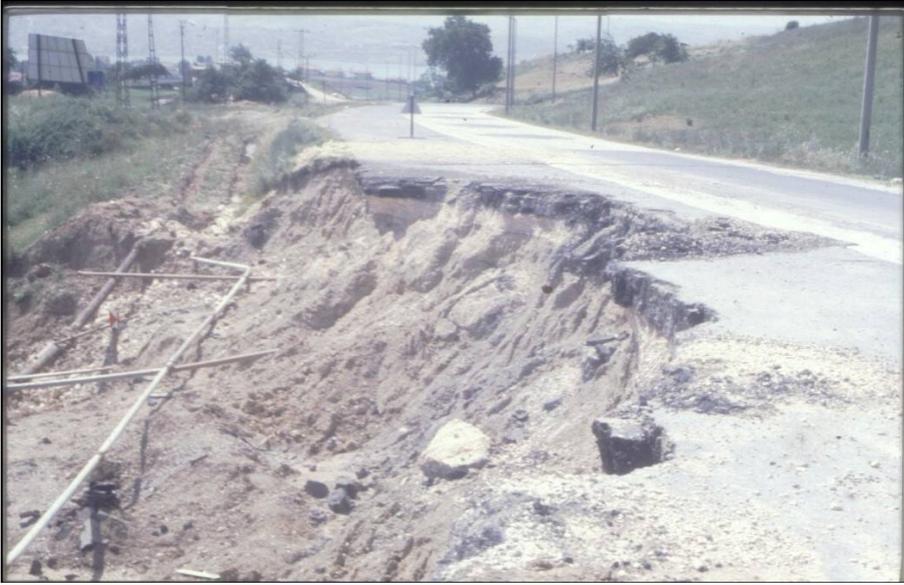
Fig 5. Landslides is suited D-100 Motorway in Devebağirtan valley N (Büyükçekmece 1998)

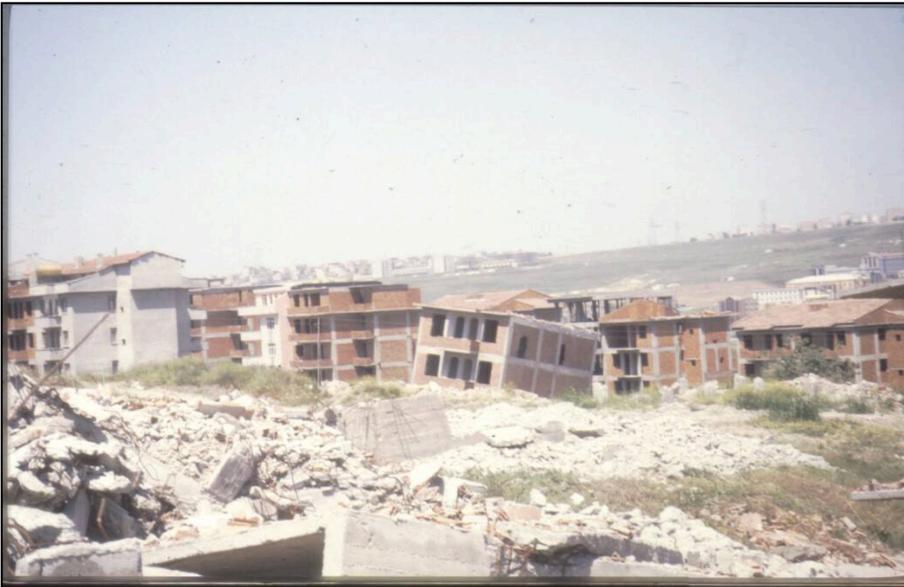
Fig 6. Damage of landslides of W part of Haramidere Valley (Yakuplu-1998)

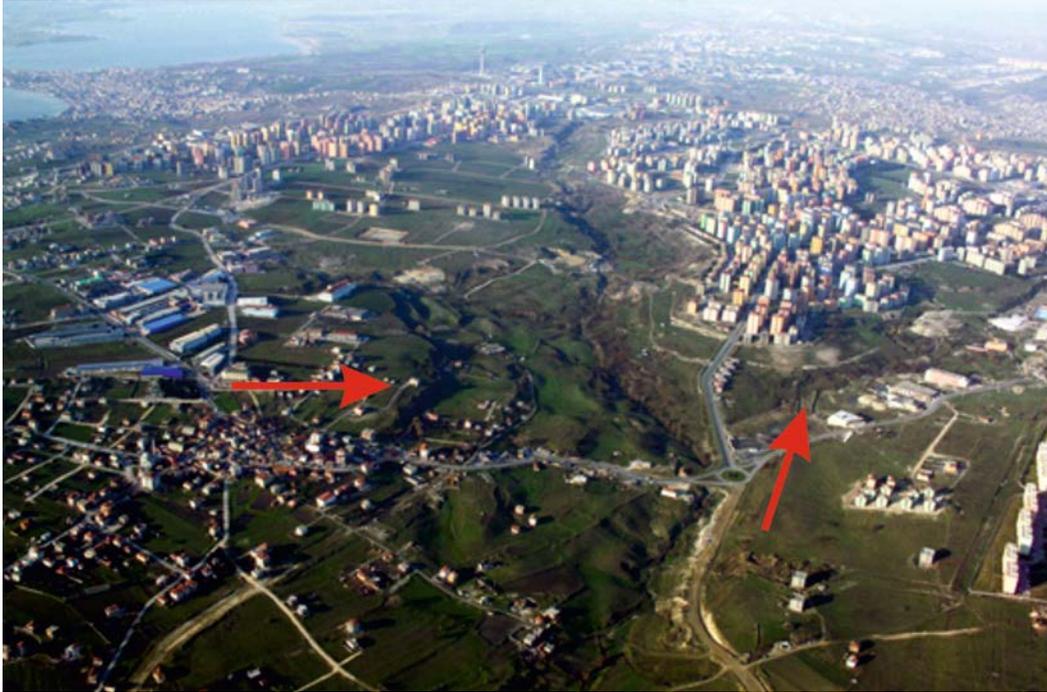
Fig 7. Landslides situated on Kavaklıdere valley (Beylikdüzü) and its branches.
