**Review Article****A Review on hydrogen embrittlement behavior of steel structures and measurement methods****Biniyam Ayele Abebe** <sup>a,\*</sup> and **Ekrem Altuncu** <sup>b</sup> <sup>a</sup>*Department of Mechanical Engineering, Faculty of Technology, Sakarya University of Applied Sciences, Sakarya, Turkey*<sup>b</sup>*Department of metallurgy and Materials Engineering, Faculty of Technology, Sakarya University of Applied Sciences, Sakarya, Turkey, Materials and Manufacturing Technologies Application and Research Center, Sakarya, Turkey*

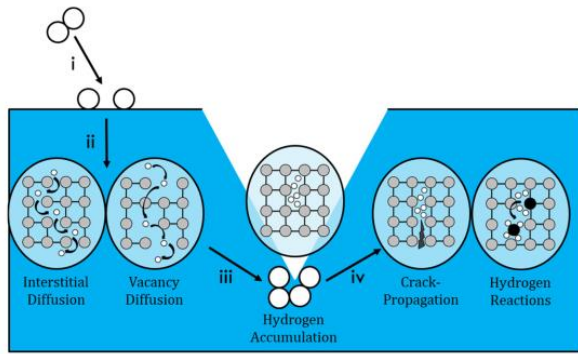
Figure 1 Diagrammatic representation of the interactions between hydrogen atoms and a metal crystal structure [5].

As hydrogen builds up in the crystal lattice and generates stress, Figure 1 illustrates the initial effect of hydrogen interaction, which is the development of HE [5].

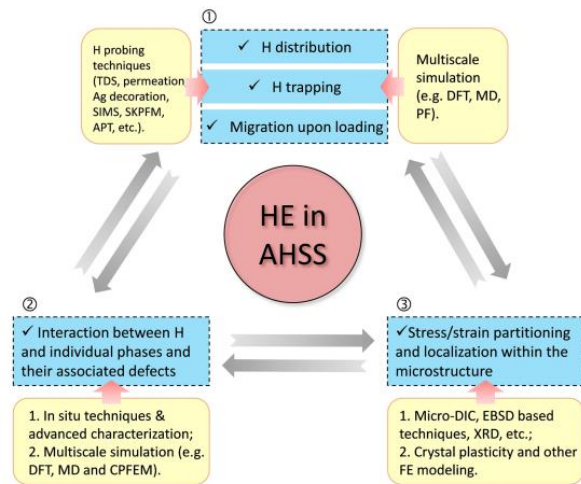
Figure 2. Hydrogen interaction and HE in AHSS [11]

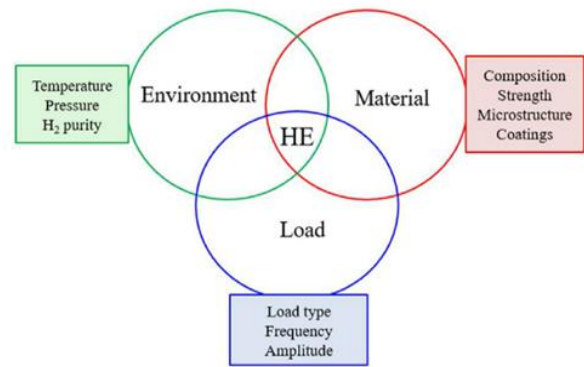
Figure 3. Factors that increase the risk of hydrogen embrittlement [3]

For advanced high strength steels (AHSS), hydrogen embrittlement becomes more significant when strength levels rise above 1000 MPa [6]. AHSSs have favorable mechanical properties, but hydrogen-induced processes have the potential to compromise their integrity [7]. When exposed to hydrogen, these materials lose some of their ductility and eventually experience HE [1-5]. This limitation could arise from exposure to the service environment, during the manufacturing process, during product assembly and termination, or both. The risk of hydrogen embrittlement can be raised by a number of variables the most common of them are shown in Figure 3.

**Load (Stress):** High levels of tensile stresses can make a material more vulnerable to hydrogen embrittlement [16]. This is especially relevant when materials are being mechanically loaded during manufacturing or during use [3]. Figure 3 shows a graphic representation of the key parameters for HE. Environmentally assisted cracking (EAC) can be observed with either a static or dynamic applied load, and the damage form is known by several names such as corrosion fatigue, stress corrosion cracking, sulfide stress cracking, and so on. One or more harm mechanisms (which may work concurrently) have the ability to initiate and/or assist each of the aforementioned damage kinds.

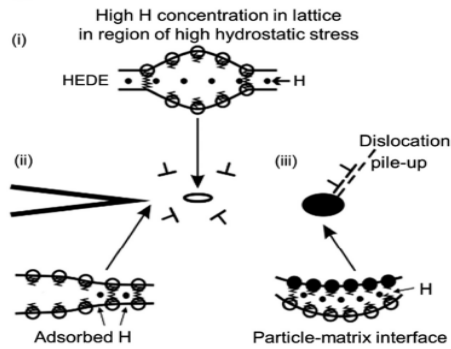
Figure 4. Schematic of the HEDE mechanism [12]

Figure 4 displays the HEDE mechanism schematic. The atomic bonds at the crack's tip weaken as a result of the crystal lattice expanding due to the admission of hydrogen. This leads to a reduction in the energy needed to facilitate the propagation of cracks, culminating in a macroscopic brittle fracture. Involving the tensile separation of atoms caused by the following: (i) hydrogen in the lattice; (ii) adsorbed hydrogen; and (iii) hydrogen at particle–matrix contacts, which weakens interatomic connections [12].

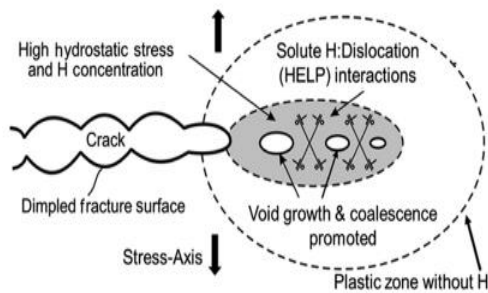
Figure 5. Schematic of the HELP mechanism [15]

The hydrogen atom is accumulated in close to the crack tip. Moreover, it lessens the opposition to dislocation motion. As a result, dislocation becomes more maneuverable and functions in a metal lattice as a carrier of plastic deformation [22]. It might be clear that it depends on the material's microstructure, stress intensity, or hydrogen clustering. Fractographic examination was carried out to verify the material's microstructure characteristics. HELP contains a wide variety of structures, such as Face-Centered Cubic (FCC), Body-Centered Cubic (BCC), and Hexagonal Close-Packed (HCP) type structures. The HELP mechanism will cause a brittle fracture surface with tear ridges, dimples, and slip [15].

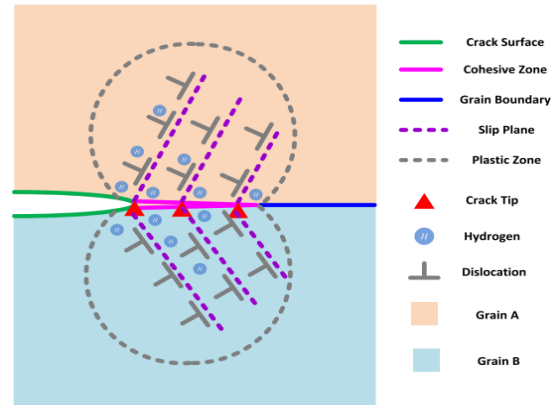
Figure 6. Diagrammatic representation of the hydrogen-induced dislocation emission from the crack tip in the AIDE mechanism model [9].

This represents the combination of HEDE and HELP. Adsorption of the solute hydrogen atoms occurs close to the fracture tip. Because of the solute hydrogen atom dislocation that forms close to the fracture tip, hydrogen adsorption at the crack tip weakens the cohesive strength and interatomic bonding of materials via the HEDE process. Dislocation promotes the formation of micro voids through the HELP mechanism and the slip-induced crack development [21]. The process known as "adsorption-induced dislocation emission mechanism" occurs when hydrogen is adsorbed on a surface, which further enhances or inhibits the dislocation nucleation at the surface and has a significant impact on surface energy. In crystalline solids, dislocation nucleation, or emission from the fracture point, plays a crucial role in the ductile-brittle transition. A quantitative model was developed, as shown in figure 6, to capture the hydrogen-affected dislocation emission from the crack tip and its effect on hydrogen embrittlement. [23].

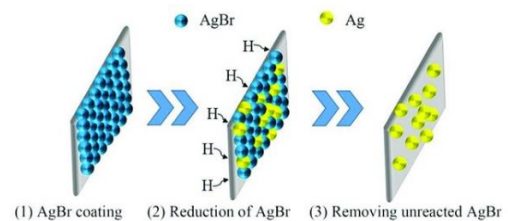
Figure 7. schematic diagram of HMT [29]

This technique has been used to calculate the hydrogen's diffusion through metal. Knowing these pathways allows for the identification of their unique microstructure and the determination of the hydrogen's effect. This high-resolution, very accurate HMT approach is relatively straightforward and distinct [27]. The hydrogen distribution on the stress field, for example in notched and deformed steel, was found using the HMT technique. The HMT process can be used on a variety of materials, including austenitic stainless steel, high strength steel, and low carbon steel [28]. During the procedure, a thin layer of AgBr gel is placed on the face of the hydrogen-charged substance. Hydrogen interacts with a silver salt as it breaks free of the metal. Following the reaction, silver ions take on a metallic form and leave an area where hydrogen contact occurred. The area has silver particles, and the extra unreacted gel is being removed from it. The sample is examined using a scanning electron microscopy (SEM), and when the sample is examined, hydrogen exits the areas where silver is present [29].

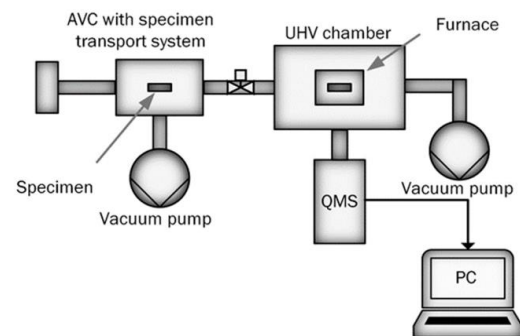
Figure 8. Schematic view of the TDS apparatus [11]

Certain features of the TDS spectra are associated with hydrogen trapping at dislocations, vacancies, vacancy complexes, grain boundaries, and interfaces of non-metallic inclusions (NMI), which enables the measurement of the hydrogen trapping activation energies. The TDS technique measures the amount of desorbed hydrogen by employing a limited and controlled heating procedure. There are traps in steel, and it's these traps that lead to the buildup of hydrogen. Hydrogen is absorbed by thermal energy when steel is heated and is released when the absorbed energy reaches a critical threshold, which is the same as the activation energy of desorption. Consequently, the temperature at which hydrogen atoms

are released is known as the desorption temperature. With quadrupole mass spectrometry, the amount of desorbed hydrogen is quantified. [11].

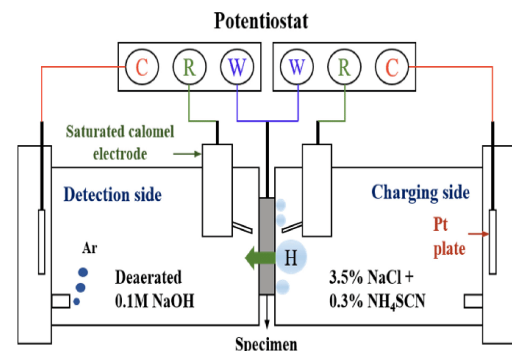
Figure 9 Schematic illustration of the electrochemical hydrogen permeation test [15]

The easiest method of measurement and the amount of diffusible hydrogen in steel are also determined by permeation testing. It is possible to determine and assess steel's HE susceptibility if the quantity of diffusible hydrogen is known. This permeation test has been used in conjunction with other testing techniques to successfully test steel [30]. In essence, this permeation test uses a two-cell system, with an entering cell (also called a charge cell) and an oxidation cell (also called an exit cell) in each chamber. A steel membrane divides these two chambers [31]. The process of electrochemistry has been employed for hydrogen charging. After entering the cell to charge it, the hydrogen moves to the oxidation cell with the assistance of membrane [15].

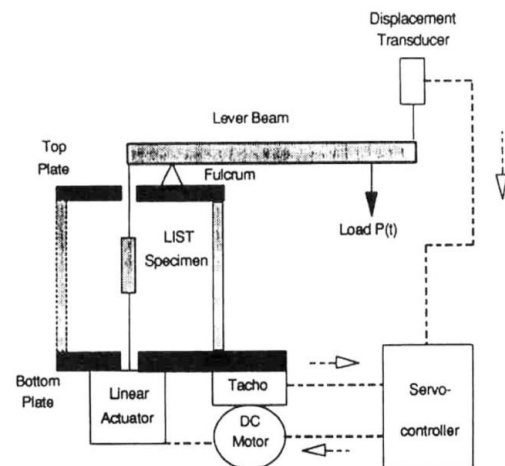
Figure 10 Schematic representation of the LIST apparatus [32]

This mechanical testing technique is used to find the HE in various material types. In this example, a sample was loaded and the applied stress was steadily increased until failure occurred. A load is applied by weight movement, and a motor regulates the load's rate of motion. Figure 10 shows the LIST method schematic. The specimen will fail whenever the threshold stress is reached in this load control HE measurement method, confirming the completion of the test. Using SEM, the fracture surfaces can be assessed after the LIST test [32]. Thus the impact of hydrogen on the material's interior microstructure can be determined. The most recommended, flexible, and user-friendly method for it is SEM. Additionally, SEM offers a three-dimensional image and shows fracture features like fisheyes, dimples, and micro voids [33 -34].

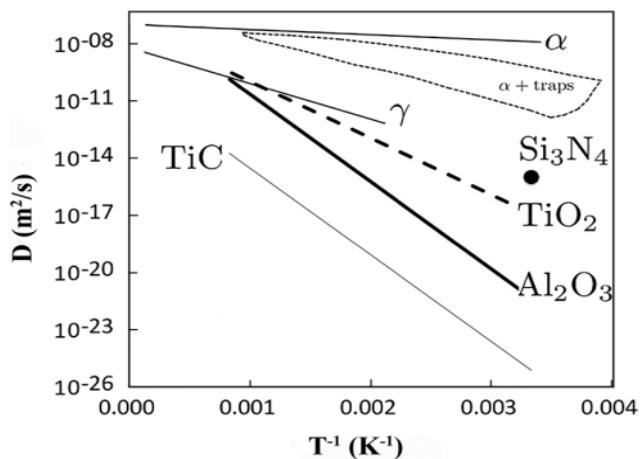
Figure 11 Temperature dependence of the hydrogen diffusion coefficient in different films [35]

Steels that are prone to hydrogen embrittlement, particularly lightweight, high-strength steels or low-cost alloy steels, should be able to be used in hydrogen-based economies thanks to hydrogen barrier coatings. Hydrogen barrier coatings are protective layers that have the ability to slow down, stop, or prevent hydrogen permeability [38]. They are made of materials with low intrinsic hydrogen diffusivity and solubility. When a coating is applied to a metal surface, hydrogen entrance into the alloy is inhibited, leading to high hydrogen resistance in the alloys [39]. When steels are treated to improve their resistance to air corrosion, a 1-3  $\mu\text{m}$  thick oxide layer is formed on their metal surface. This process is known as surface blackening. Furthermore, alloys' susceptibility to HE can be decreased and hydrogen infusion effectively suppressed by surface coatings of Ni, Cd, Al, and Al-Ni complex coatings [35]. Moreover, as figure 10 illustrates, hard coatings like TiC, Al<sub>2</sub>O<sub>3</sub>, and Si<sub>3</sub>N<sub>4</sub> are capable of significantly reducing hydrogen diffusion behavior [35]. Found that after coating the surface of stainless steel with a 1  $\mu\text{m}$ -thick TiN film, the metal's hydrogen diffusion coefficient decreased by five orders of magnitude.

The large difference in the rate of hydrogen diffusion between the austenite phase and the TiC and Al<sub>2</sub>O<sub>3</sub> coatings suggests that these films may be a good barrier to enhance the HE resistance of austenite steels. When nickel is coated on steel, it prevents hydrogen from diffusing through. Many coatings have been used as a barrier to stop hydrogen permeability, such as WC, TiC, TiN, TiO<sub>2</sub>, alumina, BN, and Cr<sub>2</sub>O<sub>3</sub>. Coatings consisting of Pt, Cu, Cd, Ag, Al, and Au can help reduce the amount of hydrogen that migrates inside steel [33] [38]. Another way to prevent HE is to coat the base material with a protective layer and incorporate some metal alloys into it [40]. Mechanical plating, organic coating, and vacuum deposited coating are a few of the coating methods. Using strong inhibitors is also crucial. When titanium is widely accessible, its presence can lower the HE susceptibility of a hot stamped boron steel by forming titanium carbide inside the alloy [41]. According to some authors, alloying aluminum may also aid in reducing the HE effect. Coatings using niobium and graphene can also shield materials from HE [42].
