Research Article

ANALYSIS OF URBAN TRANSFORMATION APPLICATIONS USING GIS METHOD (ÇALILIÖZ NEIGHBORHOOD/KIRIKKALE EXAMPLE)

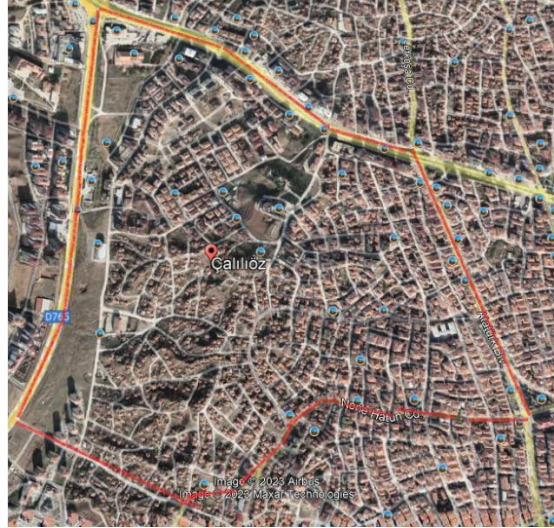
Figure 1. Satellite view of Çalılıöz neighborhood

Çalılıöz neighborhood is the district with the highest population in the province, with Kırıkkale-Kırşehir highway on its left side and Atatürk Boulevard on its right side. Under this heading, brief information is given about the parks and green areas, health areas, education and training areas, and building floor status of Çalılıöz neighborhood. Figure 1 shows the satellite image of Çalılıöz neighborhood. In Table 1, the buildings in the neighborhood are evaluated on a provincial basis. According to the table, it was seen that most of the risky buildings were demolished. In addition, it was observed that 105 of the risky buildings were built with the masonry construction system.

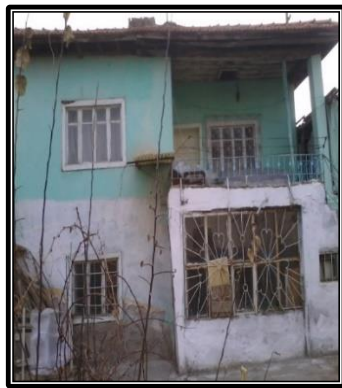
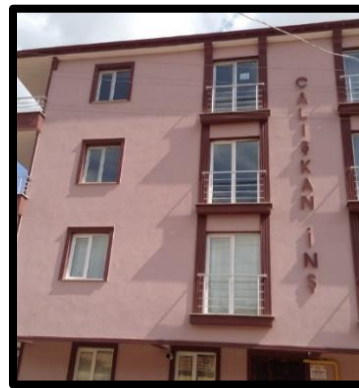
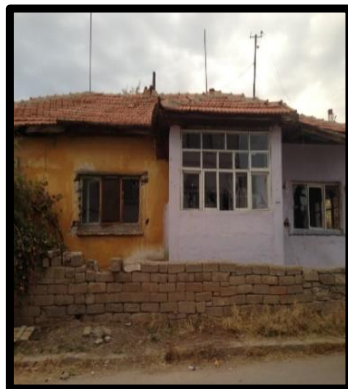
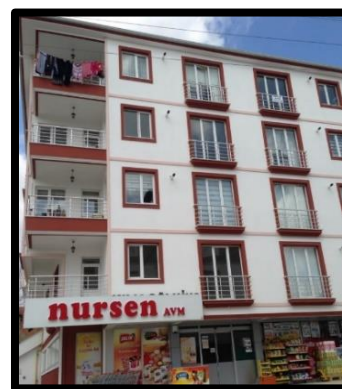
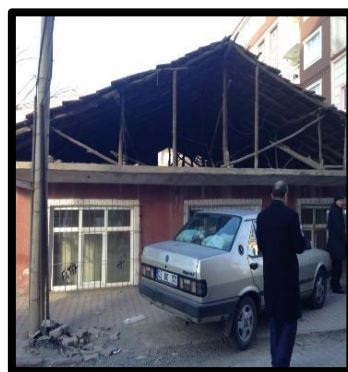
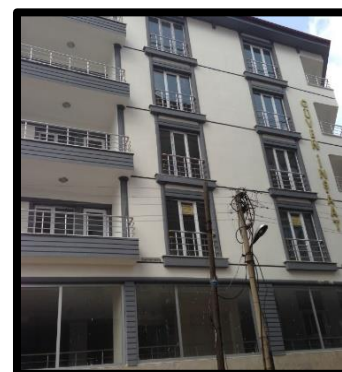
Figure 2. Images before and after urban transformation

It was observed that mostly consisted of single storey or ground + 1 floor of risky buildings in the neighborhood that the study area. After urban transformation, buildings were mostly planned as ground + 4 floors. Almost all single-storey buildings have been converted or are waiting to be transformed within the scope of urban transformation. Risky buildings are scatter within the borders of the neighborhood. Urban transformation was applied to risky buildings located on Atatürk Boulevard, Halide Edip and Nene Hatun Streets in Çalılıöz neighborhood. These structures contributed positively to the aesthetic structure of the street. The majority of risky buildings are located on side streets such as 433rd Street, 360th Street, 429th Street. Figure 4.6 shows building images before and after urban transformation.

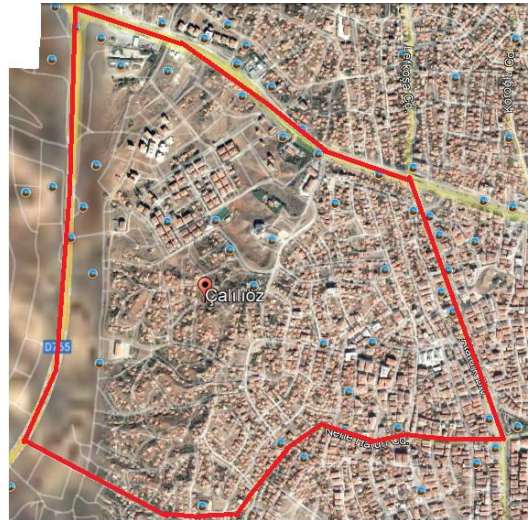
Figure 4. Satellite images of Çalıöz neighborhood in 2002

According to the 2002 view; It was observed that the building density increased towards the intersection of Atatürk Boulevard and Nene Hatun Street. The region facing the Kırıkkale-Kırşehir D765 highway (left part of the neighborhood) is the region with low building density. Since the urban transformation law came into force in 2012, it is not possible to mention this concept in the 2002 images.

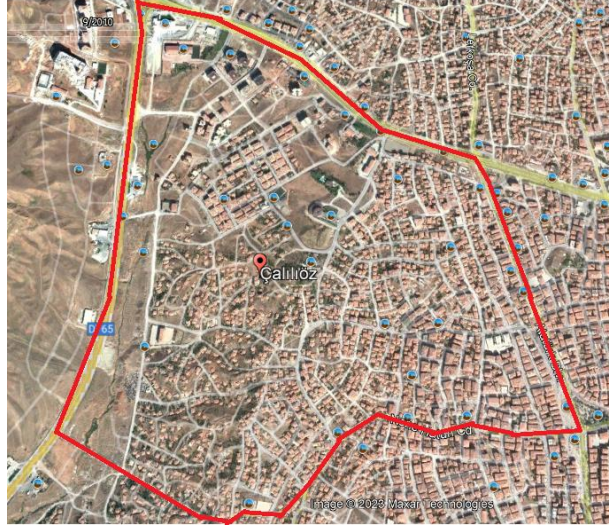
Figure 5. Satellite images of Çalılıöz neighborhood in 2010

When the 2010 image is examined; there are no major visible changes in the neighborhood between 2002 and 2010. While the population of Kırıkkale province was 286,999 in 2002, it was 280,834 in 2010. The decrease in the population of the city supports the lack of change.

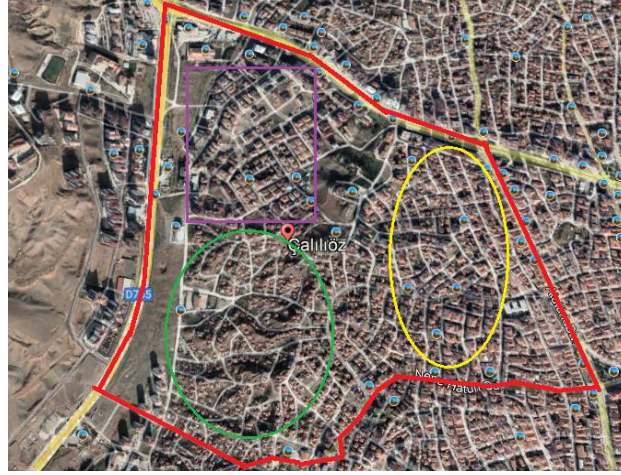
Figure 7. Satellite images of Çalıöz neighborhood in 2023

When the 2023 image is examined; it was observed that the building density increased throughout the neighborhood. The region called the upper part of the neighborhood (the region in the purple area) is a region close to the key point connecting the West to the Black Sea, the East and the South. For this reason, people concentrated on this region. Another reason is that this area, located in the northwest of the city, is handy to the university and High Specialization hospital. In the region (marked in yellow) between Atatürk Boulevard and Nene Hatun Street, where risky areas and urban transformation applies is mostly, according to the previous year, It has been observed that small-sized structures have transformed into large-sized structures. This supports the fact that single-storey buildings collapse and turn into big buildings. It has been observed that the building density in the area fronting the Kırıkkale-Kırşehir highway (marked green) has not changed much, but the green areas have increased. In the research

conducted in the area, it was determined that there are many buildings that are not included in the scope of urban transformation but that we call abandoned.
